Review and Study on Evolution of the Cracks in Karun 4 Dam during First Impounding

Mohammad Ali Karimi¹, Ghasem Basereh², Fatemeh Momeni¹

1- AbanPazhouh Consulting Engineers, Tehran, Iran

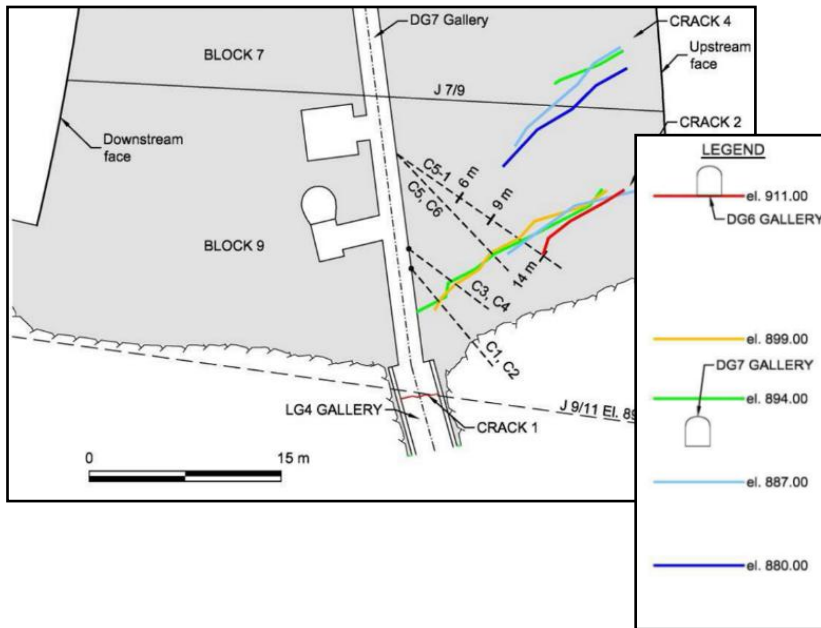
- i) April 16, 2010 (RWL: 938 masl): First subvertical crack was observed at the interface zone of dam gallery DG7 and foundation gallery LG4 (at elevation 890masl). This crack is formed within the overbreak area almost along extension of the contraction joint 9-11, where terminated in the upper lift-joint (Crack 1 in Figure 4). Based on the investigation results, this crack evaluated as the minor local crack and it was treated with some traditional measures in order to control its dropping leakage [3] [4].

Figure 4. Close-up view of 1st & 2nd cracks in block 9 and crack in block 7 (EL. 890masl)

- The cracks in block 9 (Figure 4) and block 7 (Figure 8) are forming between the two potential weak planes: “dam-foundation contact” and “dam vertical contraction joint”. Furthermore, the crack in block 7, and some branches of crack in block 9, intersects the dam contraction joints. Logically, in case of “defective dam design”, “inadequate bearing capacity of dam abutments”, or “lack of proper arch behavior in the dam body (due to inadequate grouting of the dam contraction joints)”, it is expected to have openings through the typical weak planes in the dam body, like vertical contraction joints and the dam-foundation contact. The crack situations in Karun 4 dam do not comply with this concept, and could be clearly concluded that all of the mentioned scenarios have no, or at least minor, role in crack formation.

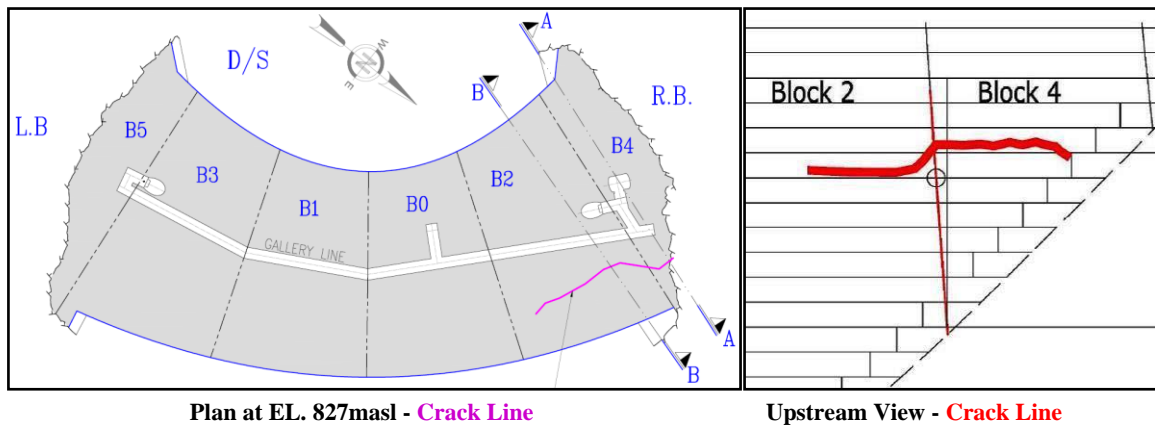
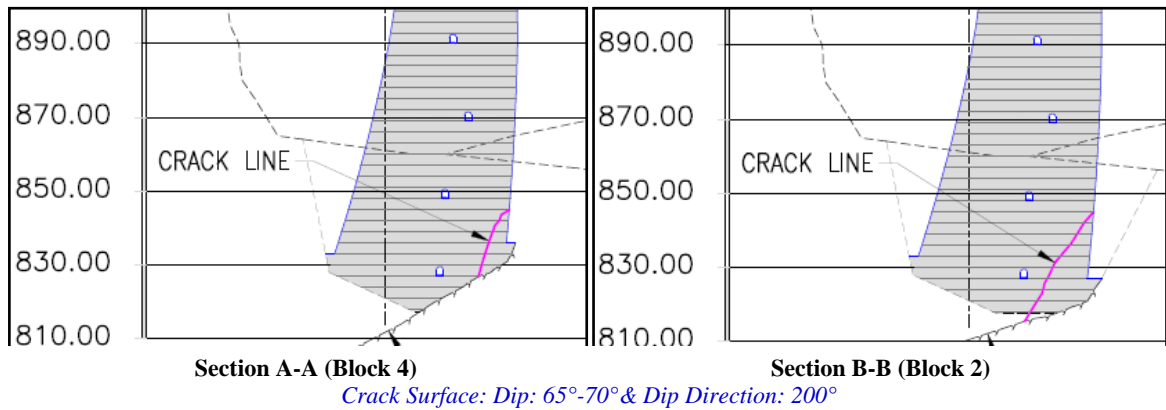
- ii) August 23 to October 30, 2010 (RWL: 1002 to 1008 masl): Leakage from air grooves of block joint 2/4 was firstly detected in dam gallery DG9 (at EL. 848masl) and then, in dam gallery DG10 (at EL. 827masl). In the relatively short time, leakage in dam gallery DG10 (at EL. 827masl) increases from 2 to 32 l/min. By grouting of the air grooves of joint 2/4 in dam gallery DG10 (in winter 2010) leads to increase of leakage in gallery DG9 from 2 to 47 l/minute. In May 2013, shortly after closing of the air outlet valves of joint 2/4 in gallery DG9, a new crack at close to the block joint 2/4, with somehow the same leakage, was formed (after this event, air outlet valves are reopened). Based on these events, the leakage from block joint 2/4 could be correlated with initiation and/or development of the cracks in dam blocks 2 and 4, which later observed by special investigation on the upstream face (Figure 5) [3].

Figure 5-Overall geometry of the Crack(s) in blocks 2 and 4

- Aperture of the crack outcrop in blocks 2 & 4 varies between few millimeters up to about 2cm (Figure 10). It should be noted that the wide apertures are apparent and local and the actual opening of the crack(s) based on the observations and borehole investigation results, is in order of mm. The variable and non-uniform situation of the crack outcrop does not comply with the potential “tension-crack” that could be formed in the lower parts of the dam upstream face due to hydrostatic loading.

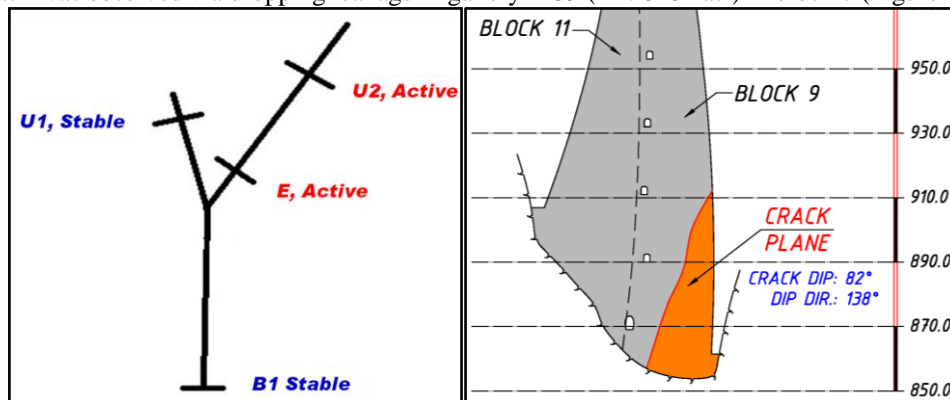
Figure 6. Crack in block 9 - Schematic view of Crack outcrop & its instruments and the investigated crack plane

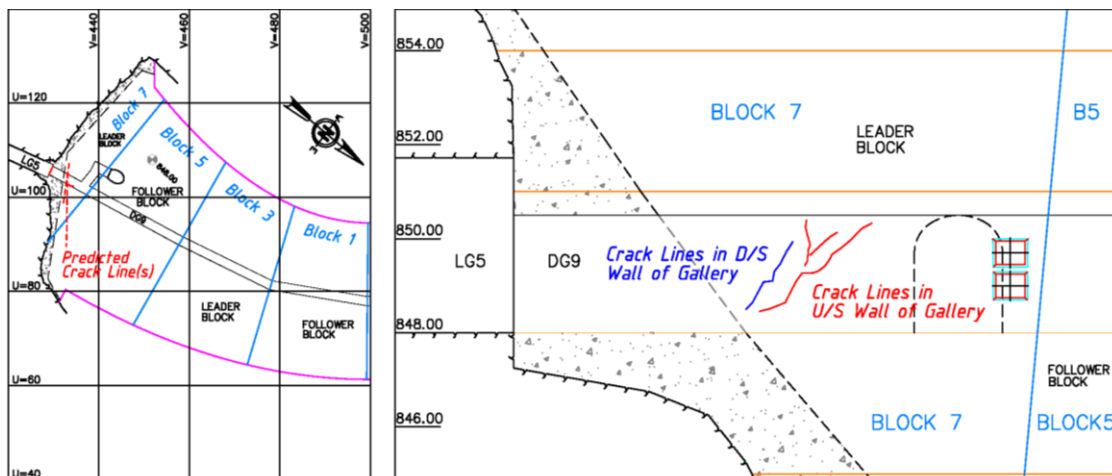
- iv) April 10, 2011 (RWL: 1019 masl): Almost one month later of observing cracks in block 9, a similar crack was observed via dropping leakage in gallery DG9 (EL. 848masl) in block 7 (Figure 8) [3].

Figure 8. Crack in block 7 in gallery DG9 (at EL. 848masl) - Plan & vertical section through the gallery

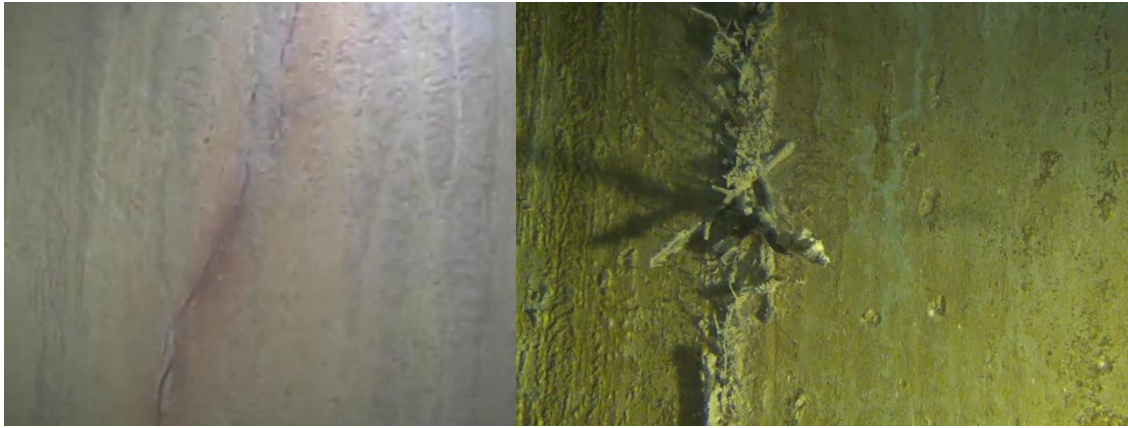
- The observations proved the leakage flow from the reservoir through the crack plane. The flow intensity was clearly visible through the height of the crack outcrop; and it could certainly be said that the leaked water through the crack plane is just partially (few percent) discharged in the dam gallery. This fact indicates the direct relation and connectivity between the dam crack(s) and the adjacent foundation discontinuities (Figure 10). Studying of geological section through the dam abutments indicates the fact that a number of subvertical and inclined major joints (and secondary faults) are intersecting with the dam body adjacent to the blocks 7 and 9 (Figure 10) [3].

Figure 9. Cracks in blocks 7 (left) and 9 (right) – sample photos from crack outcrop in dam upstream face (2013)

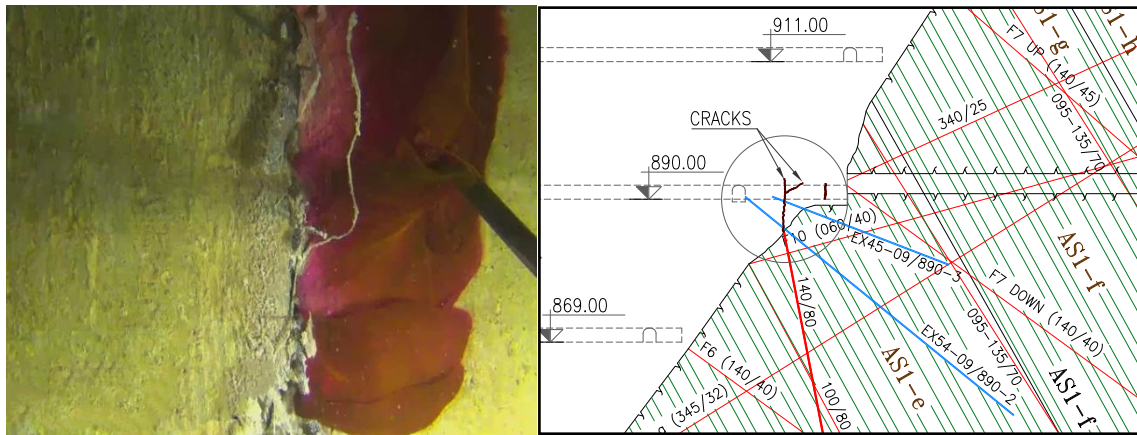
Figure 10. Dye test of the Crack in block 9 and geological section through the dam abutment close to blocks 7 & 9

- Observation of the colored materials in the leaked water to the dam gallery DG7, regardless of whether it was low, proves that the outcrops in the upstream face and inside the gallery are related to the same crack plane.

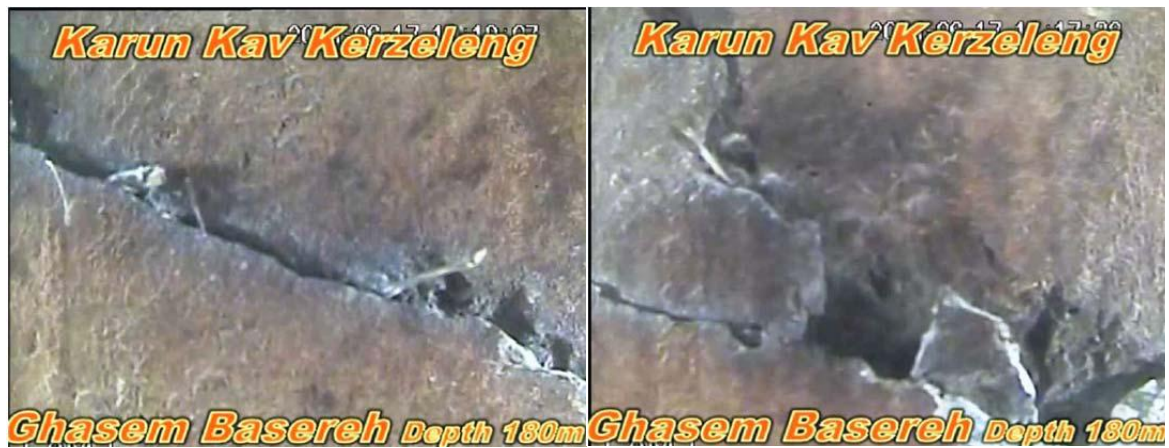
In May 2014, similar investigations were performed by the specially designed multifunction device for exploring of possible cracks in dam blocks 2 and 4. In these investigations, the device was equipped with driving engine and motorized cleaning brushes in order to clean the dam face and providing detail inspection of the crack outcrop. The results enlighten many facts about the crack and appearance specification of its outcrop (Figure 11). Observations showed that the crack outcrop is quasi-horizontal, starts (initiates) from the dam abutment at elevation about 845 (in right bank) and extends through dam blocks 2 and 4. Further investigations (drilled boreholes) indicate a downstream dip of 65° to 70° for the crack plane (Figure 5) [3]. Comprehensive borehole drilling program for investigating geometry of the dam cracks and was started by a professional contractor in spring 2014. Since then, many boreholes have been drilled both for investigation purposes and for rehabilitation works (resin grouting through the crack plane). Accordingly, the detailed geometries of the dam cracks, where presented in foregoing figures, are defined.

Figure 11. Crack(s) in blocks 2 and 4 – sample photos from crack outcrop in dam upstream face(2013)

- The presence of debris trapped inside the crack plane (both in crack in block 2 and crack in block 9) might be considered as the indication for evidence of cracking before impounding, because in case of crack initiation after impounding, such phenomenon would be very unlikely.

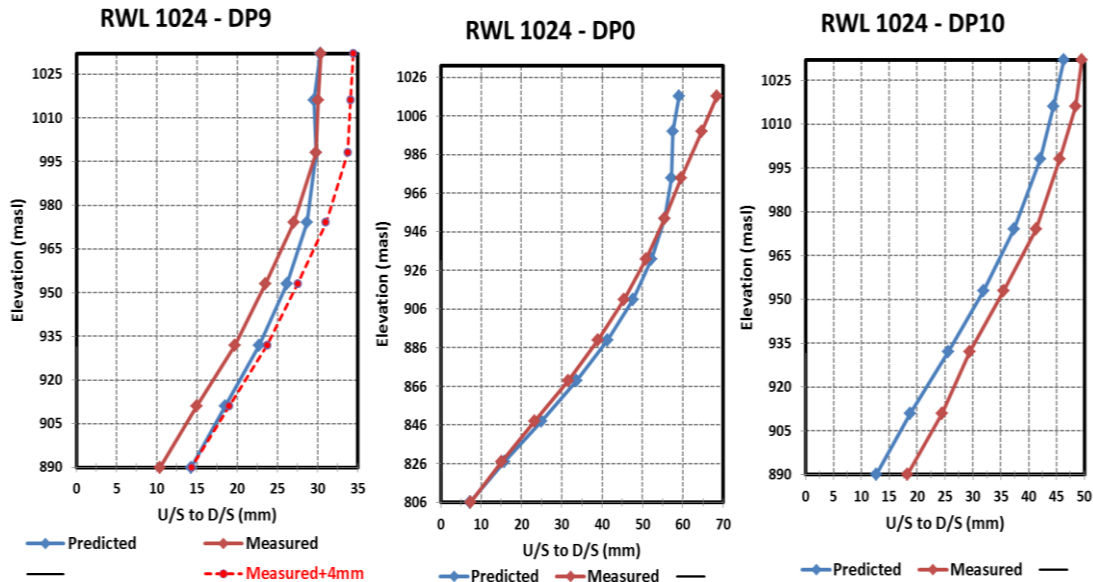
- Direct and inverted pendulums results, as the most reliable and simple instrument, indicate reasonable displacements in upstream-downstream direction in the dam and foundation in left, center, and right bank (Figure 12).

Figure 12. Measured and predicted dam and foundation displacements toward D/S – Pendulum results in May 26, 2011
