Sensitivity of the Monitoring Results and their Interpretation to Minor Imprecision in Instrument As-Built Drawings (Case Study of Karun 4 Dam)

Mohammad Ali Karimi¹, Mohammad Reza Abedini¹, Ali Dadi¹, Fatemeh Momeni¹
1- AbanPazhouh Consulting Engineers, Tehran, Iran

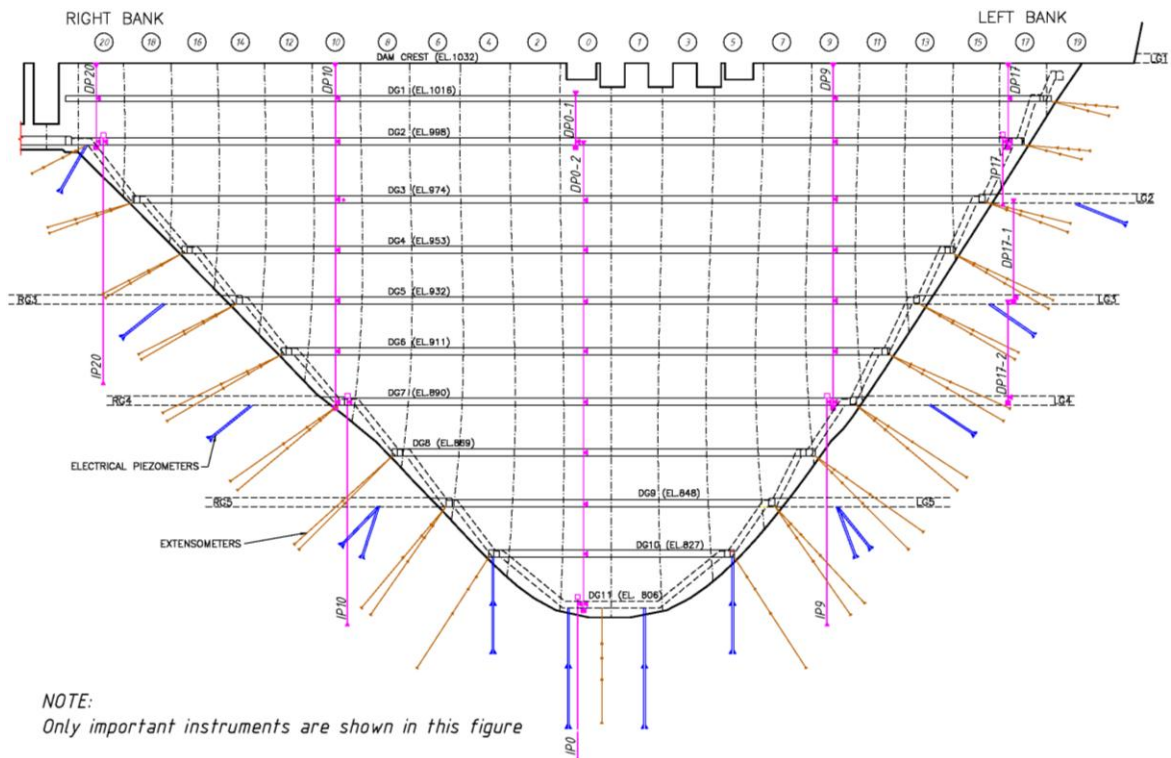
Because of malfunctioning of the invert pendulum IP17 at early stages after start of impounding, this pendulum reinstalled on its upper 1/3 depth and its remaining defective parts replaced by two direct pendulums DP17-1 & DP17-2, as shown in Figure 2. This rehabilitation and replacement works lasted almost until the end of the first reservoir impounding; therefore, representative pendulums for evaluation of the dam behavior are “IP10 & DP10” in the right, “IP0, DP0-2 & DP01” in the center, and “IP9 & DP9” in the left.

Figure 2. Main instrumentation of the Karun 4 dam and its foundation (dam D/S profile)

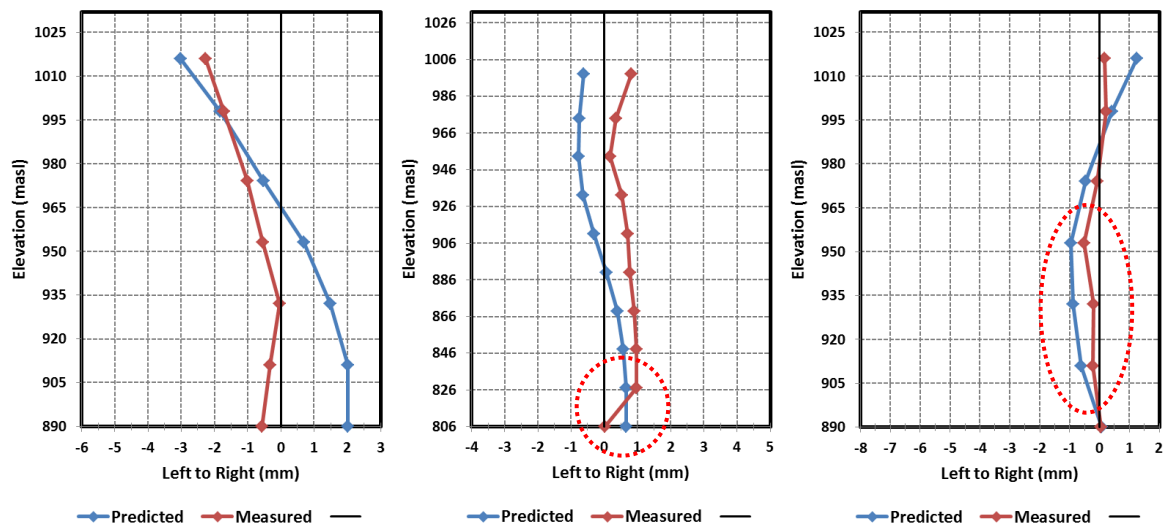
By growing up of reservoir water level during the first impounding, a series of abnormal lateral (left to right) displacements were resulted in some pendulum measuring stations, especially in pendulums in central block “0” and block “10” in right bank [2] [4]. The related predicted and measured “left to right” displacement lines are presented in Figures 3 to 5 corresponding to reservoir water levels (RWLs) 980, 1005 & 1016 masl, respectively. The “zigzag” or “broken” displacement lines, which somewhere intersect the predicted displacement lines, could not be explained by the elastic deformation of the continuum dam body; considering that the dam body is relatively rigid against lateral displacements. These abnormal pendulum results had been remained during operation for about 5 years.

Figure 3. Abnormalities in pendulum results in block 9 (left), block 0 (center) & block 10 (right) – RWL 980masl

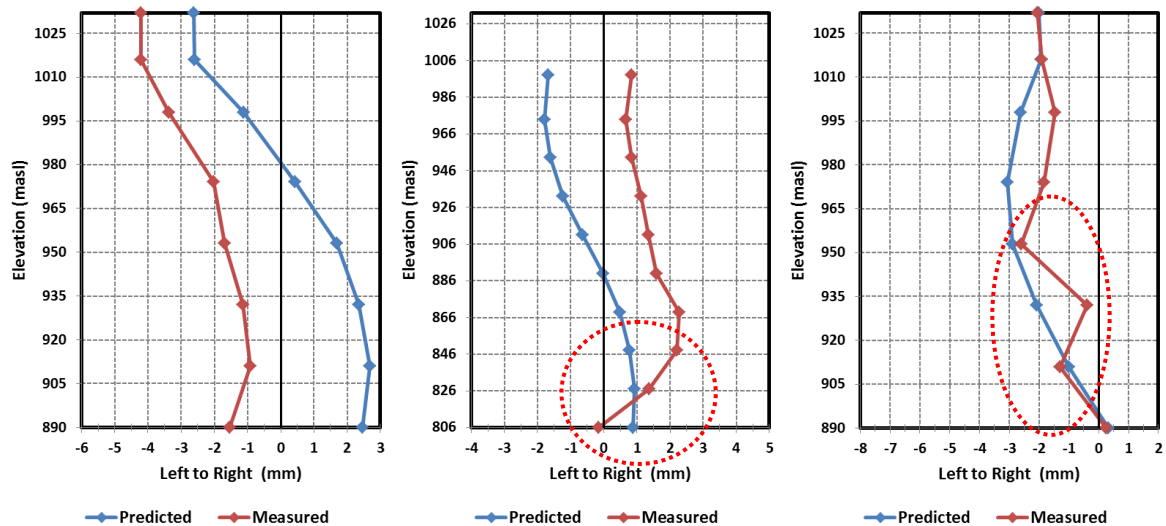
Figure 4. Abnormalities in pendulum results in block 9 (left), block 0 (center) & block 10 (right) – RWL 1005masl

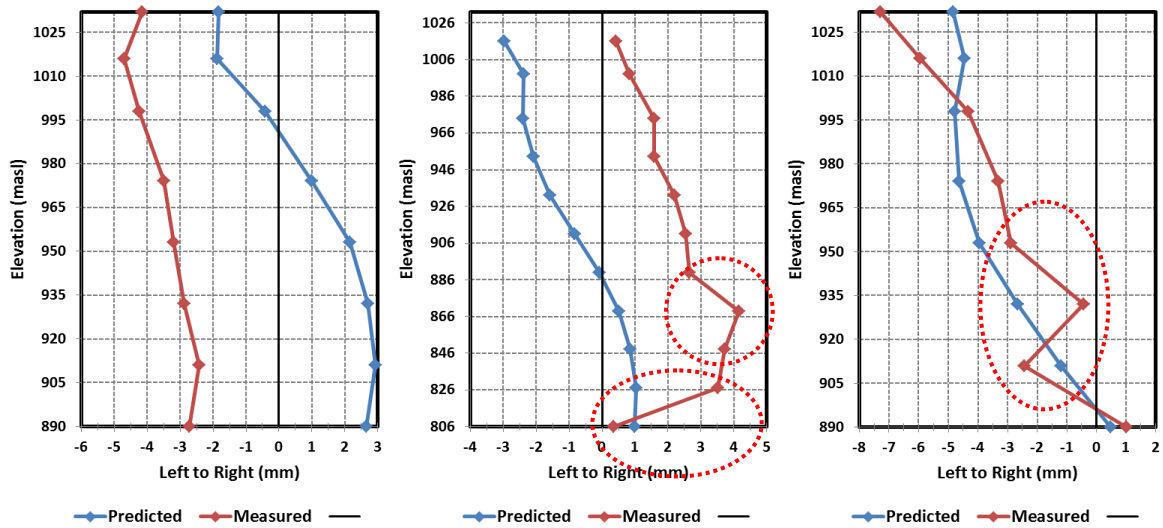
Figure 5. Abnormalities in pendulum results in block 9 (left), block 0 (center) & block 10 (right) – RWL 1016masl

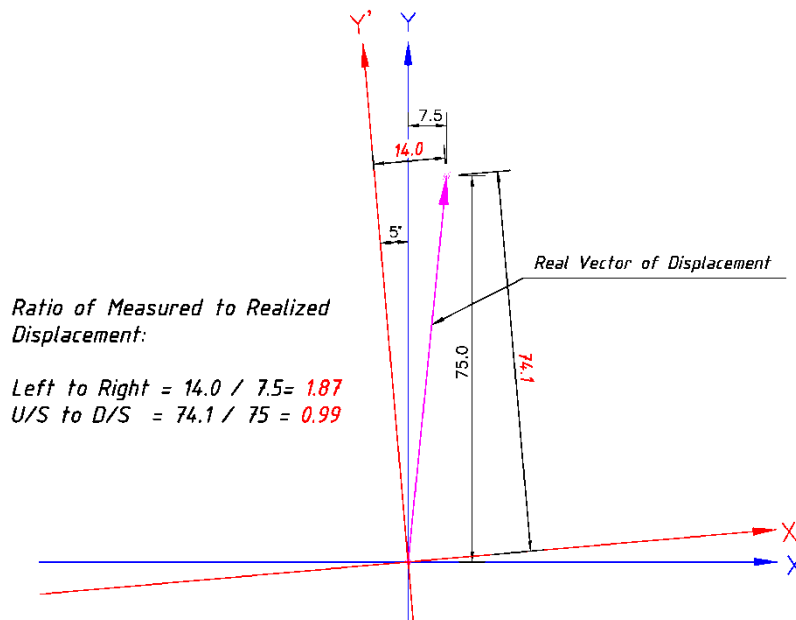
The obtained results are presented in Table 1; accordingly, the average deviation in set plate azimuths is about 2.7 degrees, with the maximum values of 4.5° in block 9, 5.1° in block 0, and 6.4° in block 10. Despite these minor deviations in the pendulum set plates, sensitivity analysis of the displacement vector indicates that the lateral component of displacement is highly sensitive to minor variation of the set plate azimuth. As indicated in Figure 7, 5°-rotation in set plate azimuth could introduce 87% error in the lateral displacement component. This effect magnifies by increasing the displacement component in U/S-D/S direction.

Figure 7. Sensitivity of the lateral displacement component to minor deviation in set plate azimuth

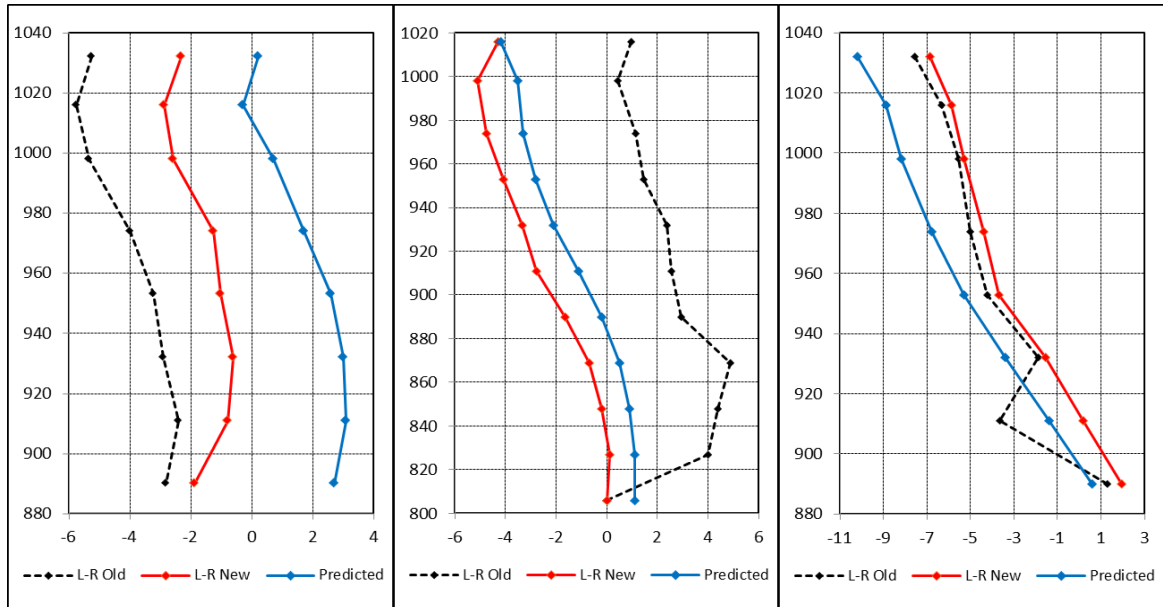
Modified pendulum results by applying the related transfer matrix for each reading station are presented in Table 2 and Figure 8. As indicated, the lateral displacement lines are fully changed and the broken and sharp variations are almost disappeared. The other important issue is changing the tendency of lateral displacement in block “0” (central block) toward the left bank, as expected due to the dam geometrical specification.

Figure 8. Old & New (modified) pendulum results in left to right direction – Pendulums 9, 0 & 10 - RWL 1026m
