AN EXTRAORDINARY EVENT AT THE MARIBORSKI OTOK DAM

P. ŽVANUT

Slovenian National Building and Civil Engineering Institute, Ljubljana, Slovenia

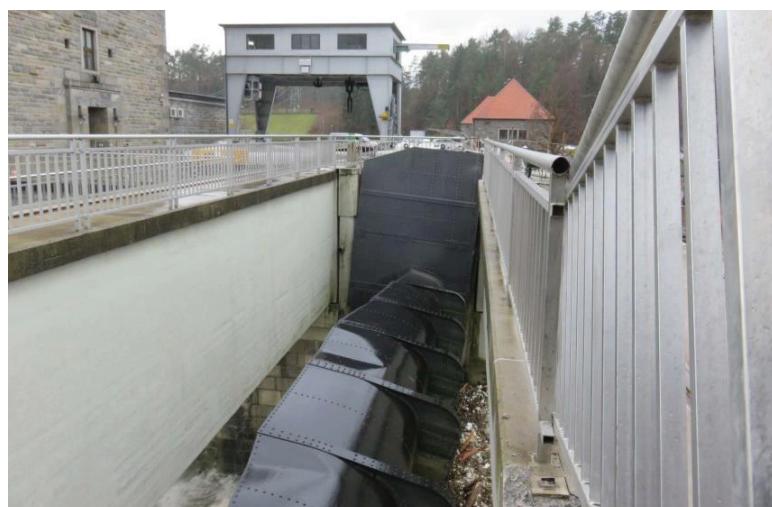
In December 2017, the malfunction of the steering system of the upper spillway gate management of the fourth spillway caused unexpected overflowing of $230 \text{ m}^3/\text{s}$ of water between steel gates, which severely damaged the upper spillway gate (Fig. 6). In addition, the concrete beam of the crane rail on the crest of the dam was also damaged (Figs 7-8).

Figure 6 : Inclined and damaged the upper spillway gate in the fourth spillway.

The scope of the renovation includes the repair of damage of the concrete structure and the repair of the equipment of the spillway gate of the fourth spillway on the following sets of equipment: upper spillway gate, lower spillway gate, drive mechanisms and concrete parts.

- disassembly and cutting of the upper spillway gate,
- displacement and support of the lower spillway gate,
- disassembly of the lower spillway gate equipment,
- implementation of non-destructive testing on equipment,
- production and supply of new upper spillway gate and other equipment,
- renovation, reconstruction and modification of existing equipment,
- corrosion protection of equipment,
- construction works,
- delivery and replacement of electrical equipment,
- assembly of equipment,
- testing of equipment and finally
- trial operation.

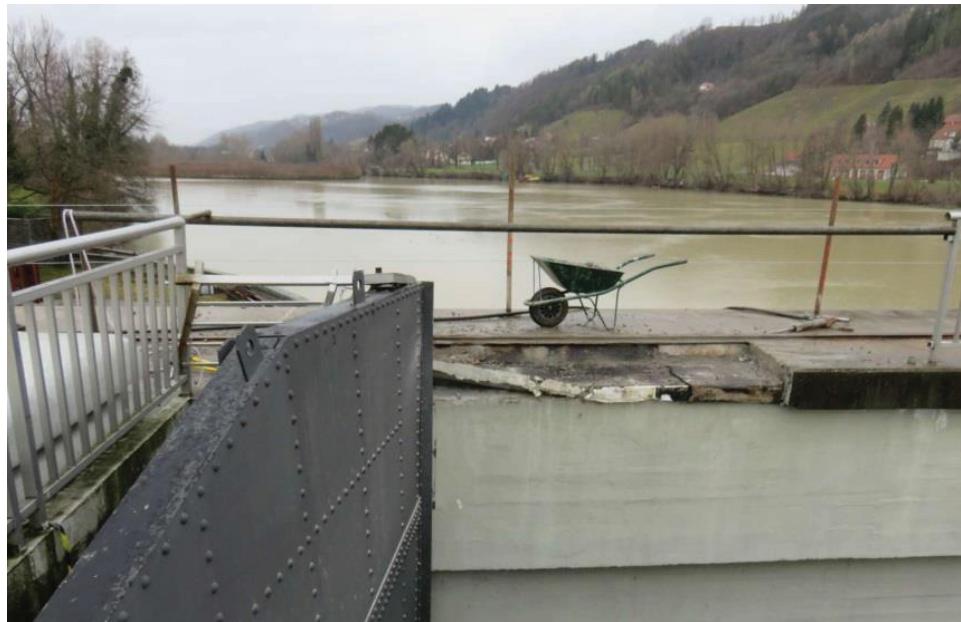
Figure 7 : Damaged concrete beam of the crane rail on the dam's crest (right side of the fourth spillway).

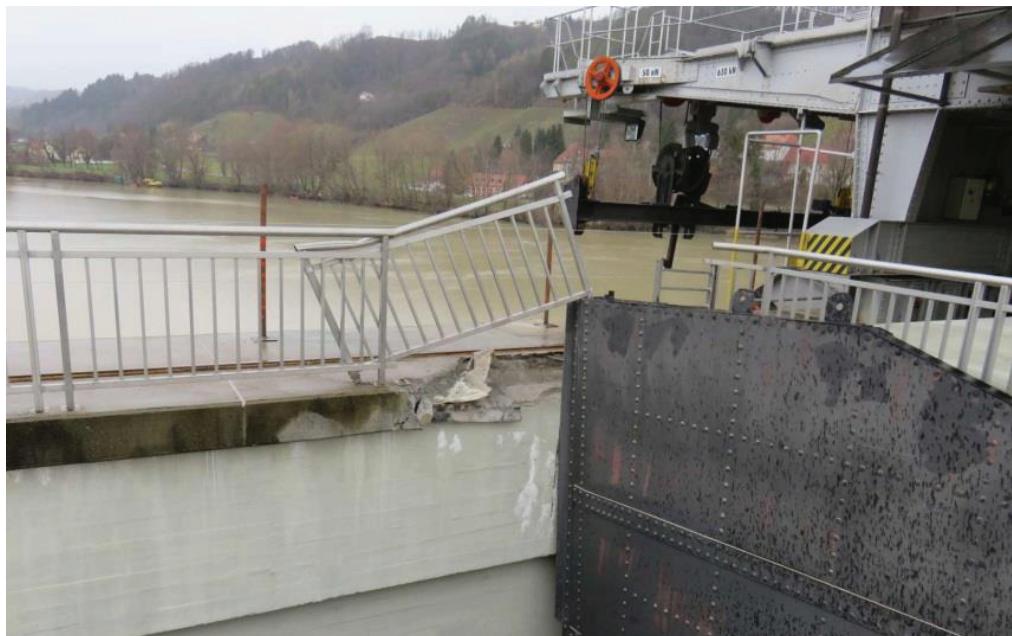
Figure 8 : Damaged concrete beam of the crane rail on the dam's crest (left side of the fourth spillway).

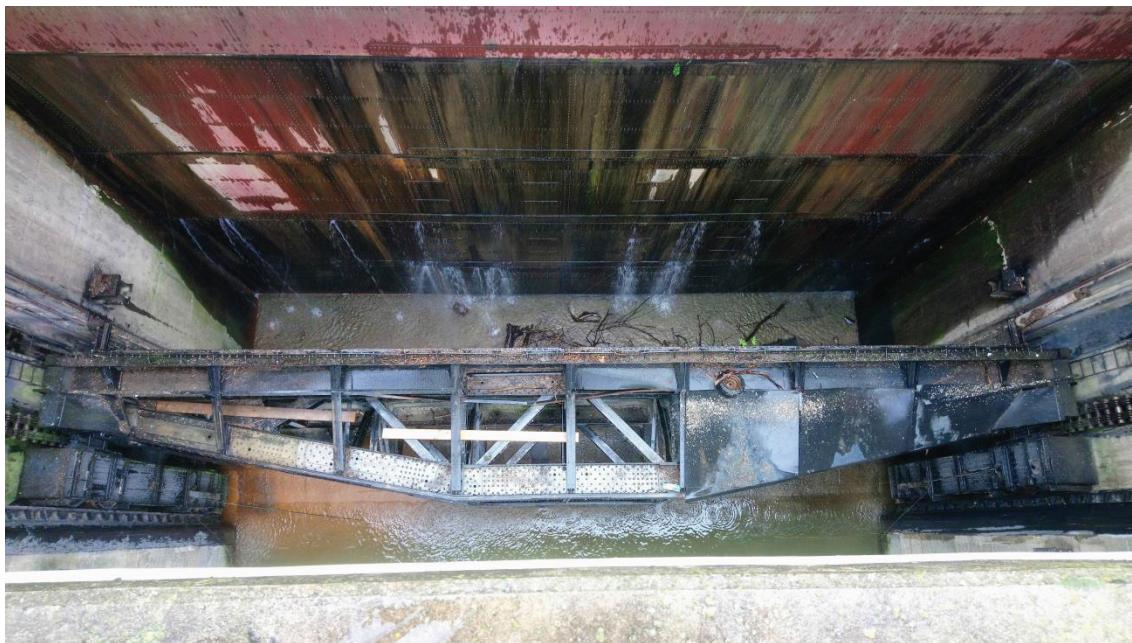
Figure 9 : The first phase of rehabilitation works - auxiliary spillway gates inserted.

However, technically demanding rehabilitation works on the dam, estimated at about 2 million euros, were anticipated. Firstly, auxiliary spillway gates were inserted (Fig. 9), which enabled, for the first time since the dam was built, the required lowering of the reservoir level by 6.5 m. In September 2019, the second phase started (Fig. 10), which includes restoration of the damaged concrete structure and of the spillway gate as well as the restoration of the remaining undamaged equipment of the fourth spillway, with the main purpose of extending its service life by another 30-40 years. Rehabilitation works are expected to be completed by the end of 2020.

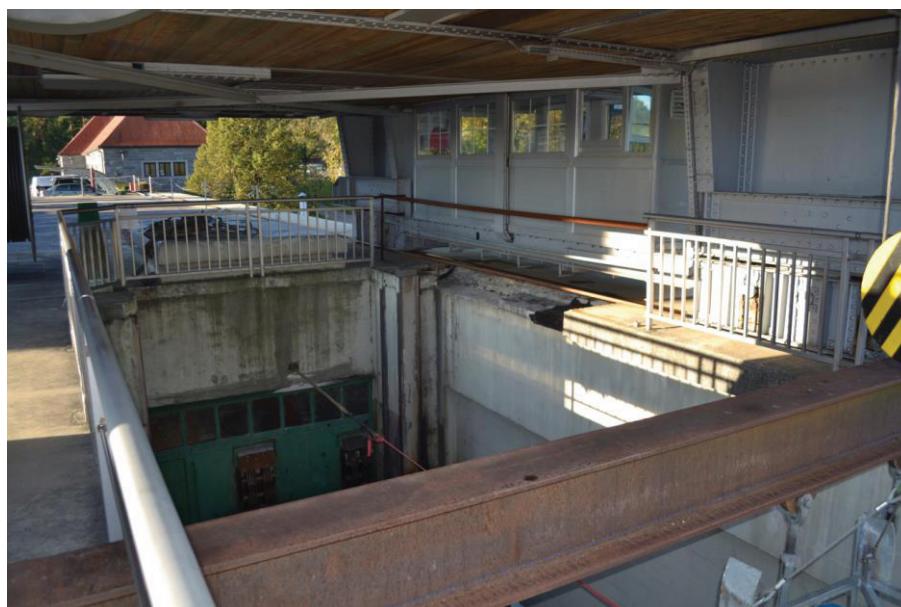
Figure 10 : The start of the second phase of rehabilitation works – disassembly of the upper spillway gate.
