ASSESSMENT OF SEEPAGE THROUGH SUBSOIL OF HIDKAL DAM, KARNATAKA AND REMEDIAL MEASURES

DR. SANJAY A. BURELE

Scientist 'B', Central Water and Research Station, Pune, India

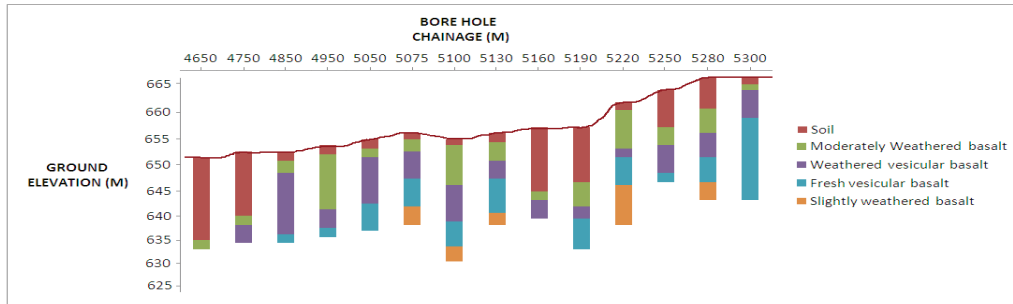
Figure 1 : Borehole data of Dyke-1 of Hidkal dam

It was observed that the principal rock formation at the upstream as well as on the downstream side of Dyke-1 is weathered basalt, though stretches of quartzite at depths has also been encountered. The rock mass was found to have undergone various degrees of weathering and disintegration from ground level to depths ranging from 0.6 m to 20 m. After inspecting the rock cores and the permeability test results at the Ch. 4050 to 5330 m, it was observed that core recovery was very poor and the strata was not improving even at depth of 15 m as shown in Figure 1. So, it was suggested to the Project Authorities to arrange to drill the inspection bore holes up to 20 m depth from Ch. 5100 to Ch. 5330 m. All the cores were inspected as per the core logs prepared by the site geologist. The layout of investigation hole of Dyke-1 of Hidkal dam is given in Figure 2 and the details of Borehole data of Dyke-1 of Hidkal dam are shown in Figure 1.

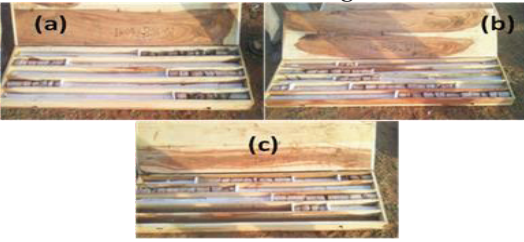
Details of borelogs, permeability values	Description of borelogs
<p>IH-9 CH:5300 26 to 262 lugeons</p>

<ul style="list-style-type: none"> ➤ 0 to 1 m- soil layer ➤ 1 to 2 m- slight to moderately weathered medium grained granite rock ➤ 5 to 6.5 m- soil layer with grayish to pinkish colour of return water was found ➤ up to depth 20 m - weathered medium grained pinkish granite rock
<p>IH-8, CH: 5280m, 62 to 130 lugeons</p>

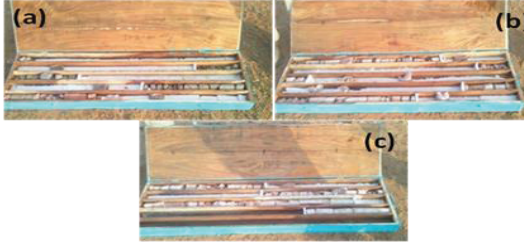
<ul style="list-style-type: none"> ➤ 0 to 5 m- soil layer with in between slight to moderately weathered medium grained granite with grayish colour of return water ➤ 1 to 2 m- slight to moderately weathered medium grained granite rock ➤ 5 to 6.5 m- soil layer with grayish to pinkish colour of return water was found ➤ up to depth 20 m - weathered medium grained pinkish granite rock
<p>IH-7, CH: 5250m, 54 to 132 lugeons</p>

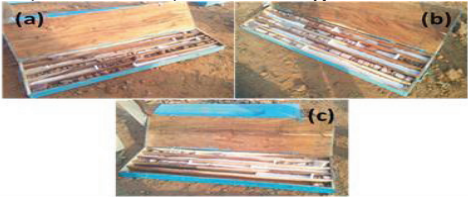
<ul style="list-style-type: none"> ➤ 0 to 3 m soil layer with grayish colour of return water ➤ 3 to 4.5 m weathered medium grained pinkish grey granite rock ➤ 4.50 m to 15.0 m weathered Medium grain grey granite ➤ 15.0 to 20.0 m weathered medium grained pinkish granite

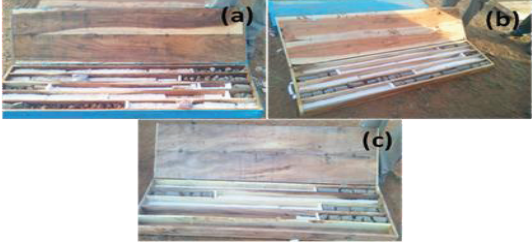
<p>IH-6, CH: 5220m, 50 to 498 lugeons</p>

<ul style="list-style-type: none"> ➤ From top to 1.2 m depth. The core log shows up to 1.5m soil layer with black pebbles ➤ From 7.5 to 9 m slight to moderately weathered medium grained granite with pinkish colour is found. ➤ From 9 to 13.5 m soil layer with reddish colour of return water.
<p>IH-5, CH: 5190m, 60 to 157 lugeons</p>

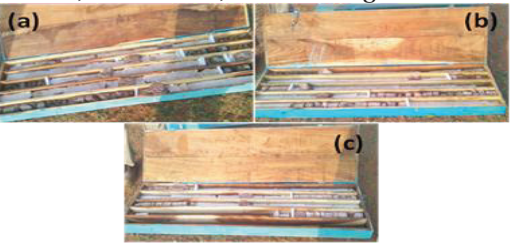
<ul style="list-style-type: none"> ➤ Up to 9.0 m slight to moderately weathered medium grained granite rock ➤ 9 to 13 m and 14.5 to 15 m there was a soil layer with pinkish colour of return water
<p>IH-4, CH: 5160m, 54 to 203 lugeons</p>

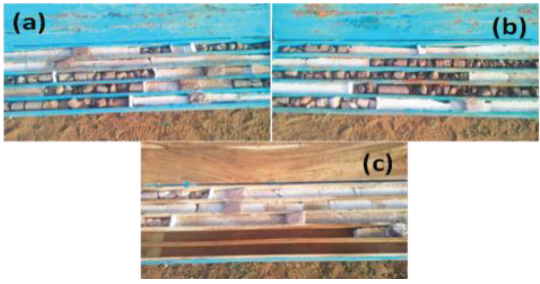
<ul style="list-style-type: none"> ➤ 0 to 3 m soil with a layer of slight to moderately weathered medium grained granite in between soil with whitish colour of return water. ➤ 3 to 7 m there was slight to moderately weathered medium grained granite with grayish colour. ➤ 7.5 to 12 m slight to moderately weathered medium grained granite with grayish colour is obtained. ➤ 12 to 13.5 m there was slight to moderately weathered medium grained granite with pinkish colour is found. ➤ 13.5 to 15 m there was slight to moderately weathered medium grained granite with whitish colour is obtained. From 15 to 18 m there was slight to moder-

<p>ately weathered medium grained granite with pinkish</p> <ul style="list-style-type: none"> ➤ Colour was found 18 to 20 m slight to moderately weathered medium grained granite with pinkish to whitish colour is found.
<p>IH-3, at CH: 5130m, 60 to 147 lugeons</p>

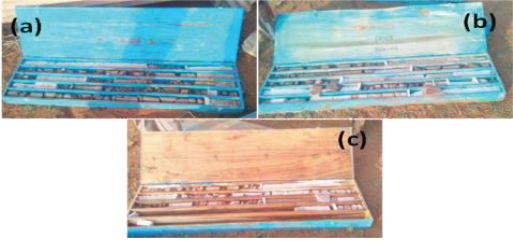
<ul style="list-style-type: none"> ➤ Top 1.5 m soil with a layer of weathered medium grained granite in between soil. ➤ 1.5 to 4.5 m slightly to moderately weathered medium grained granite. ➤ 5 to 7.5 m slightly to moderately weathered medium grained granite grayish colour. ➤ 7.5 to 11 m there is slightly to moderately weathered medium grained granite with pinkish colour shade is obtained. ➤ 12 to 13 m a soil layer is found. ➤ 13 to 14.5 m there is slightly to moderately weathered medium grained granite. ➤ 14.5 to 15 m there is soil layer with reddish colour of return water.
<p>IH-2, at CH: 5100m, ≥ 60 lugeons</p>

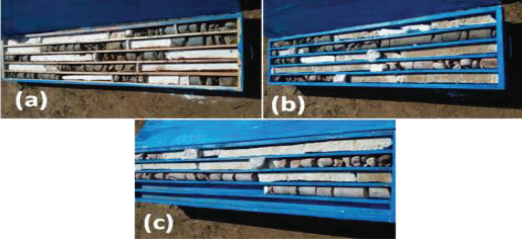
<ul style="list-style-type: none"> ➤ 1m soil layer. ➤ 1 to 7.5 m-slight to moderately weathered medium grained granite with whitish colour. ➤ 7.5 to 10.5 m slight to moderately weathered medium grained granite with whitish colour. ➤ 10.5 to 13.5 m-slightly weathered medium grained granite with reddish colour. ➤ 13.5 to 15 m colour gradually changes from pinkish to red colour ➤ 15 to 15.5 m slightly weathered medium grained granites reddish to pinkish colour. ➤ 15.5 to 17.5 m soil layer with pinkish to white colour of return water. ➤ 17.5 to 18.5 m slightly weathered medium grained granite ➤ 18.5 to 20 m slightly weathered medium grained granite

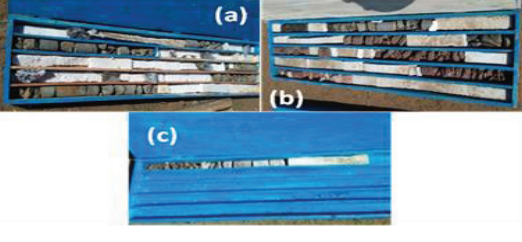
<p>IH-1 at CH: 5075m, ≥ 60 lugeons</p>

<ul style="list-style-type: none"> ➤ Up to 1 m soil layer. ➤ 1 to 2 m soil layer with slight to moderately weathered medium grained granite rock. ➤ 2 to 3 m slight to moderately weathered medium grained ➤ 3 to 6.5 m soil layer with slight to moderately weathered medium grained granite. ➤ 6.5 to 9 m slight to moderately weathered medium grained granite. ➤ 9 to 16 m slightly weathered medium grained granite with pinkish to deep pinkish colour.

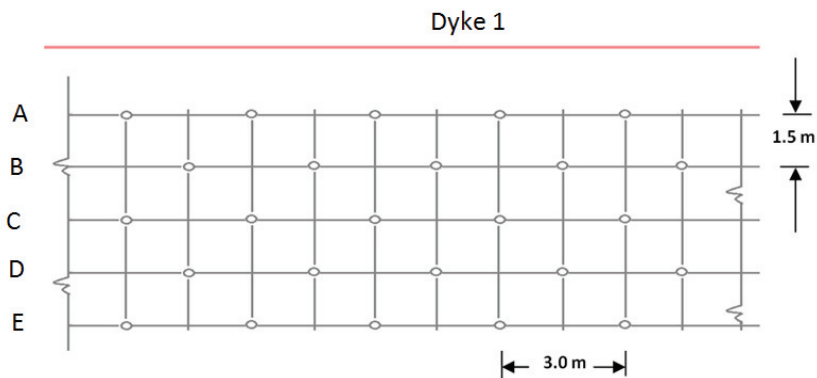
Figure 4 : Sketch showing grouting pattern

Curtain grouting was carried out from chainage 5067 m to 5330 m in five rows of boreholes. Row spacing was 1.5 m and grouting pattern are shown in Figure 4. The cement intakes for different chainages are given in Table-2.

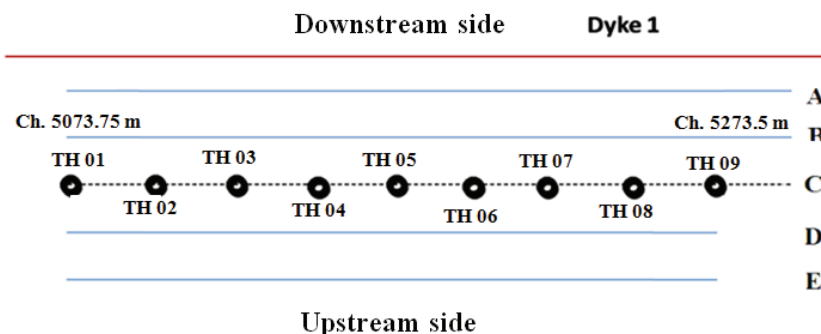
Figure 5 : Sketch showing post-grouting locations

In order to check the effectiveness of the grouting, post grouting permeability tests were carried out in the center of the grouted holes, at chainages 5073.75, 5098.75, 5123.75, 5148.25, 5173.5, 5198.75, 5223.75, 5248.5, 5273.5 m (Figure-5) in the grouted portion for the entire depth of the boreholes.

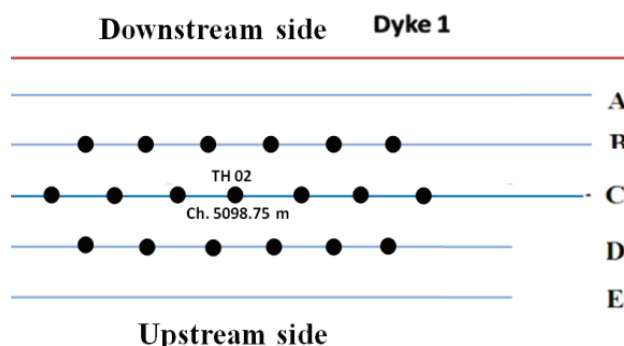
Figure 6 : Sketch showing re-grouting locations at Ch. 5098.75 m

From the table, it is observed that Lugeon values in inspection Bore Holes TH-01, TH-03, TH-04, TH-05, TH-06, TH-07, TH-08 and TH-09 were found to be satisfactory except hole no. 2 (TH2) of chainage 5098.75 m of stage I (i.e. from 13 to 16 m), where the Lugeon values are found to be between 12 to 31, which are on higher side. To reduce the Lugeon value in that area, regrouting work was carried out between lines BC and CD at an interval of 3 m. 3 number holes on each side of the borehole no. 2 of chainage 5098.75 m are also drilled and grouted (Figure - 6)

Post grouting permeability tests at Hidkal dam dyke-1 were conducted at chainage 5273.75, 5248.75, 5223.75, 5198.75, 5173.75, 5148.75, 5123.75, 5098.75 and 5073.75 of 9 nos. NX bore holes. Overall Lugeon values are found to be satisfactory except hole no. 2 (TH2) of chainage 5098.75 m of stage I (i.e. from 13 to 16 m), where the Lugeon values are found to be between 12 to 31, which are on higher side. To reduce the Lugeon value in that area, regrouting work was carried out between lines BC and CD at an interval of 3m. 3 number holes on each side of the borehole no. 2 of chainage 5098.75 m are also drilled and grouted.
