UNDERWATER LEAKAGE DETECTION AND REHABILITATION FOR CONCRETE FACED ROCKFILL DAMS

JIANHUA LU, YI XU, XIAOMING ZHOU AND JINZHANG TIAN

Changjiang Survey, Planning, Design and Research Co., Ltd., Wuhan, China And National Dam Safety Research Center, Wuhan, China

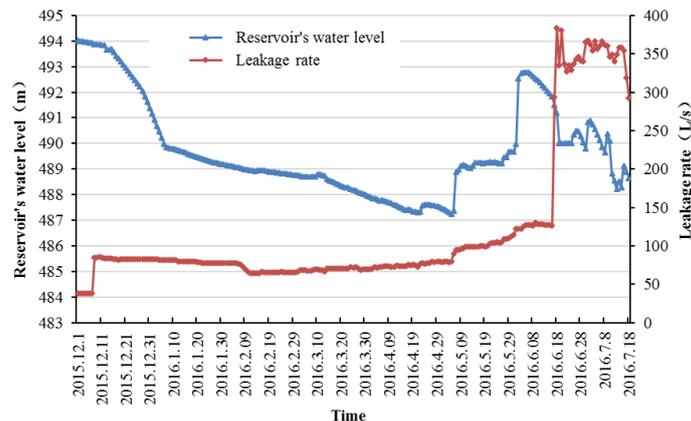
The Liaoye Reservoir commenced impounding in December 2011. During the first few years of operation, the leakage rate of the main dam has basically remained at 30~40 L/s at high water level, and the seepage monitoring instruments in the dam body are basically normal. When the water level reached above 493.88m in December 8, 2015, several leakage points were observed along the downstream of the dam toe, and the leakage rate increased to 84.4 L/s. When the water level of the reservoir was lowered down, the leakage rate showed a slight decrease. After a total rainfall of 100 mm at the dam site area in May 6, 2016, the reservoir's water level rose rapidly, and the leakage rate at the dam toe had a sudden increase again. After the rainy season began around June 2016, the reservoir's water level reached above 492.78m, and the maximum leakage rate was estimated approximately to 381 L/s. Subsequently, it is maintained at about 330 L/s. Fig. 2 shows the evolution curves of reservoir's water level and leakage rate from December 2015 to July 2016.

Fig. 2 : Evolution curves of reservoir's water level and leakage rate

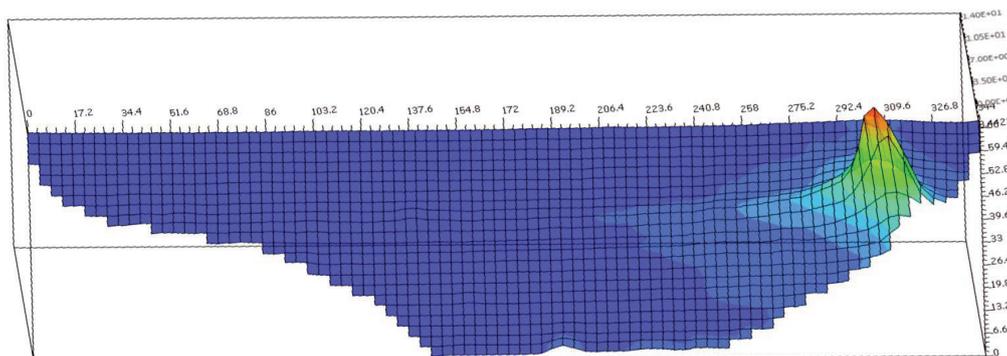
The sonar detection technology was used to detect the areas below the reservoir water level, including the face slabs, sealing structures in the joints, the plinths and the bank slopes near the dam. For the Sonar detection, the test lines were arranged parallel and perpendicular to the dam axis to form a 4m×4m testing grid, and the sonar probe was dropt down the water level at each point to measure the seepage velocity. For the anomaly leakage zones found during the detection process, the testing grid was then refined to 2m×2m. The detected results show that there was a concentrated leakage point on the No. MB33 face slab on the right side of the dam, with the elevation of 462.5m. The velocities at this concentrated leakage site was larger than 0.1cm/s, with a maximum value of 0.82m/s. The leakage velocity contours map obtained by sonar detection is shown in Fig. 3.

Fig. 3 : Leakage velocity contours map obtained by sonar detection

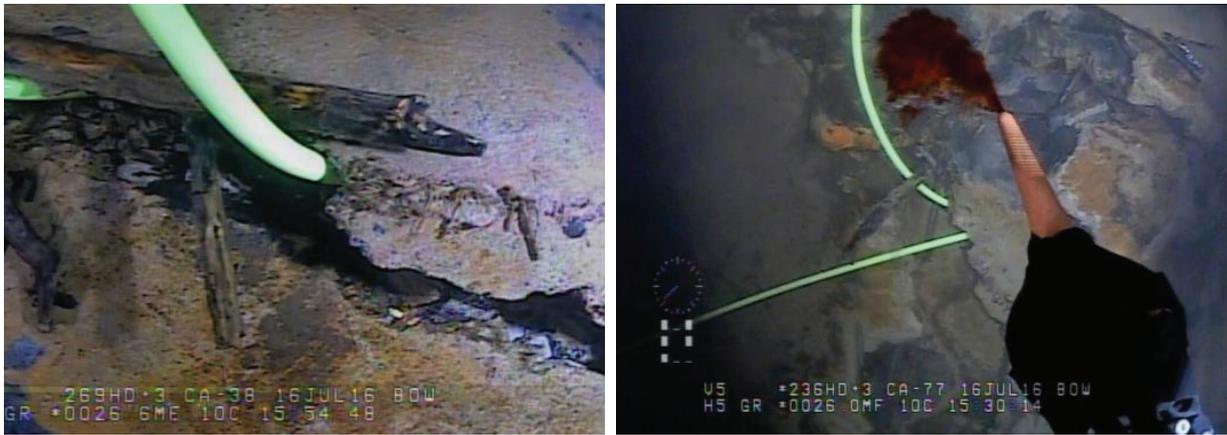
Underwater ROV with high resolution cameras, image sonar and an inkjet device, was utilized to take an inspection the face slabs and joints located above the crest of the upstream blanket zone, and to take high resolution video around the anomaly leakage zones found by sonar detection. To confirm the leakage and its location, tracer experiments were also undertaken along with the ROV video recording. It was found that the concentrated leakage site turned out to be several large cracks in length of over 5m on the face slab. The largest shear displacement between the two sides of the cracks was observed to be more than 5cm. The ROV inspection and tracer experiments around the concentrated leakage site can be found in Fig. 4.

Fig. 4 : The ROV inspection and tracer experiments around the concentrated leakage site

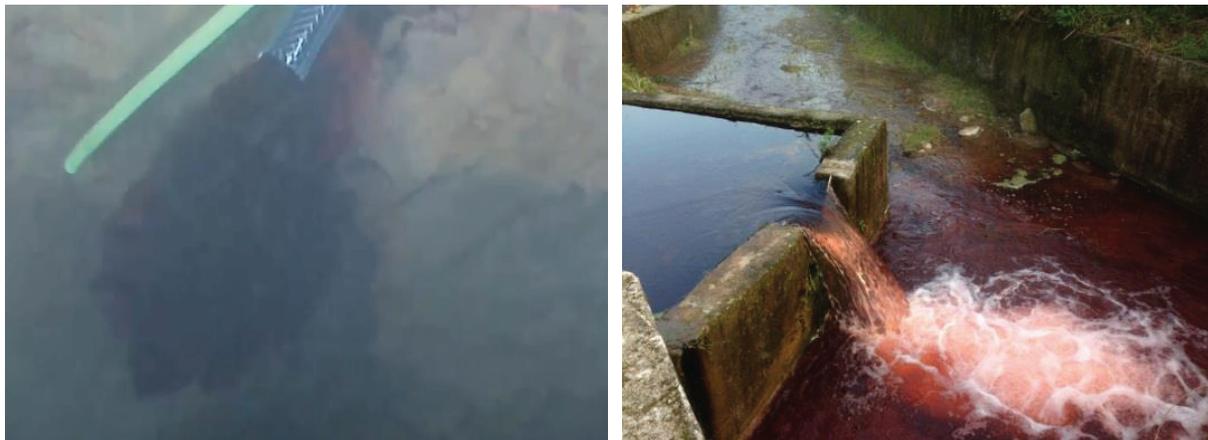
Hydraulic connectivity test was conducted to validate the presence of the leakage path. The concentrated leakage site was found on the concrete face slab with elevation around 462.5m at the right side of the dam. A large amount of pigments was injected and absorbed in to the cracks around the concentrated leakage site. After about 6 hours, the outflow from the measuring weir afterwards the dam toe changed its color as the released pigments (see Fig. 5), and the color got darken with increasing time. This test provides evidence of hydraulic connectivity between the concentrated leakage site and the leaked water at the downstream side of the dam. From the travelling time of the released pigments, it was found that a concentrated and connected leakage path has been formed inside the dam body.

Fig. 5 : Hydraulic connectivity test

Underwater leakage detection found that there was a concentrated leakage path caused by the shear cracks on the face slab near the elevation of 462.5m at the right side of the dam. According to the experience of Zhushuqiao Dam, Baiyun Dam and other similar projects, the excessive leakage caused by the failure of the anti-seepage body (face slabs, joints and sealing structures, etc.) would lead to the continuing loss of fine particles of the fine particles in the cushion and transition layers under hydraulic gradient. A long time leakage might even cause the seepage failure of cushion and transition layers, which will bring about further damage and deterioration to the face slabs, raising safety risks of the dam. In order to ensure the safety operation of the dam, it is necessary to carry out emergency treatment and repair of the dam leakage as soon as possible.

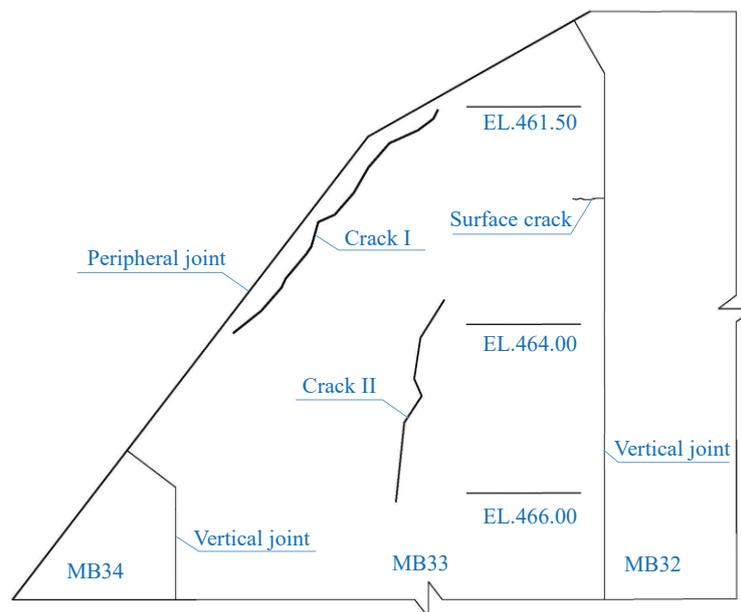
Diving operations were carried out more than 20 m below the water level, to clean the damaged slab by highly pressurized water within a certain range area, and take a detailed and careful inspection to check the damage and cracks of the slab. The inspection found that: (1) Crack I was located on No. MB33 slab, at the elevation of 463.7~466.1m, with crack length of 4.0m and crack width of 2~3mm; (2) Crack II was located at the bottom of No. MB33 slab (near the peripheral joint), at the elevation of 461.5~464.1m, with crack length more than 5.3m and crack width about 3~5cm. Concrete around the cracks was severely damaged and shedding. The Crack II has been proved to be the main entrance of the leakage, and the infiltration velocities near this crack were considerably large. Illustration of the crack distribution on No. MB33 slab is shown in Fig. 6.

Fig. 6 : Illustration of the crack distribution on No. MB33 slab

The flow velocities in the concentrated leakage site at No. MB33 slab were considerably large. In order to reduce the flow velocities, a large amounts of silt materials mixed with fly ash and fine sand is injected into the cracks through a conduit. The silt materials were composed of coarse and fine particles and easy to be driven by water flow. As a result, the silt materials were brought into the cushion layers under the slab to produce the supporting effect to the above slab, reducing the flow velocities at the leakage site. During the injection process, the particle gradation

After the injection of silt materials was completed, the flow velocities have been considerably reduced around the concentrated leakage site. Underwater sealing material (i.e., underwater cementitious material) was then used for filling the cracks and repairing the damaged slabs.

Underwater grouting treatment methods usually include cement and fly ash slurry grouting and chemical slurry grouting. Cement and fly ash slurry grouting was conducted in the cushion layer around the cracks and the damaged slab. The grouting treatment could rebuild the cushion layer's supporting effect near the damage slabs, and rehabilitate the anti-seepage performance of the damaged face slab.

After the underwater grouting, the concentrated leakage site and the damage face slab were tightly sealed by pasting an impervious SR cover sheet. The impervious SR cover sheet extended larger than the area of the damaged slab, and was held on the slab by bolts. A geomembrane was finally used to cover the concentrated leakage site entirely, provides additional watertightness.

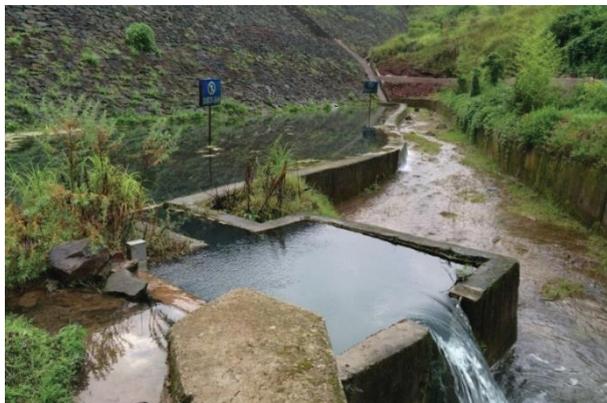
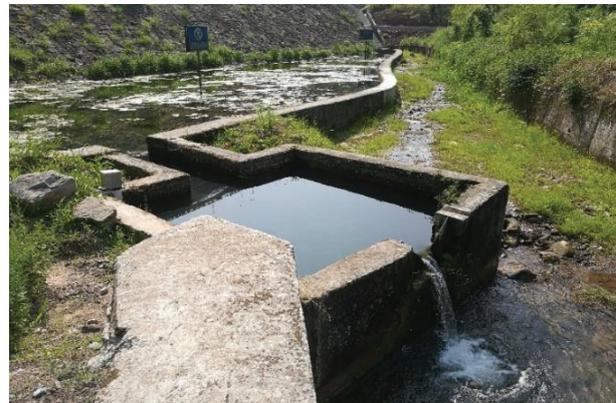
The leakage repair and rehabilitation of Liaoye CFRD began in mid-August 2016. With the gradual implementation of various treatment measures in respect to the cracks and damaged slabs, the leakage rate of the dam has progressively decreased. After the completion of the underwater injection of silt materials, the leakage rate at the measuring weir was observed to decrease to below 7L/s. After the underwater grouting, the leakage rate was reduced to 2.5L/s; In mid-September, 2016, all of the treatment measures has been accomplished, and the leakage rate was lowered to 1.8L/s. So far, the leakage of the dam has been quite stable within the rate of 5L/s. The comparison of the leakage at the measuring weir before and after the treatment is shown in Fig. 7. The leakage rate of the dam has been significantly reduced, and the damaged face slab has been fully rehabilitated, largely migrating the risk of dam safety.

(a) Before the treatment

(b) After the treatment

Fig. 7 : Comparison of the leakage at the measuring weir before and after the treatment
