ICOLD Symposium on Sustainable Development of Dams and River Basins, 24<sup>th</sup> - 27<sup>th</sup> February, 2021, New Delhi

# REHABILITATION AND PREVENTION OF FROST DAMAGE TO THIN CONCRETE DAMS IN COLD REGIONS

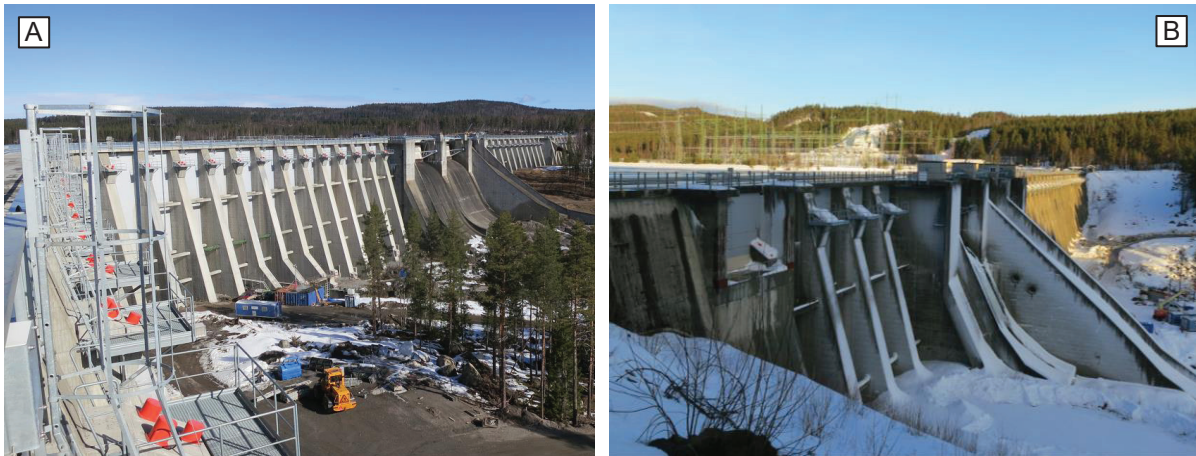
Figure 1 : The concrete buttress dams at Storfinnforsen (A) and Ramsese (B).

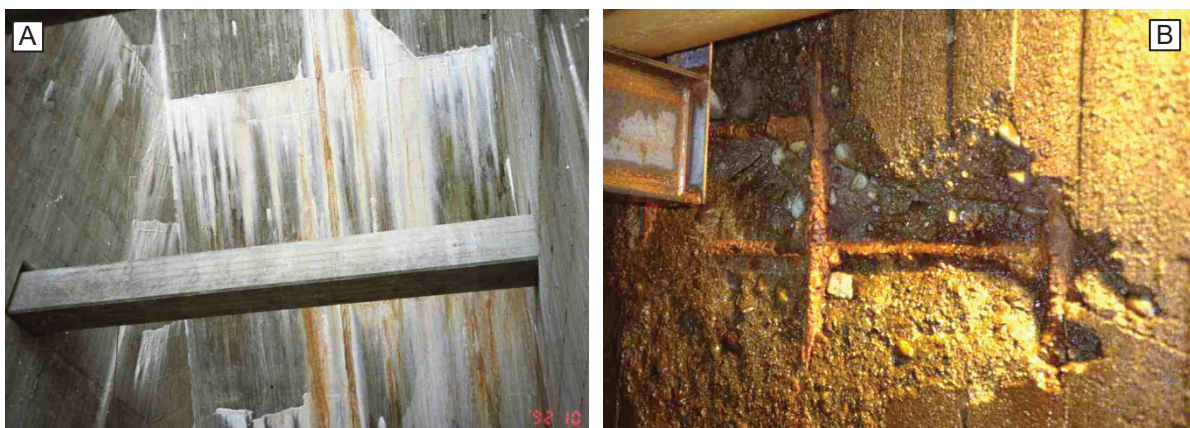
Shortly after the completion of the buttress dam at Storfinnforsen, a considerable amount of cracks appeared in the flat slab. The cracking was mainly horizontal and it became worse during the initial reservoir filling (Figure 2A). Investigations conducted in the early 1960s showed that the cracks were continuous from one side of the flat slab to the other. Most of the cracks developed at depths greater than 10 m where the flat slab continuously becomes thicker (Bergström & Nilsson 1962). A second crack mapping was conducted in the late 1980s. It showed that the number of cracks had increased.

When soft water flows through cracks in concrete, two mechanisms occur; dissolution of solid phases and transport of dissolved ions out of the concrete. Dissolution of solid phases is caused by hydrolysis in order to maintain thermodynamic equilibrium between the pore solution of concrete and the surrounding hydration products. Water flowing through cracks brings dissolved ions out of the concrete where efflorescence may form on the surface (Figure 2A).

During inspections of the buttress dam at Storfinnforsen, spalling of concrete was observed in the vicinity of leaking cracks and dilatation joints on the downstream face. In some places, the concrete cover was missing. In other places, the concrete appeared soft and could be removed by hand. During inspections of the upper part of the upstream face, divers were able to remove pieces of concrete with their bare hands. The damaged areas varied between 0.5 and 10 m<sup>2</sup> in size and were up to 200 mm in depth, leaving reinforcement bars open in the water (Figure 2B). The majority of the damaged areas were located below the normal water level and some 10 m down. Reservoir water level fluctuations are limited to 0.5 m. Hence, frost damage to the upstream face occurred underwater. Similar damage to the upstream face, but to a lesser extent, was discovered on the buttress dam at Ramsele.

Figure 2 : Efflorescence on the downstream face due to leaching (A). Frost damage to the upstream face (B).

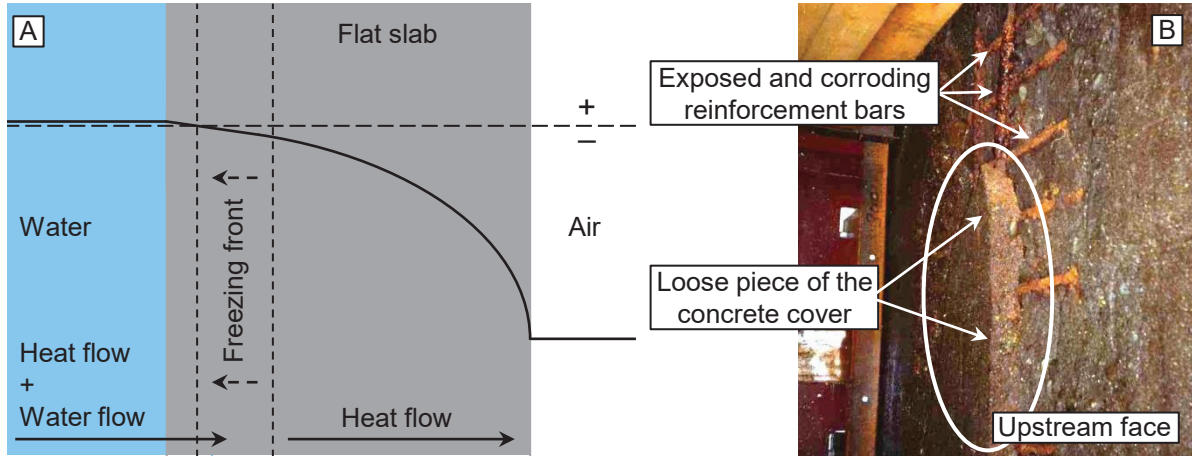
During the winter when the dams are subjected to unidirectional freezing, heat is conducted from the upstream side towards the downstream side (Figure 3). If the heat loss is greater than the heat supply, a freezing front moves towards the upstream side. Until equilibrium between the heat supply and the heat loss is obtained, the freezing front continues to move towards the upstream side. Ice coatings on the upstream face confirmed that balance in heat transfer was not reached until the freezing front had reached the upstream face.

**Figure 3** : Movement of the freezing zone within the dam (A). Exposed reinforcement bars due to frost damage to the upstream face of the buttress dam at Storfinnforsen (B).

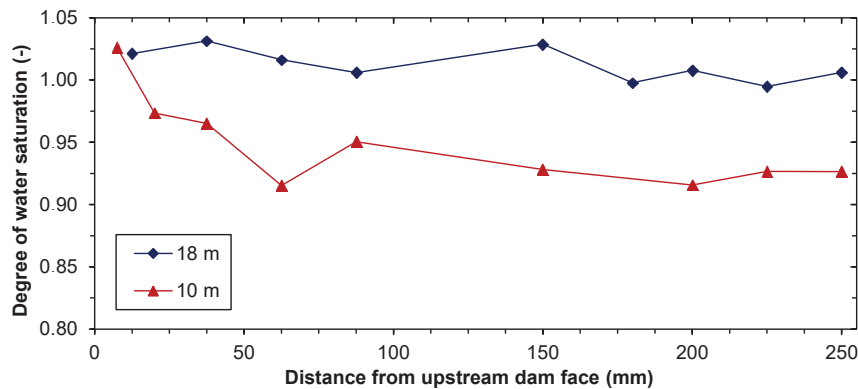
where  $m_{wet}$  is the mass of the sample in the moist state,  $m_{sat}$  is the mass of the sample after saturation and  $m_{105}$  is the mass of the sample in the dry state. The results are shown in Figure 4. As can be seen in the figure, the water content is greater at 18 m water depth compared to 10 m. At both depths, the degree of saturation is close to 1 which is equivalent to water saturation. At such water content levels, there is an imminent risk of frost damage to concrete if subjected to freezing.

Figure 4 : Degree of water saturation in two concrete cores from the buttress dam at Ramsele.

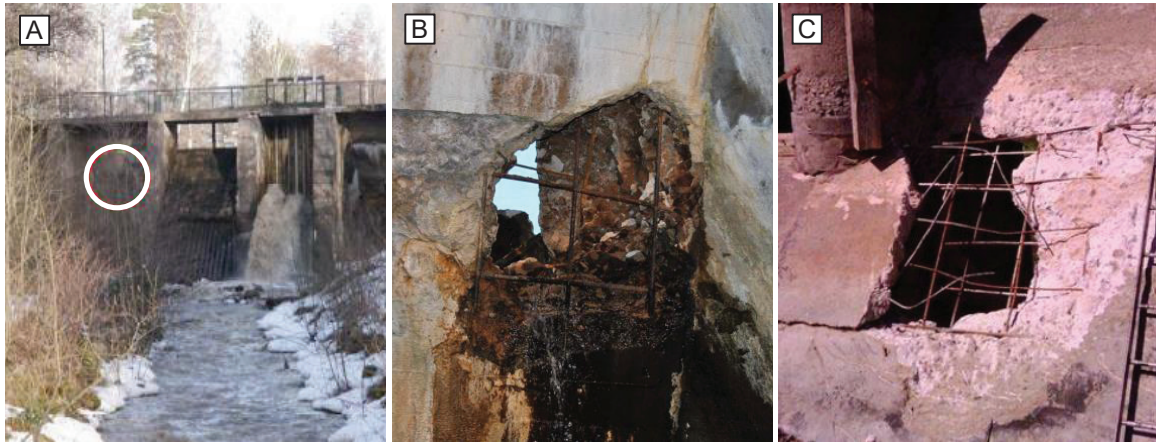
In one case, severe spalling of concrete had been noticed on the downstream face during inspections. Reinforcing steel bars were exposed in some places and the concrete surface was visibly wet due to water leakage through cracks in the flat slab just above the damaged areas. However, no measures were taken to prevent further degradation of the dam. Suddenly, a hole appeared in the flat slab in early spring (Figure 5A-C). The size of the hole was approximately 0.8 m in width and 1.2 m in height. All loose pieces of concrete were flushed away by the water escaping through the hole. Reinforcing steel bars were seen from both sides of the flat slab.

The buttress dam was built in the early 1940s, making it about 70 years old when the hole appeared. The maximum height of the dam is 9 m and the crest length is 51 m. The thickness of the flat slab is approximately 400 mm. Neither the cement used nor the w/c-ratio of the concrete are known to the authors. Due to the severe damage sustained to the dam, it was temporarily taken out of service.

**Figure 5** : A 70 year old buttress dam (A). In early spring, a hole appeared in the flat slab at a location where frost damage previously had been noticed on the downstream face (B-C).

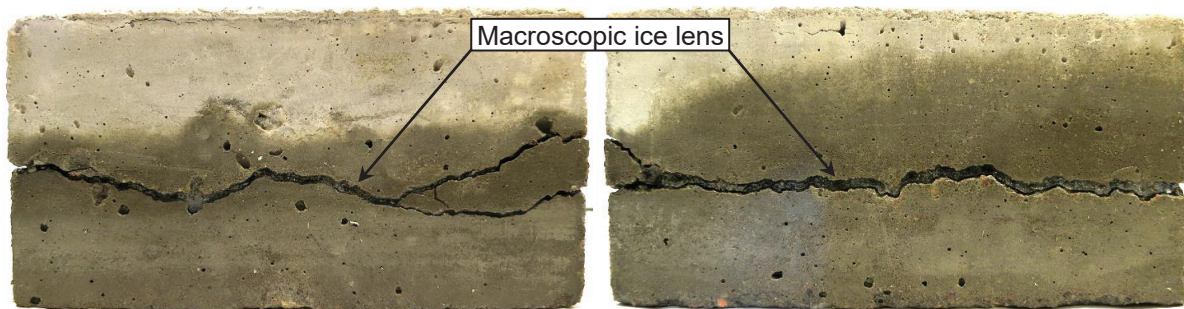
Of similar importance are cavities and other imperfections of the concrete material that may exist in the vicinity of reinforcement bars due to inadequate compaction during casting. It was shown that growth of macroscopic ice lenses also occur in normal quality concrete with imperfections (Figure 7). However, the period of freezing required to facilitate the formation of macroscopic ice lenses increases with decreasing w/c-ratio. Nevertheless, the risk of concrete spalling in thin concrete dams cannot be overlooked since unfavourable temperature and moisture conditions may occur over time in structures with long service life. Hence, extension of the service life of thin concrete dams is closely related to the issue of durability of concrete.

Figure 7 : Macroscopic ice lens formation in a specimen with paper sheets cast into the concrete to represent various types of imperfections of the concrete.

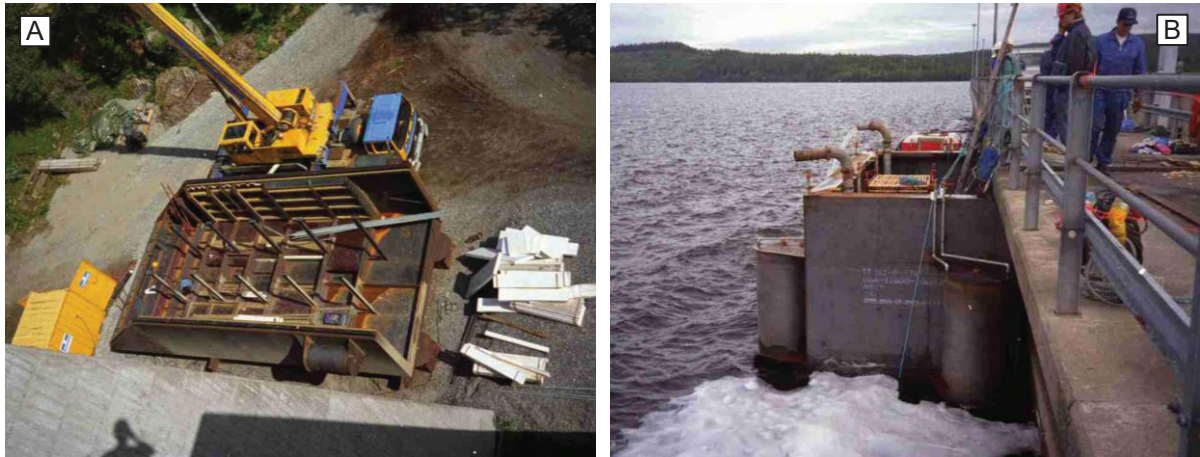
**Figure 8** : The custom-made steel caisson used to allow work on the upstream face of the buttress dams (A). The caisson in place on the upstream side (B).

The extent of repairs on the upstream face was smaller compared to the downstream face. A custom-made caisson of steel was manufactured in order to enable repair work below the normal water level on the upper part of the upstream face without lowering the reservoir level (Figure 8). The 10 m high caisson could easily be moved between places where frost damage was discovered.

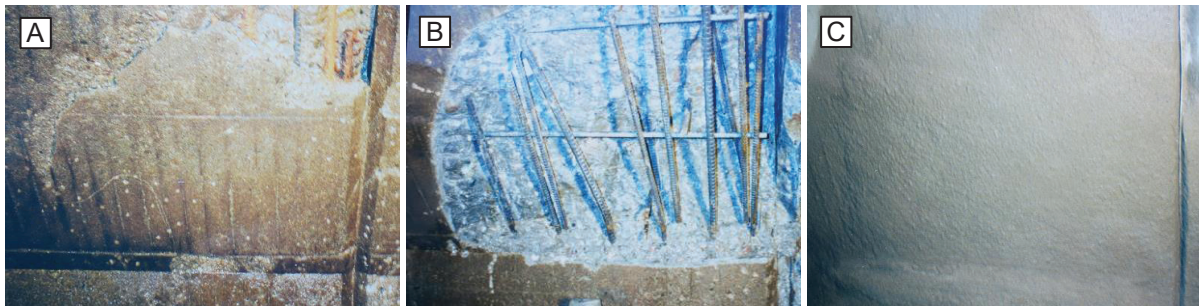
**Figure 9** : Spalling of the concrete cover on the upstream face (A). Degraded concrete removed and reinforcement bars cleaned (B). Sprayed concrete applied (C).

Degraded concrete was removed by jack hammering and abrasive blasting. Exposed reinforcement bars were cleaned and showed only superficial corrosion. Hence, the reinforcement bars were not replaced. Similar to the downstream face, a layer of sprayed concrete was applied to the old concrete. The repair process is shown in Figure 9.
