# MODERNIZATION, OPTIMIZATION AND REHABILITATION OF AGEING DAMS

## **9. CASE STUDY 1**

## **10. CASE STUDY : 2**

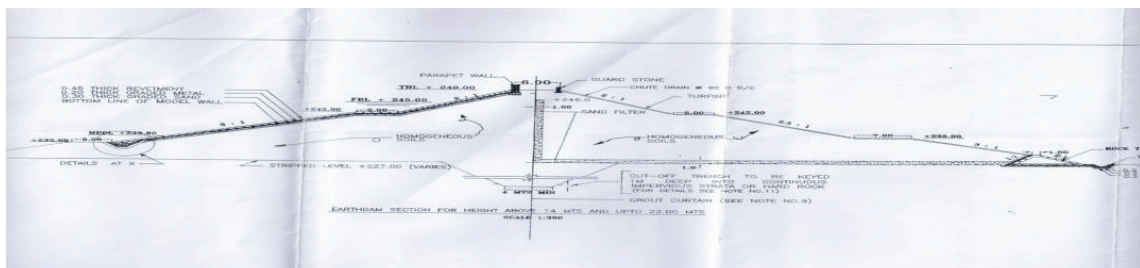
Drg. 2 : Existing Earth Dam

The earth dam was designed as a homogeneous section with clayey sand (SC) type of soils along with upstream slope. The earth dam has been provided 1 m thick vertical & horizontal sand filters along with 0.45 thick upstream riprap, 0.2 thick metal & 0.3 thick sand inverted filters to dissipate upstream pore pressures in case of drawdown conditions. Stability analysis has been carried out as per BIS: 7894 1978 and the required section was adopted, the profile of dam section is enclosed in annexure. It has a head regulator @ KM. 1.403 and has a water spread area 5.915 sqm.

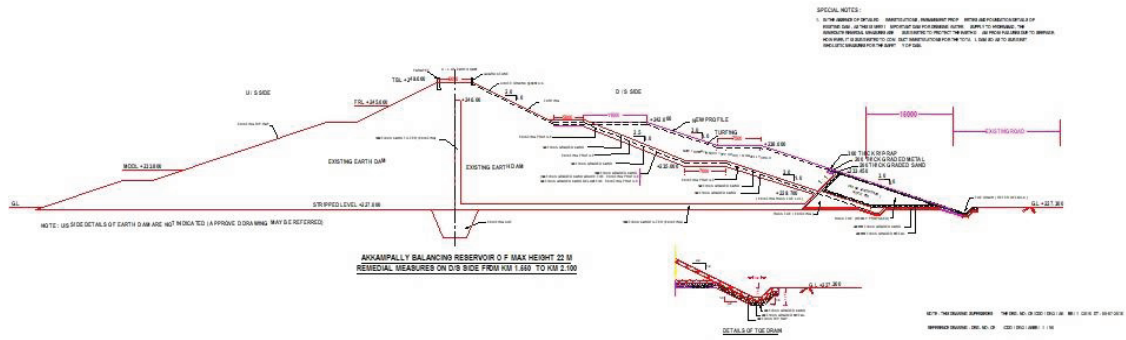
Drg. 3 : Downstream Remedial Measures, Site Photographs during Execution:

The major distress noticed in the AKBR project is the seepage problem, which has started since 2016 and efforts are made to overcome it. The seepage has appeared on downstream berms and slopes with an increase in the water level above +242.00m, where there is no sign of seepage when the reservoir level is at +238.00m and below i.e., MDDL. Slushy conditions are appeared on the 2nd berm +235.00 with water flowing through the chute drain. Chute drains are under dilapidated conditions and deep rooted vegetation on upstream and downstream side of the earth dam are observed.

The following remedial measures were proposed based on the above investigations and Site inspections (Refer Drawing No.3):

1. HG line based on seepage levels is arrived as around 1 in 6 at FRL and for this a 500 mm thick sand filter in d/s profile after stripping up to 500 mm thick, thus totally 1000 mm thick to bring HG Line well within the body of the earth dam.

2. The berm width has been increased to 11.0 m in addition to the existing berm of width 5.0 m at first berm level +242.00.
3. The berm width has been increased to 7.5 m from 7.0 m at second berm level +235.00 along with a rise in berm level to +238.00.

4. By Heightening the rock toe from existing level of +229.700 to +233.45 i.e., height of 3.6m, so as to impart more stability and also to drain seepage water.

5. To provide a 300 mm thick riprap over 200 thick graded metal and 200 thick graded sand, to protect against rain / wind in lieu of proposing turfing.

6. Turfing is proposed on the downstream slopes of the embankment to protect from slippage.

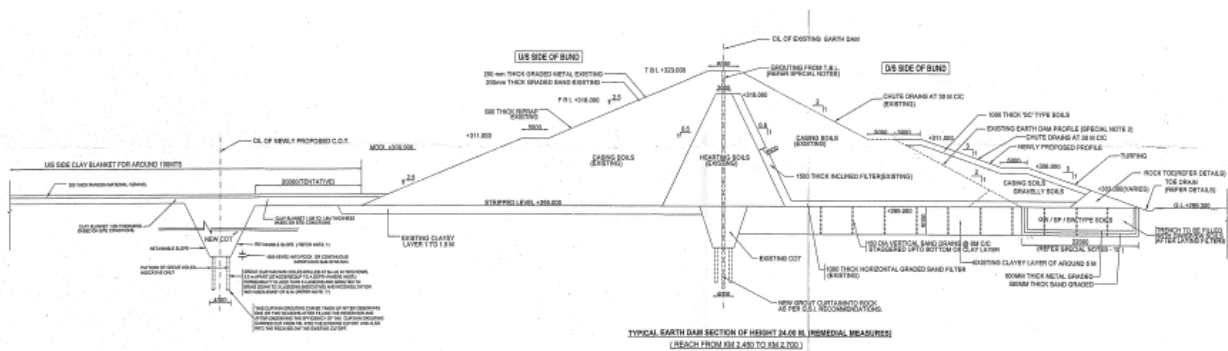
Drawing showing the Remedial Measures for Mid Manair Reservoir in the Reach from Km.2.450 to 2.700

FRL of the reservoir is +318.00m, TBL of the reservoir is +323.00m. While impounding the reservoir with water (first filling of the reservoir with pumped water of Kaleshwaram scheme), when water level is at +312.0 m, it was observed that there is some seepage & sand boils occurred along with piping on d/s side in the toe drain & also at 10 to 30 mts away from the d/s toe of the earth dam in the reach between KM 2.450 to KM 2.700. Stripped level is around +299.0 m at that location. Height of the water column at the time of leakage / piping is around 13 mts. The water emanating on the d/s side is turbid (Photograph:7).

The Committee after studying the Geo Physical investigations and Sub Strata conditions, the following remedial measures are proposed:

1. New positive cut off trench at a distance of about 20 mts from the u/s toe of the earthen dam along with curtain grouting if required into rock based on site conditions is suggested. Clay blanket of 1.0m to 1.5m thick connected to positive cut off shall be laid upto 100 mts from the u/s side toe of the earth dam. If the clay strata already exists on the u/s side, gaps if any remaining shall be filled with clay blanket of 1.0m thick 30cm thick gravel/random material shall be laid over the clay blanket. The C.O.T. keyed into 1.0m continuous impervious strata or hard impervious rock. This is to minimize or avoid any seepage to the main C.O.T. as per site conditions.

2. Grouting is to be carried out from the TBL into the existing COT with cement & Bentonite. The curtain grouting shall be in the rock below the existing COT to strengthen and to arrest any seepage through fissures or joints which may have developed after the construction of earth Dam.

3. Trench of 22mts x 5Mts x 250 mts. filled with GW/SP/SW with filters of 500 mm thick graded metal & 500 mm thick graded sand is proposed as a part of soil stabilization near d/s toe after removing the existing slushy soils and function as a additional filter.

4. New rock toe along with toe drain etc shall be constructed utilizing the material from the existing Rock Toe which would be removed.
5. 150m dia vertical sand drains at 6mts c/c staggered shall be proposed on the existing d/s base width of the connected to the horizontal filter to relieve inbuilt pore pressures.

6. Existing berm at +311.000m is increased by 5m and a loading berm of 5m is proposed at +306.00m. This is proposed to nullify any expansive action of the foundation soils.
