ICOLD Symposium on Sustainable Development of Dams and River Basins, 24<sup>th</sup> - 27<sup>th</sup> February, 2021, New Delhi

# INNOVATIVE SEEPAGE AND SPILLWAY REMEDIAL DESIGNS OF A PUDDLE CLAY CORE DAM

**E.A. TOMS AND H. FORSLING**

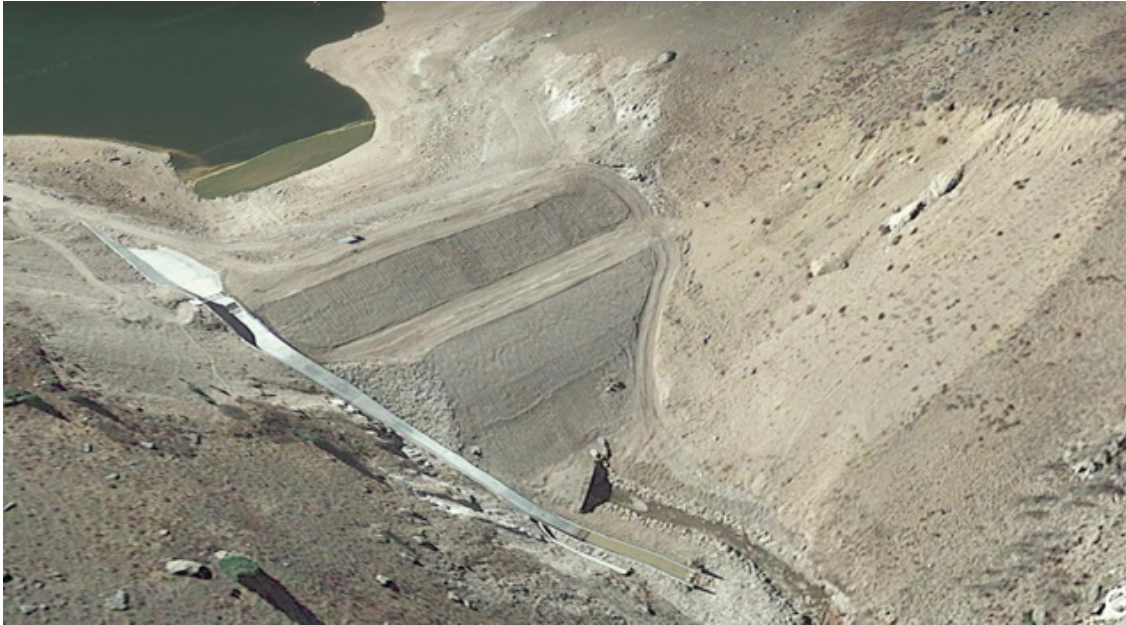
**Figure 1 :** Continental Dam, Colorado, USA, showing the left abutment slide area that directly contributed to mid-height, downstream dam face, seepage which was a failure mode concern.

A field investigation program showed that seepage was transmitted from the reservoir through the left abutment land slide area surfacing at about mid-height of the downstream dam face. AECOM used a limited investigation program to identify that the seepage was entering along a left reservoir rim glacial drift geologic formation appropriately elevation 3127 m (10,260 ft). The local geology of Continental Dam consists of surficial Quaternary-aged deposits underlain by Tertiary volcanic rocks. The Quaternary-aged deposits are glacial drift which allow potential seepage paths through the formation. The Tertiary volcanic rocks consist of welded and non-welded gray, red, brown, and white tuff.

The filter blanket consisted of a two-stage filter consisting of ASTM 33 sand (filter sand) and No. 89 gravel (drain gravel) as shown in Figure 5. The filter sand and drain gravel placed against the re-graded 2H:1V slope was 91.4 cm (3 ft) (horizontal distance) thick which was imported materials. The buttress fill consisted of common fill produced from excavated materials from the spillway chute and stilling basin. It was placed to widen the existing crest by 4.6 m (15 ft) at elevation 3136 m (10290 ft) with a 10 m (33-ft) wide bench at elevation 3129 m (10265 ft). Drain gravel was placed closest to the rock fill in the excavated trench followed by a 1.5 m (5-ft) wide (horizontal distance) filter sand layer. Figure 6 shows the placement of the filter sand, gravel, and common fill.

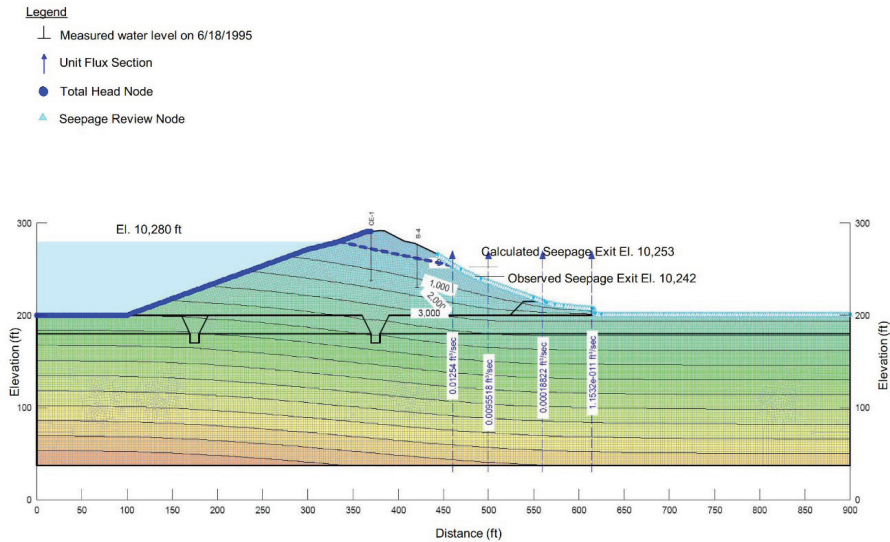
**Figure 2 :** The calibration model results assuming the puddle clay core was not effective lowering the phreatic surface. The model results indicated that the phreatic surface exit location was appropriately at the observed elevation.

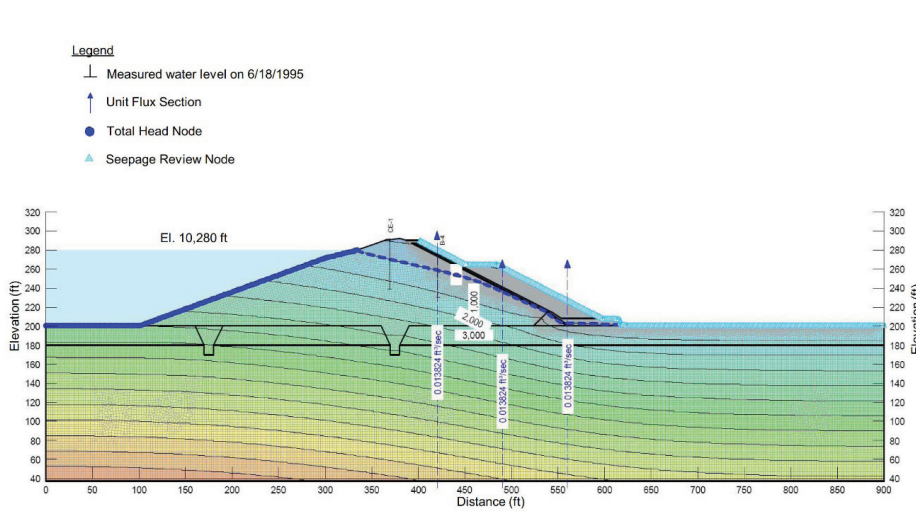
**Figure 3 :** The model presents the design section of the embankment which included the filter system extending up to the dam crest and the stability berm extending up about 2/3rds of the dam face.

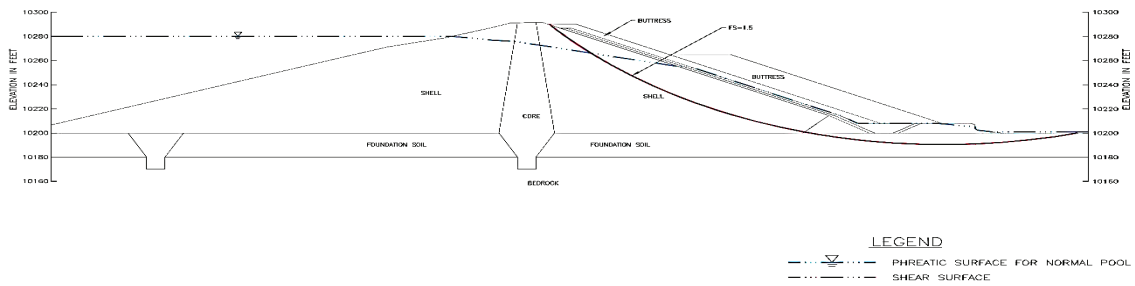
Figure 4 : Stability results from UTEXAS4 and the Spencer’s method of slices indicated that the design was suitable meeting the required factor of safety of 1.5 for the steady state conditions. The post-earthquake stability analysis was also performed which exceeded the required factor of safety of 1.2.

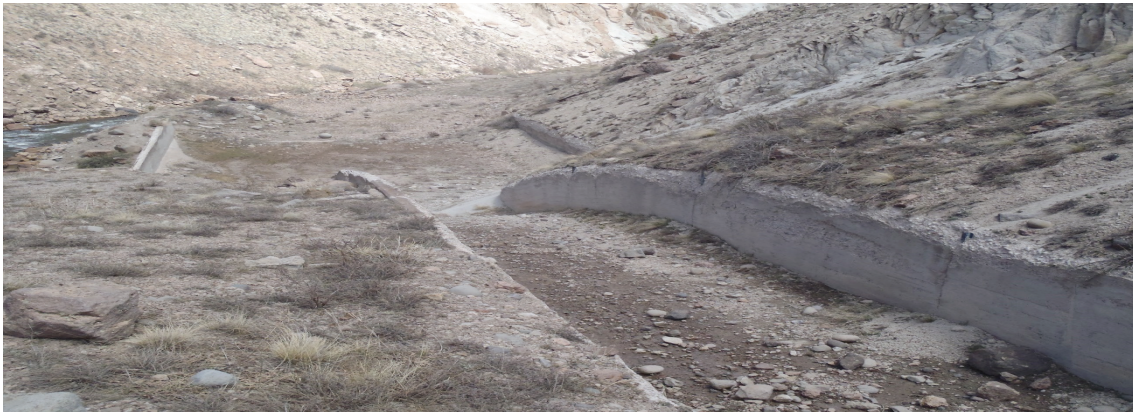
The existing spillway was rehabilitated by constructing a new reinforced concrete spillway inside the existing spillway chute walls utilizing the existing walls as forms. The major features of the new spillway included 1) Spillway Underdrain, 2) Spillway Chute Walls and Slab, 3) Stilling Basin Walls and Slab, and 4) Foundation Anchors. The existing spillway was experiencing freeze/thaw concrete deterioration as shown in Figure 8.

**Figure 8 :** Typical concrete freeze/thaw deterioration within the spillway discharge chute.
