ICOLD Symposium on Sustainable Development of Dams and River Basins, 24th - 27th February, 2021, New Delhi

REQUISITE OF GEOTECHNICAL EVALUATION FOR AGE OLD DAMS AND APPURTENANT STRUCTURES TO ENHANCE THE EXISTING HEALTH STATUS FOR THEIR LONGEVITY – A CASE STUDY OF SELECTED DAMS IN TAMIL NADU

2. ADAVINAINARKOIL RESERVOIR PROJECT, TIRUNELVELI DISTRICT

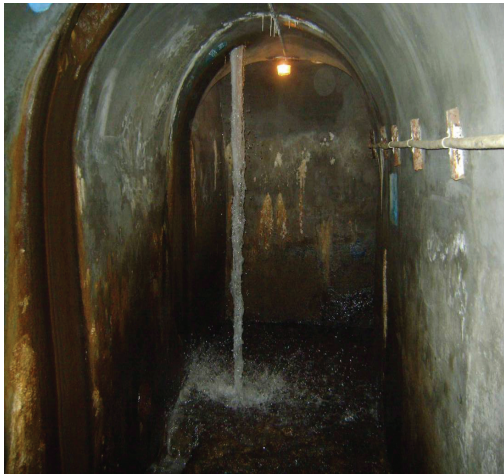
The Adavinainarkoil reservoir project envisages the construction of a 74.20 m high and 670 m long Masonry dam with uncontrolled central spill way of 100 m length, built across the Hanuman Nadhi (River), a tributary of Chittar River in Tamiraparani basin, with a storage capacity of 174 m c ft. The dam has been provided with three drainage galleries of standard size and shape at different elevation levels. It is abutted against the massive charnockite in the right and weathered charnockite gneiss in the left. The foliation shows N 65°-70°W S 65°- 70° E with steep to moderate dip (50°-65°) due S 20°-25° W. The dam axis oriented almost parallel to the foliation. Achan koil lineament aligned in NW-SE direction is the major tectonic feature which is passing 2.5 km south of the project site. Heavy seepages reported from the foundation by the project authority. To ascertain the source of heavy seepages, investigation was carried in the area around the project site to identify the causative factors for water tightness. The investigation reveals that no visible sign of distress observed on either side of the abutments and d/s foundations. However, seepages observed in the drainage galleries especially the blocks provided between 7 and 9 (500 to 700 LPM) with the corresponding reservoir level of 116.252 to 114.25. In the lowest gallery at El 210.6, the vertical drainage shaft hole No 60,61&63, where the water flows/piped out with heavy force and noise depicts that the seepages may be >1000 lpm and sand particles are also observed in the drainage chute (Fig -1). Besides, the vertical drainage shafts located in different levels of galleries are choked/ blocked with 50–90 % calcinations (Fig.2), recommended for immediate attention.

Fig. 1 : Ingress of water into drainage gallery by piping

The investigation brought out the fact that the *seepages are from the Dam civil structure (Anthropogenic) and not from the foundation (Jayabalan et al 2009)*. Significant findings and recommendations were implemented by the project authority for restorations as a result the seepages arrested from the civil structures and the project is intact.

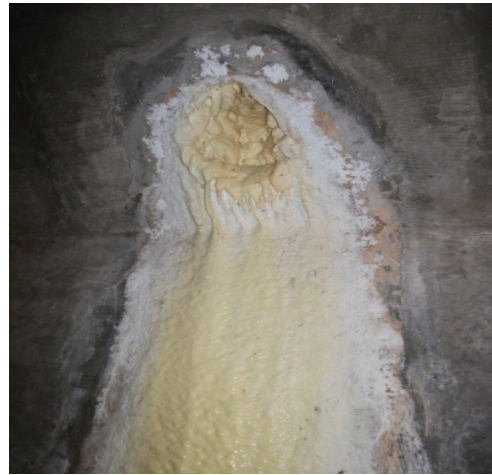
Fig. 2 : Drains are choked with calcinations

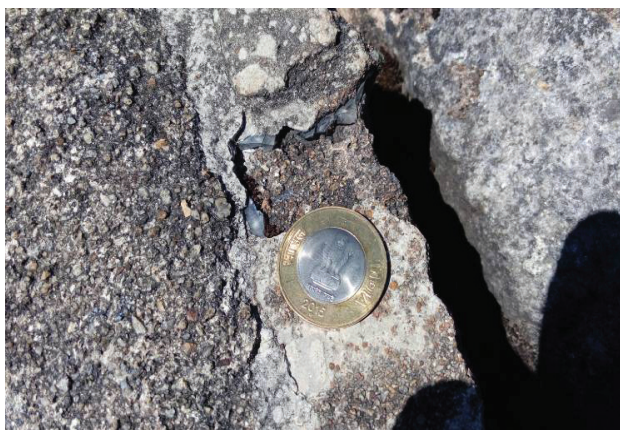
The Mukurthy Arch dam is first of its kind in India constructed between 1932– 1938, with automatic spillway arrangements. The dam site exposes fresh charnockite in the d/s side of the stilling basin area with 3 sets of prominent joint pattern. Site inspection reveals that the right abutment does not possess hard rock, hence an embankment type of abutment has been provided. Since, it is an arch dam, it takes the maximum load into the abutment, hence it is presumed that arching action of the dam would also involve additional load to the distressed right abutment, as the right abutment has considerable amount of overburden which is already saturated with dam water. Therefore, recommended to monitor the right abutment periodically for any settlement of embankment both in the u/s and d/s face, by **placing sufficient glass tell tales** (Fig. 3). Distress on the u/s face of the wing walls observed on both the abutments with separation, tilting and sinking of blocks. Similarly, the *d/s face of the right abutment sinking is measured about 32 mm*. The d/s portion of the right flank is now being protected with retaining walls with weep holes (Fig. 4) but the slopes have been provide with chain link and concreting without any weep holes. Therefore, recommended to provide random weep holes and placed at 45° angle sloping outwards and also insert with perforated pvc pipes, wherever warranted. Detailed investigation indicated that the slope failures were attributed due to the pore pressure and concomitant excavation at the toe region for siting the power house (Jayabalan et al 2016).

Fig. 3 : Broken tell-tale on the right abutment u/s

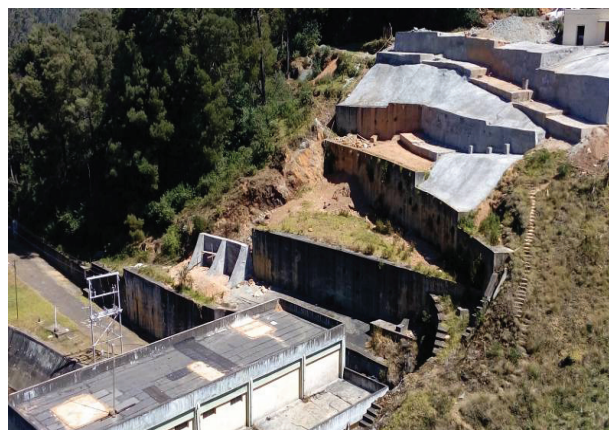
Fig. 4 : Slope protection/retaining wall with weep holes on the d/s right abutment above PH

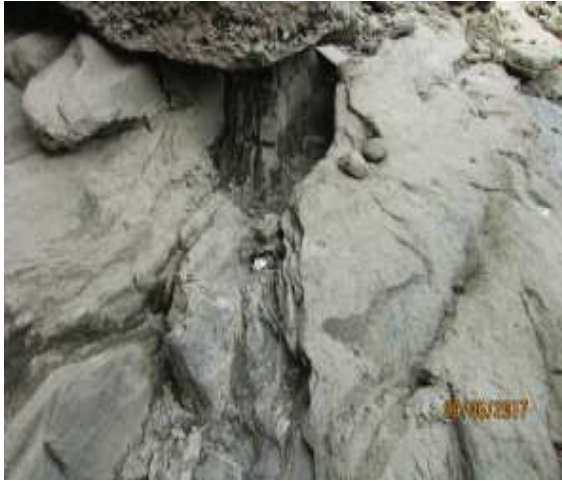
Foundation failure of Pier-3, 4 & 14 at Bhavani-Kattalai Barrage-III HEP was reported on 27th June 2017 by the project authority. In response, joint site inspections carried out along with the project authority. Site condition reveals that the entire river bed exposes intermittent outcrops of migmatitic gneiss and charnockite of Archean age. Gneissosity shows parallel to the river course with sub horizontal dip due SW. Longitudinal shear with mylonite encountered on the left bank of the river course with multiple fractures and close spaced joint sets. It was observed that the foundation of piers 3, 4 and 14 are damaged, of which, the foundation of Pier No -3 was completely removed and sand bags were kept below the pier as temporary support (Fig. 5). While verifying the detailed geological/foundation map of the said pier site and core log data indicated that at ch.54 m (pier - 3 location) where fresh rock is available at 13m below ground level and heavy core losses were recorded due to sheared/weathered zone occurred at pier 3 location (Fig 6). Thus, recommended to found the pier at fresh rock level at this particular location (Pitchaimuth et al 2006). Whereas, the present site condition revealed that the rock beneath the pier-3 is sheared and highly weathered fissile gneiss with compressive strength of < 100 kg/cm² (calculated using Schmidt hammer) and founded on shallow depth (3m below ground level) over sheared/weathered rock. A raft foundation was made between weathered and massive sheet rock without reinforcement, which has paved way for eroding the sheared weathered bed rock beneath the pier foundation due to water turbulence. This would have been avoided, if geological and geotechnical recommendations implemented during the construction stage of the piers.

Fig. 5 : Eroded foundation of Pier- 3, view from u/s to d/s facing towards left bank

Similar type of erosion and foundation failures observed in Pier 4 and 14. If the geological and geotechnical findings pertaining to the adverse geologic features (sheared/weathered rock) would have been treated during the construction stage as per the recommendations, this untoward incidences/foundation failures might have been avoided. However, detailed post construction stage investigation was carried out and recommended to lower the foundation up to firm bed rock with proper reinforcement, in view of massive fresh rock exposed an adjacent areas and also recommended to apt design pattern of the piers foundations to sustain the water turbulence (Asrar Ahmed 2019). The recommendations were judiciously executed at the project site and the piers are intact and PH become operational without any distress.

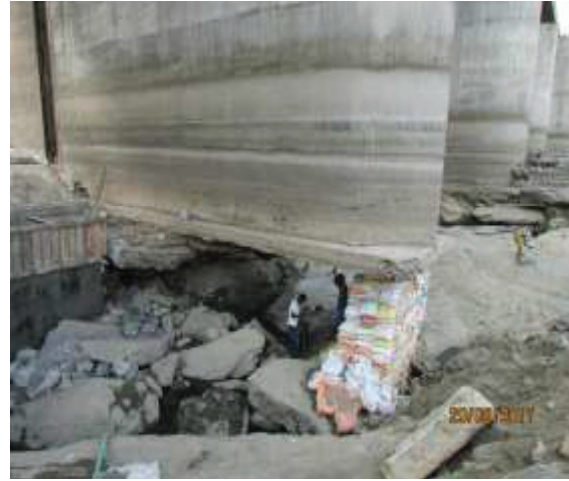
Fig. 6 : Shear plane day lighted at foundation of pier-3 the sheared/weathered rock scooped out by water action
