MANERI DAM - REPAIR OF SPILLWAY AND ITS ENERGY DISSIPATER SEVERELY DAMAGED BY ROLLING BOULDERS DURING FLOODS – CASE STUDY

VINOD K VERMA, C.S.MATHUR, YOGESH NANASAHEB BHISE AND HEMANT JOSHI

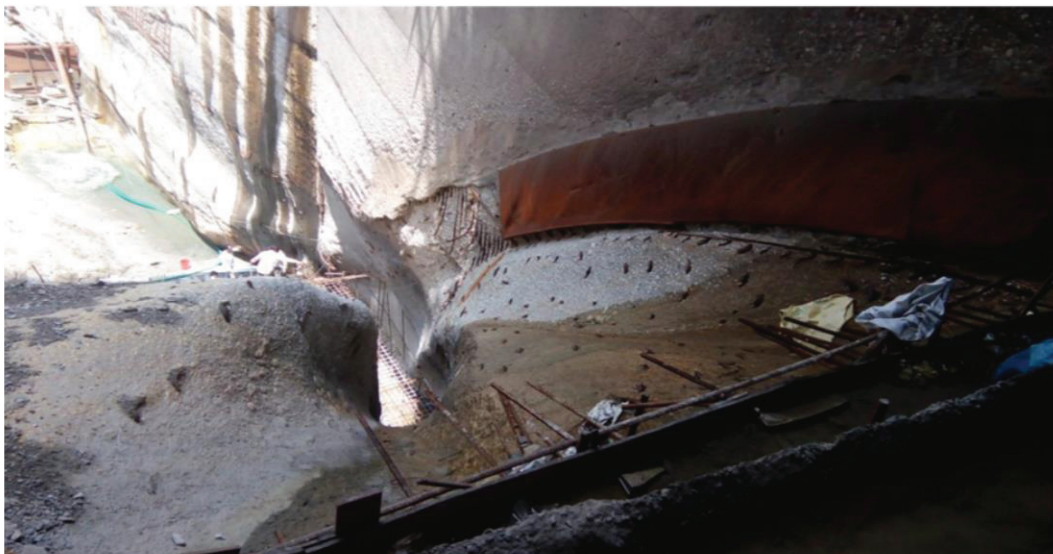
Photograph 2 : Shows the damages in Spillway bay no-1

The damages observed in Spillway bays no. 1 & 2 on the right bank (Photograph 2) were mainly as under: -

- (a) The sill beam of stop log gate and radial gate was washed out in a length of approximately 6.00 m and 8.00 m respectively out of a total length of 13 m. The flange of the remaining sill beams was also completely damaged.
- (b) As both the sill beams were washed out in some length, therefore a cavity of about 6 - 7 m in length along the piers having a depth up to 2.00 m was created in between the radial gate and stop log gate. The flood also damaged the spillway glacis on the right side and in the d/s of radial gate sill beam throughout its length & up to the slotted roller bucket in about 3.00 m width with varying depth with a maximum 13.00 m depth.

- (a) Maneri dam is silted up to the spillway crest. Because of this, big size boulders which come with the floods in monsoon period roll down the spillway and cause damages to the spillway glacis, bucket and downstream training walls of Maneri dam.
- (b) In the upstream side, there is a turn in the river and shortest radius of the turn is towards the bay no.1 on the right bank. Because of this, rolling boulders in monsoon season pass more through bay no. 1 in comparison to other spillway bays resulting in more damages in the bay.
- (c) The width of the river downstream of the slotted roller bucket is converging. The training walls obstruct the flows released downstream from the spillway resulting in adverse flow conditions d/s of bucket/return flows with eroded materials drawn into the bucket etc. and results in damages to spillway structure and roller bucket.

Initially to arrest leakages, temporary arrangements such as caulking of gates were undertaken. After the monsoon of 2014, comprehensive rehabilitation/repair of Maneri Dam was planned by UJVNL. First of all rehabilitation works for the spillway bays no. 1 & 2 on the right bank were undertaken. The repair works of these spillway bays were carried out on priority basis in two phases: -

- (a) Repair work from the sill beam of stop log gates to 2.00 m downstream of sill beam of radial gates by taking shutdown of Power House for a period of 36 days from 02.12.2014 to 07.01.2015.
- (b) Repair work in entire spillway glacis from 2.00 m downstream of sill beam of radial gate in running powerhouse condition.

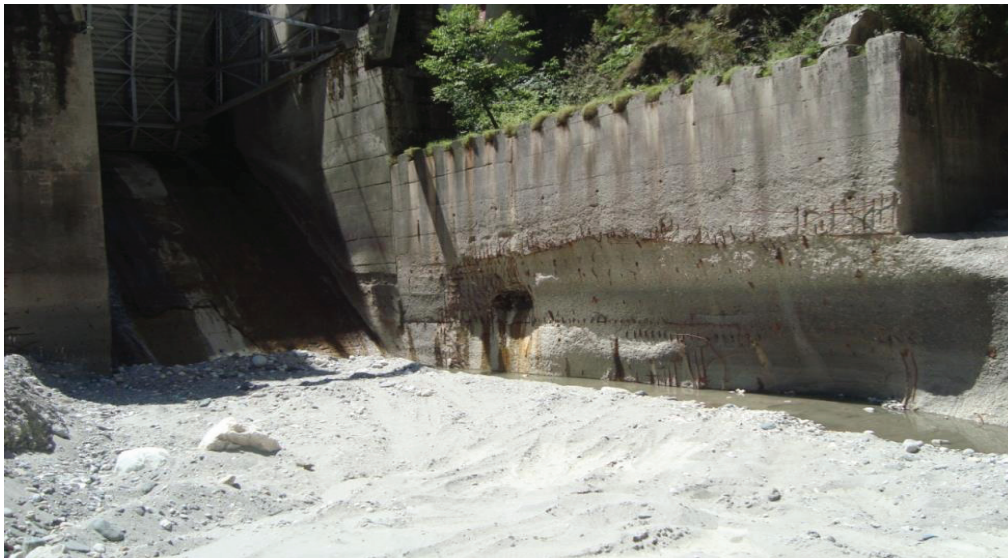
Photograph 6 : (Damaged Left Training wall)

- (a) The slotted roller bucket was completely damaged and was washed out (See photograph 6).
- (b) Deep scour holes/cavities were observed in the bucket area (See photograph 7).
- (c) The spillway training walls were badly damaged – the damages being much more in the right training wall (See photograph 6 for the left training wall).

The training walls were originally constructed with a converging alignment in plan. In addition to the slotted roller bucket which was totally damaged, the training walls were also badly damaged in the floods of August 2012 and June 2013 as can be seen in photograph 6. To improve the flow conditions and to mitigate the damages due to flowing boulders, these walls were dismantled and re-constructed with a straight alignment. A drawing showing their original spillway plan and cross-section is attached as Drawing no. 1.

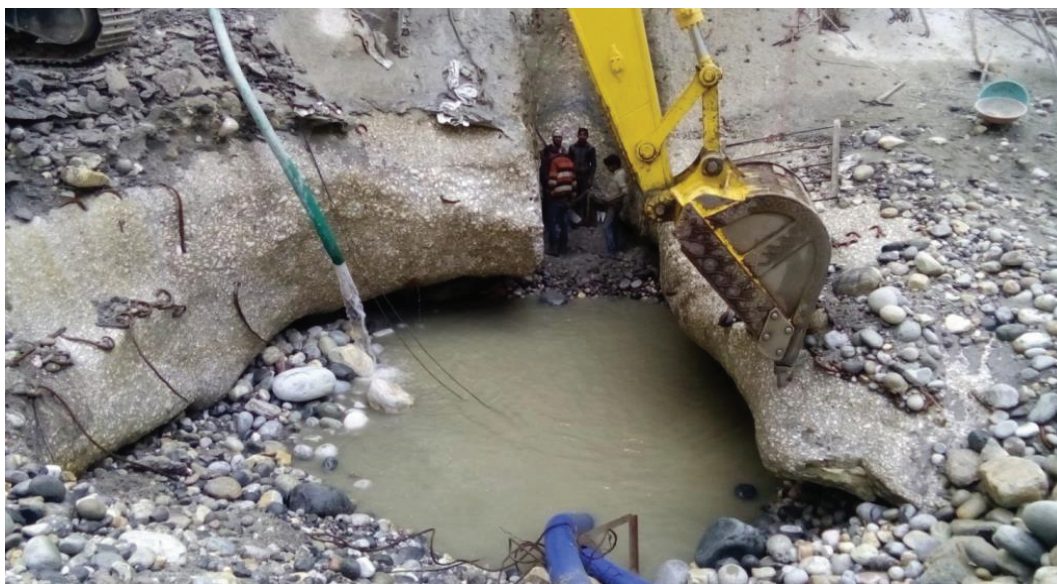
Photograph 7 : (Cavity in Slotted Roller Bucket)

Three deep scour holes /pits of big size had formed in the bucket area in front of bays 1, 2 & 3. One of the pit in front of bay-3 was the deepest. These pits were reported to be inter-connected. For filling these holes /pits, the following was recommended:

- (a) First select the scour hole / pit with the minimum depth for repairs, out of the three for repairs.

- (b) After dewatering, chipping of the entire concrete surface of the hole /pit to get a rough surface, is to be carried out.
- (c) After cleaning and drying of the pit and provision of dowel bars, fill the pit with M20 concrete with non-shrink admixture by tremie concrete in lifts of 1 m height and giving a time gap of minimum 72 hours between each lift.
- (d) Provide reinforcement mesh of 20 mm dia. Tor steel bars @ 150 mm c/c both ways in the top layer and flush it with the existing surface. This area is later to be covered with high strength concrete as required for the EDA.
- (e) Consolidation grouting of the area in the bucket portion to close any inter connections of pits and damaged rock mass with open joints etc.
