EXPERIENCES IN THE REPAIR OF MORE THAN 300 DAMS WITH FULL RESERVOIR LEVEL

A. GONZALO

HCC-ES, Madrid. Spain

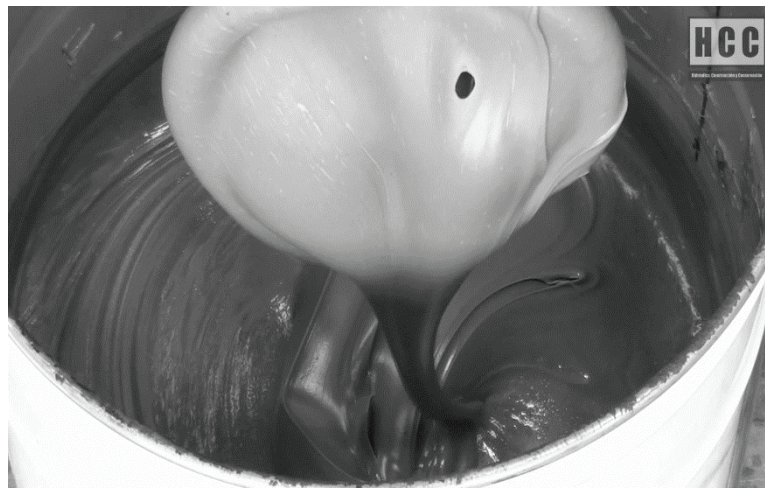
The other disadvantage of commercial epoxy resins is their low viscosity, which makes them unsuited for injecting into fast flowing water as they are easily washed away. Analysing the technical features as given by the main manufacturers of these materials, we can see viscosity figures generally between 400 cP and 10,000 cP (water's is 1cP). However, figures above 100,000 cP and up to 1 million Cp, are required for sealing leakages in a dam. (Fig.1)

Figure 1 : High viscous-thixotropic putty flowing. Viscosity can be one million times more than water.

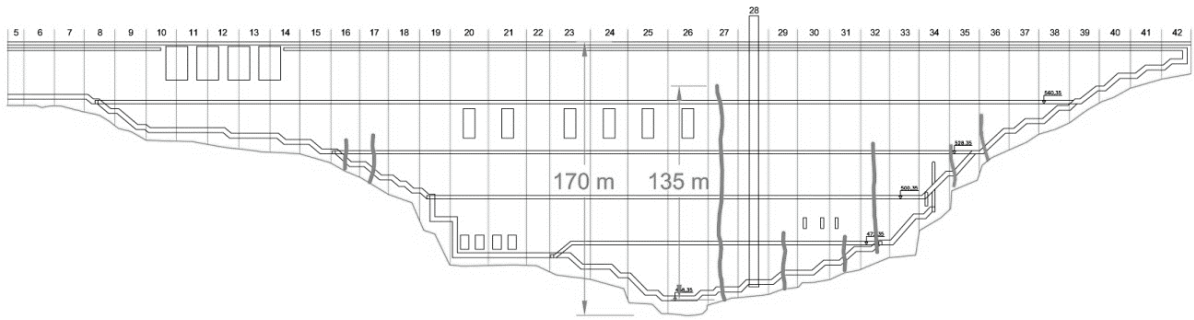
Fig. 2 : Elevation plan of the estimated crack dimensions. Solid lines are cracks of thermal origin and green lines are structural cracks.

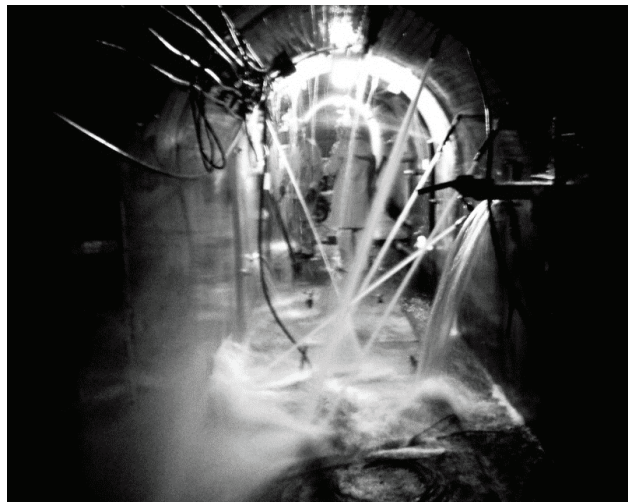
The dam's construction concluded in 1991 and it was first filled in 1992. Thermal gradients between the dam body and the upstream face in this first filling, increased because the face quickly cooled down as a consequence of low water temperatures. This high temperature gradient caused significant vertical cracks up to 5 mm wide and up to 135 m long, and leakage flows close to 300 l/s in some of them (Fig. 3).

Fig. 3 : Leakage up to 300 l/s

The chosen solution was an injection of epoxy resin with high-performance mechanical characteristics into the entire crack area, whilst keeping the dam in service and the reservoir close to maximum load.

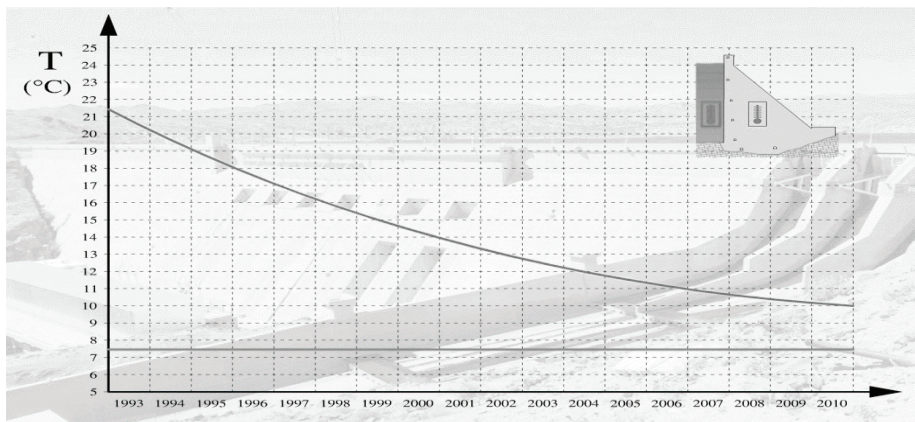
The dam's thermal balance first had to be achieved in order to execute this sealing operation. Fitted in the body of the structure, numerous sensors indicated that the initial setting heat was regularly but slowly dissipated. The change in average temperatures is shown (Fig. 4). In 2010, 18 years after the dam was first filled, full stabilisation of temperatures was still not achieved. However, under these conditions there was no longer any risk of cracks extending since, even under the worst hypotheses, the traction stresses such a thermal gradient might produce would be only 0,2 to 0,3 MPa, values below the concrete's tensile strength.

Fig. 4 : Change in temperatures detected over time.

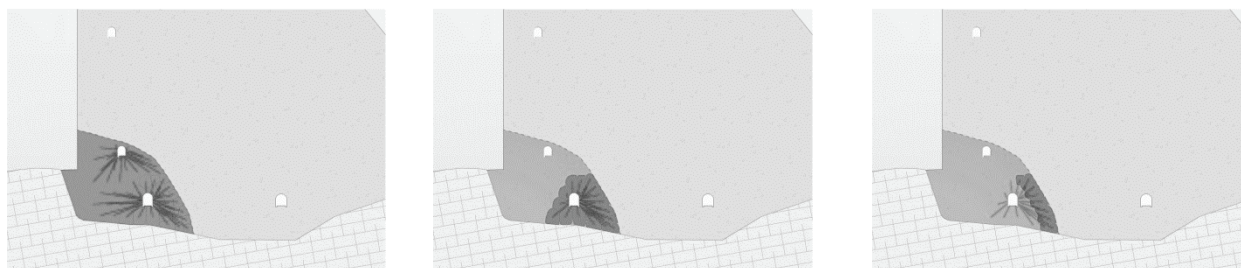
Fig. 5 : Stages of injection of a crack

Once the size of each crack had been determined by exploratory drilling, a network of boreholes was drilled from the galleries, allowing the injection to be carried out uniformly, starting with the lowest level downstream, and moving on in stages, as shown (Fig. 5), until the downstream face was reached.

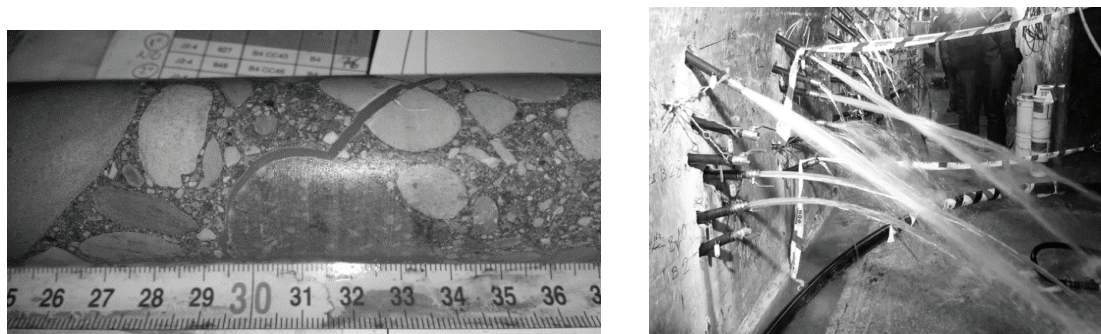
Control boreholes drilled in the injected areas show that not only has the leakage been stopped, but the resin has bonded to the cracked concrete, restoring structural integrity. (Fig. 6).

Fig. 6 : Gallery during injection and bonded core.

The total resin amount injected has been more than 40 tons. The injection of high viscosity resin has already resulted in the recovery of the structural integrity of the injected blocks. Resin was injected with very high-pressure pumps without emptying the reservoir, with 220 metres of water pressure.

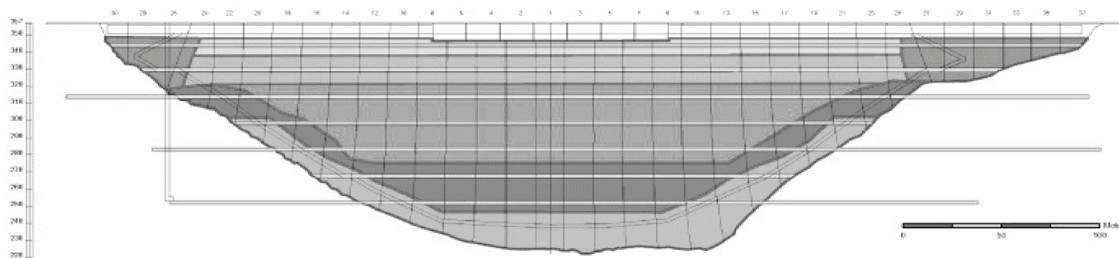
Auscultation of the Dam revealed that the transmission of compressive stresses of contiguous blocks did not have the desirable continuity for a structure of this kind. Therefore, the opening of joints between blocks showed some drift, which made advisable to proceed with the re-grouting of the vertical joints, to improve the structural response of the dam to the solicitations it received, mainly thermal and hydrostatic load, and to regain their ability to transmit stresses between blocks, up to the stirrups.

Figure 8 : Elevation view of the Dam with zones and campaigns of vertical joints re-grouting.

In order to define the re-grouting, we analyzed historical records of joints movements, setting them according to the time of year and reservoir levels suitable to undertake the work in each area of the dam (Fig. 8).

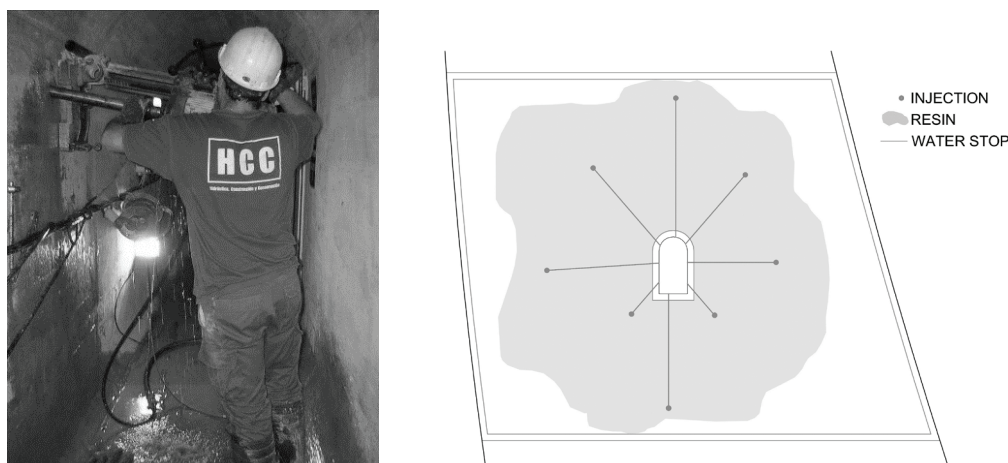
The condition of the observed joints was variable, with some joints detached, others filled with apparently insufficient grout, and even some bonded joints. Over 1,500 boreholes were made along the dam, with a total length drilled over 6,000 mts.

Figure 9 : Sketch of the proposed drilling in one of the joints, and drilling works

It was decided to perform the grouting by secant drills to the joints, executed from the galleries, with uniform distribution in each joint, to cover the entire area to be grouted (Fig. 9). As specified in the Project, rotation boreholes were drilled, with samples extraction using diamond core and commercial diameter of 46 mm, with different lengths and inclinations. The fact that the work was carried from within the galleries and the holes had depths of up to 20 mts in some cases, required the use of a small-sized machinery, albeit with sufficient power.
