THE USE OF HYDROPHILIC WATERSTOPS IN DAMS CONSTRUCTION

S. TAUBERT AND P. BUCHANAN

GHD Pty. Ltd., Melbourne Dams, Tailings and Hydropower, Victoria, Australia

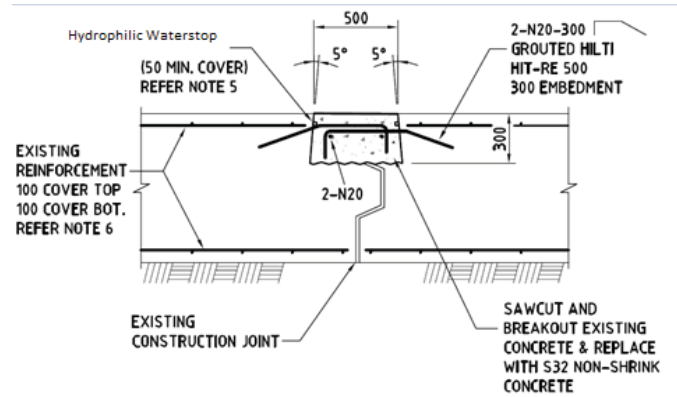
The upgraded slab was made continuous by excavating a 500 mm wide, 300 mm deep slot along the existing joints of the slabs, with 250 mm on each side of the joint. Reinforcing bars were drilled and grouted into the resulting faces of the trench along the joints. Prior to backfilling the slot with concrete, the sides of the joint were protected with a hydrophilic waterstop.

Critically, the waterstop was designed with 75 mm depth cover which was as per the manufactures specifications. This depth allowed the waterstop to provide sufficient protection to the joint and was located above the reinforcement, meaning no additional measures to protect the reinforcement from corrosion (such as stainless steel) were required. As part of the works, the slab was irrigated with cold water to reduce the temperature of the existing concrete to minimise the future possible contraction of the slabs, which may have led to the opening up of cracks at the interface of new and old concrete.

Figure 2 : Detail of joint repair at Dam A

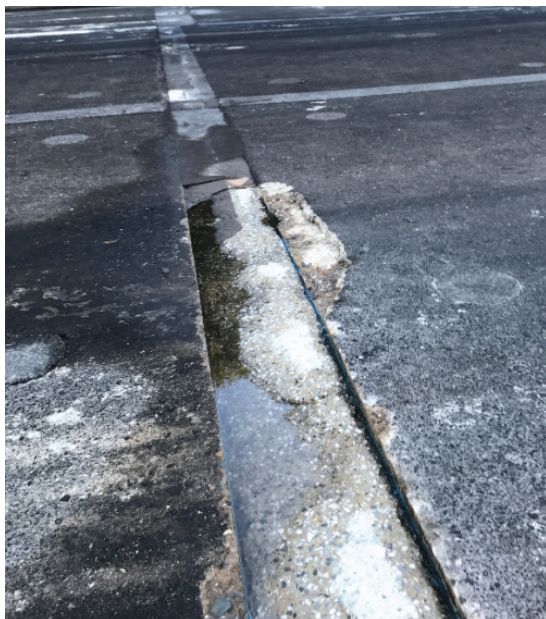
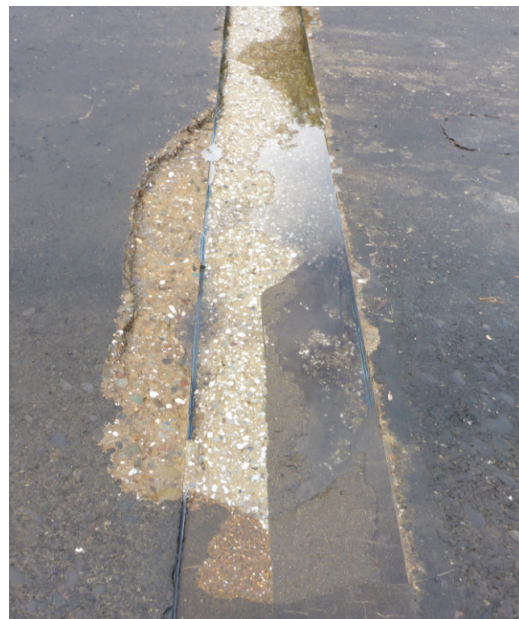
In the years following the upgrade works to the slab, it was noticed during inspections that spalling and cracking of the new concrete in the slab was occurring. Over a number of subsequent reviews it was determined that the spalling and cracking was the likely the result of the hydrophilic waterstop activating swelling pressure. The spillway had not operated since the installation of the new joint details, meaning any swelling of the waterstops was the result of rainfall infiltration only.

Despite being installed in line with the specifications, the waterstop resulted in delamination and spalling failure of the concrete indicating that the manufacturer's recommendations may not have been adequate. Furthermore, if the concrete strength was limited to 15 MPa then it may be considered too weak for the purpose, however it is understood that the concrete had sufficient strength.

Figure 3 & Figure 4 : Damage of joints at Dam A

Given the relatively small cover, it is anticipated that waterstop swelling during rainfall events caused large tensile forces to form. These forces were transmitted to the concrete above, which had no reinforcement above the waterstop and therefore unable to resist the tensile forces. It is likely that this would have contributed to the spalling and delamination of the new concrete. During detailed reviews of the slab it was further suggested that the waterstop expansion alone might not have caused the issue, however the cavity formed by the waterstop combined with the standard horizontal expansion forces formed from temperature would further exacerbate the issue.

An alternative solution to the joint repair is currently being undertaken and has not been shown in this paper. The design includes the installation of a PVC dumbbell waterstop above the existing construction joint. This design is considered more robust and defensible but difficult and time consuming to construct compared to the original modifications.

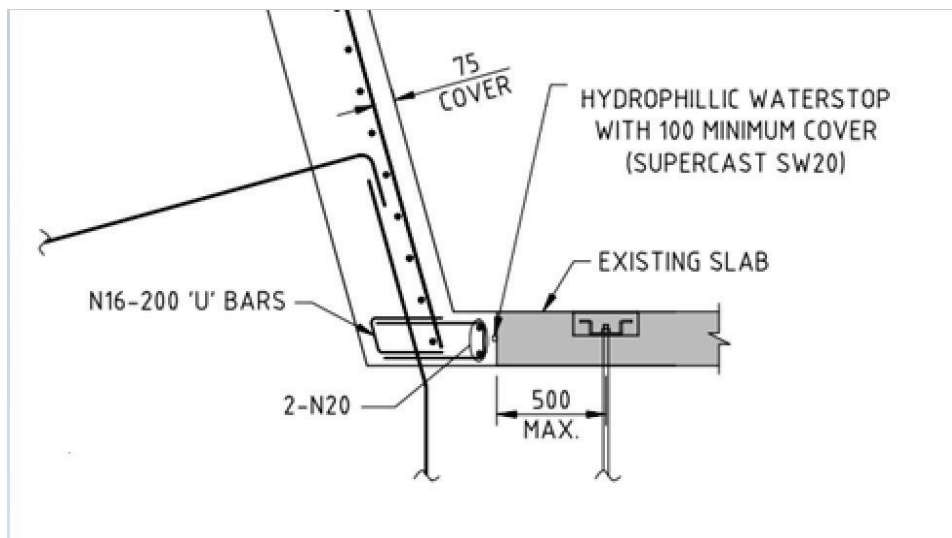
The upgrade design to the spillway included the raising of the existing upstream and downstream chute walls. This included breaking out the top one (1) metre of existing concrete and retaining the vertical reinforcement. A further 30 mm deep saw cut was made into the existing concrete to form a neat joint. This joint was protected with the installation of a hydrophilic waterstop so that a water seal could be provided. Other existing walls (based on condition) were completely removed with the floor slab being broken back 1 m from the existing wall. A 30 mm deep cut was also made in this location and protected with a hydrophilic waterstop.

Figure 5 : Detail of wall repair at Dam B

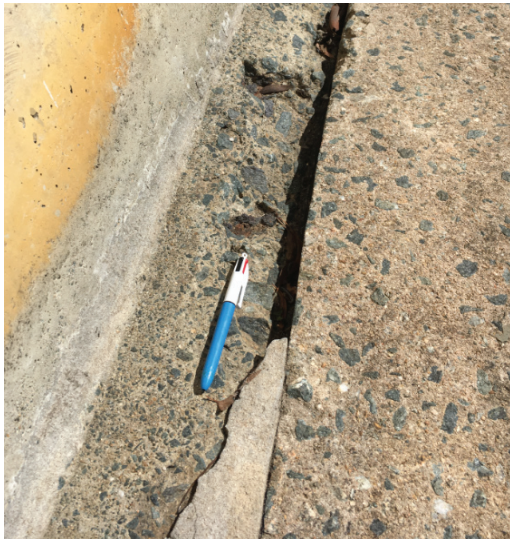
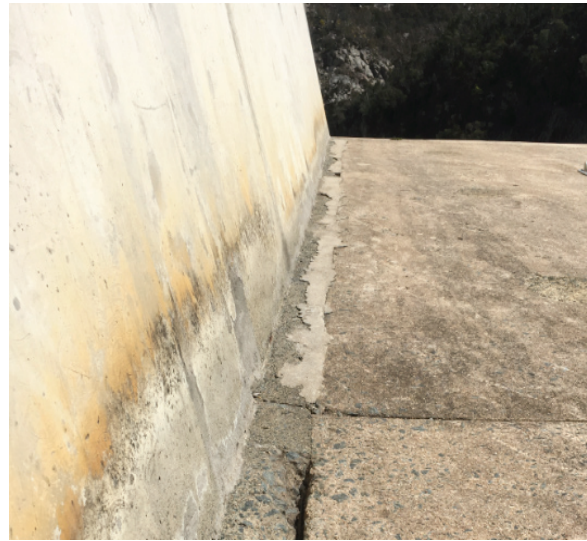
During the comprehensive inspection of the spillway walls after the remedial works, it was observed that the repairs made previously at the joint had debonded from the existing concrete. The remedial design had allowed for 100 mm cover which meets manufacturer recommendations but when the repairs were later investigated it was seen that the cover was far less than the design with some as shallow as 40 mm. This indicates that without diligent supervision and quality assurance, the waterstops can be installed incorrectly.

Given the confined space available and the geometry of the slab and wall connection, it is possible that even with supervision, the waterstop may have still lead to spalling and delamination and seen in Figure 6 and Figure 7. The photos also show that the damage is seen in locations where the waterstop was at depth of less than 100 mm. In locations where the depth of waterstop was at 100 mm or more, there was no damage.

It is noted that the spillway experienced the flood of record shortly after the spillway remedial works were completed. However, there is no record of the joints failing during this event. It is concluded that the key reason for the damage to the concrete was insufficient cover above the waterstop.

Figure 6 and Figure 7 : Damage of points of wall interface

The owner of the dam has undertaken repair works to the damage joints. This repair again included the use of a hydrophilic water stop but placed in the joint with a cover of 150 mm. Additional reinforcement and dowels have also been added.

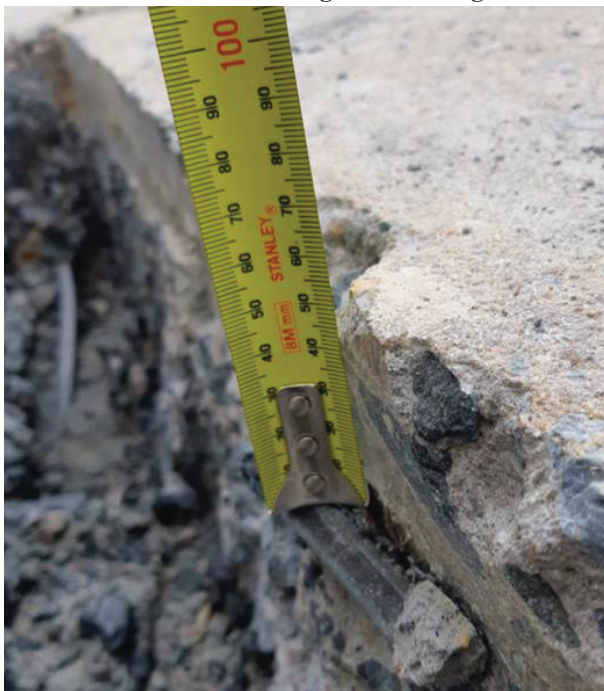
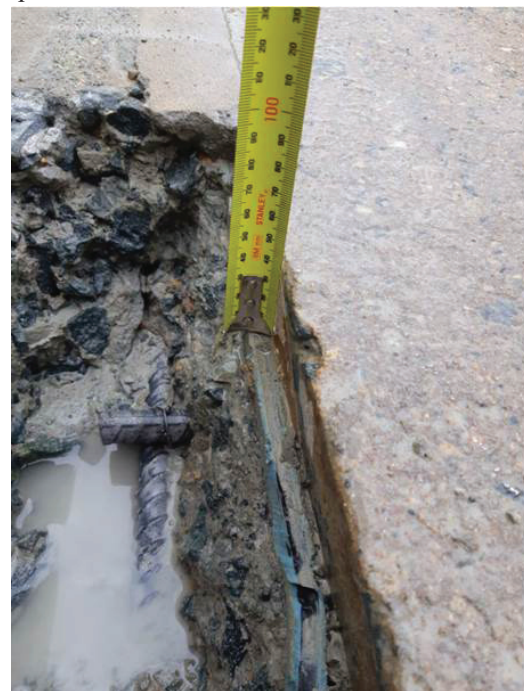
Figure 8 and Figure 9 : Exposure of waterstop at joint at Dam B

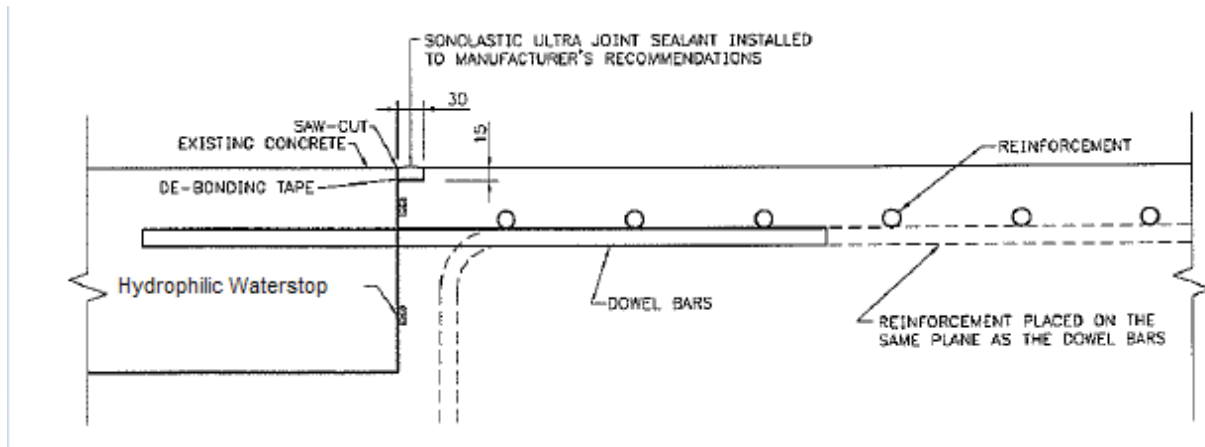
installed and a hydrophilic waterstop placed above and below the reinforcement at the joint between the retaining wall and new slab (Figure 10). The design cover for the waterstop is believed to have been 50 mm. A further joint sealant was installed at the surface of the slabs. The choice of waterstop was driven by availability and constructability. Given the limited space and difficult geometry, it was believed that PVC waterstops would be difficult to install and place concrete around possibly resulting in an ineffective waterstop.

Figure 10 : Detail of joint repair at wall interface at Dam C

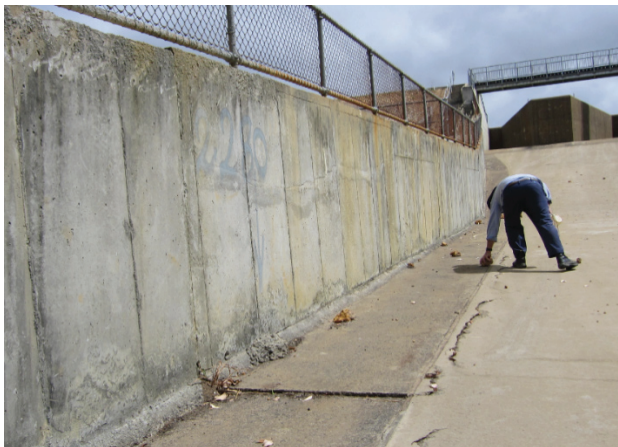
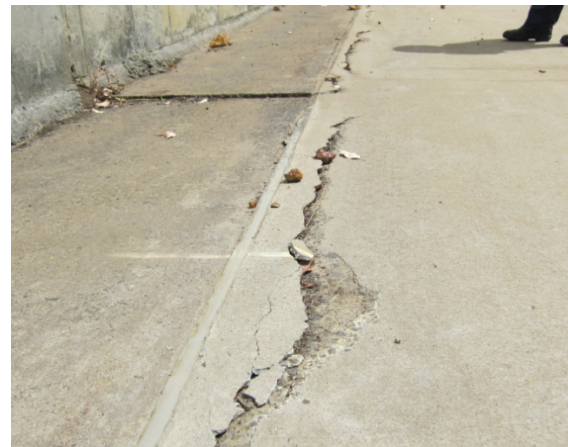
Following an inspection one (1) year after the upgrade works were completed, cracking, spalling and delamination was noted along the joint between the wall and slab. It is suggested that the hydrophilic waterstop was designed and possibly installed with inadequate cover and therefore damaged the concrete when it expanded. This example is similar to the Dam B with the insufficient cover resulting in excessive tensile forces being placed on the concrete above the reinforcement and failure of the concrete.

Figure 11 & Figure 12 : Damage of concrete slabs at wall interface

Following the inspection of the damaged concrete, it was agreed by the owner that given the consequences with such a structure, repairs would be necessary. The remedial measures included removing the damaged concrete around the joint as well as removing and hydrophilic waterstop where possible. Once cleaned, the repaired area was filled with a repair mortar.

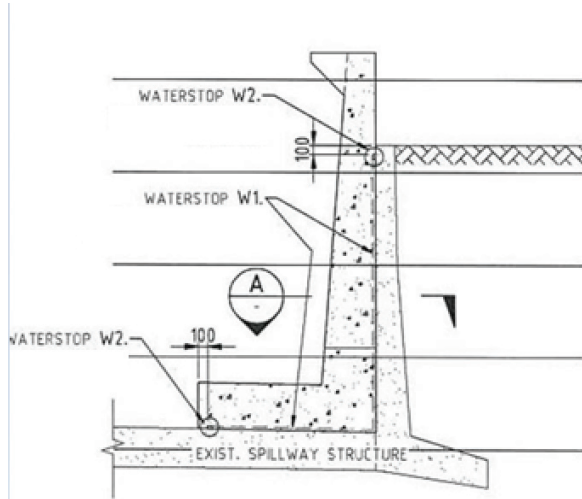
Figure 13 : Hydrophilic waterstop location

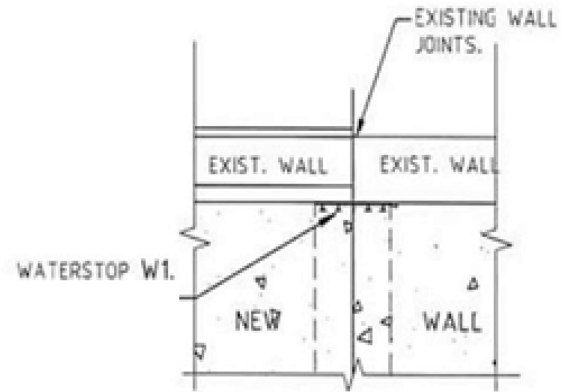
Figure 14 : PVC waterstop location – Section A

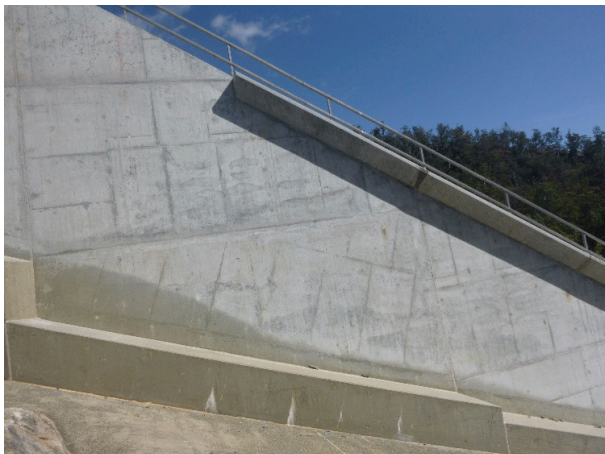
Following the completion of this stage of construction, spalling and cracking of the new concrete was visible, both due to the residual moisture in the concrete activating the hydrophilic waterstop. The combination of no correct adhesion, poor placement as well potential excessive tensile stresses from the waterstop is believed to have led to the eventual concrete damage. Following the construction of the first pour of wall it was decided that any water pressure getting into the walls would not compromise the integrity of the walls and that no waterstop was required at the top of rear wall. The damage in the concrete and any visible waterstop was removed and new patch concrete used.

Figure 15 : Newly constructed wall

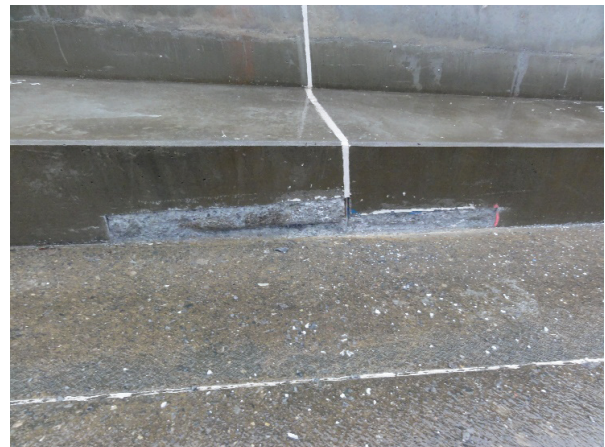
Figure 16 : Removal of damaged concrete

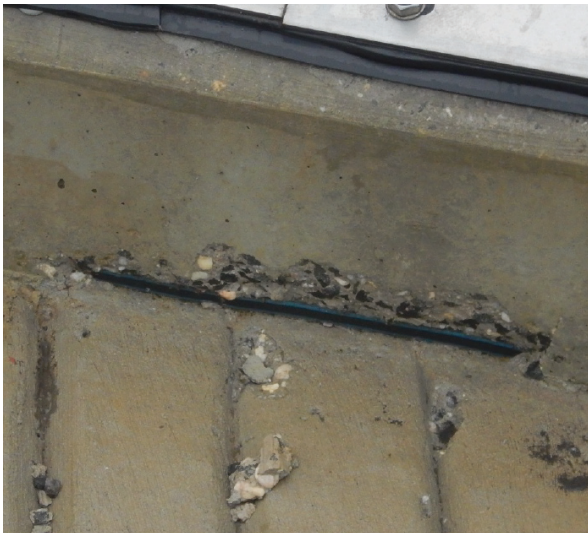
The concrete connection to the HDPE liner anchor ring beam and boat ramp was observed to have cracked and spalled during routine inspections. This damage was attributed to insufficient cover allowing for the hydrophilic waterstop to expand and place excessive tensile forces on the concrete. The manufacturer specification for the waterstop required 50 mm cover (minimum) and constructions records indicate that this achieved throughout the process. It is understood that the continually submerged concrete was in progressively worse condition, which may be due to the waterstop expanding more, given the greater supply of water, or possibly, due to an initial mechanical damage, which would be exacerbated by the waterstop. This deficiency was also visible on the overflow chute but the damage was less. Ultimately the damaged observed on both structures was in the location of the hydrophilic waterstop and associated with the primary reason for the damage.

Figure 19 : Damage of concrete at boat ramp

Both structures although not critical to the operation of the storage were seen as having consequences should they fail completely and both were repaired within two (2) years of first being noted. The repair measures included maintaining the hydrophilic waterstop and constructing a 150 mm nib wall, which included the drilling of starter bars. Prior to pouring the concrete, cracked and damaged concrete was removed. Since the repairs, no major damage has been noted.

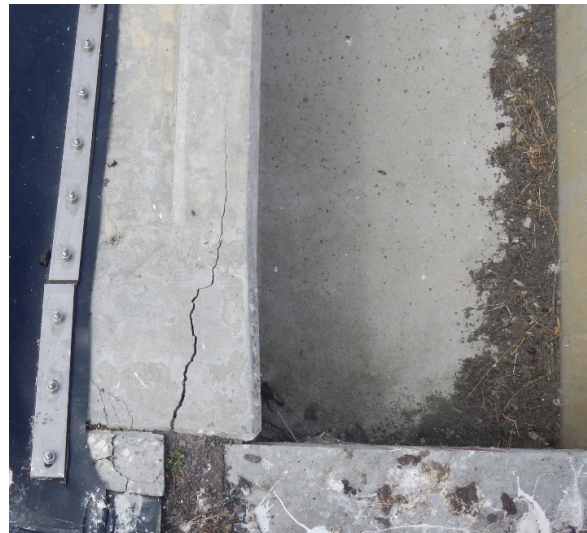
Figure 20 : Damage of concrete at outlet
