THE VIEW INSIDE : TAILINGS DAMS

B.M. CASTILHO

P. SHAW

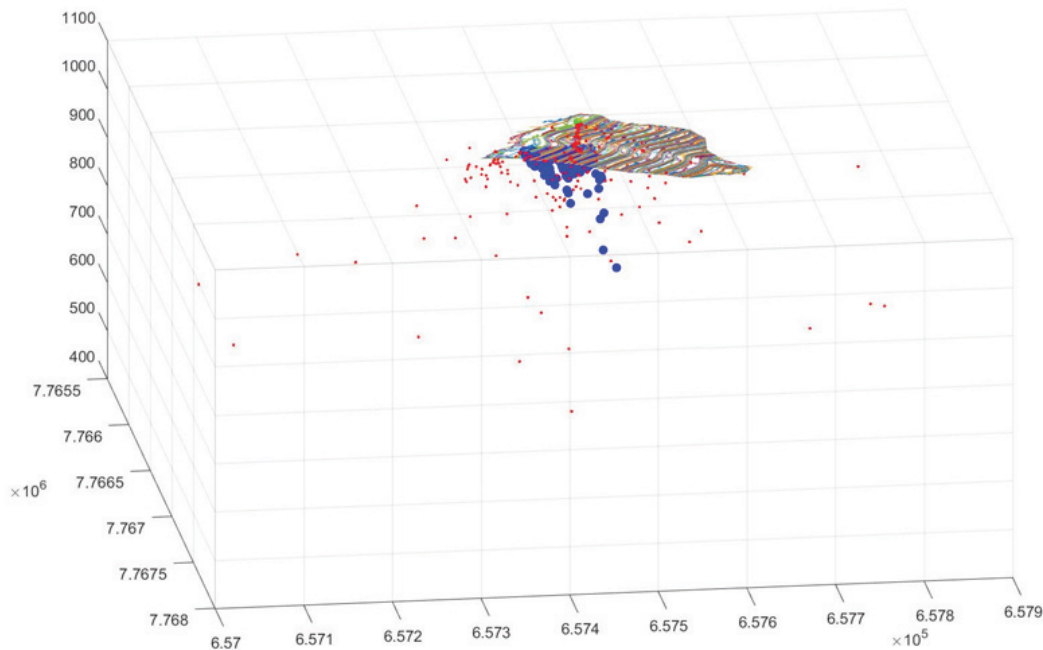
Figure 1 : Typical movements reported for the period between Dec.2016 to Feb. 2017.

The area of the water movement – shown in blue, is approximately 250 meters wide (across the dam), and extends into the water reservoir some 350 meters. The main area for seismic activity shown as red is a line extending into the water reservoir some 150 meters.

It should be noted that these locations were uncertain, and prior to the changes discussed above. Typical data recorded after the changes, and also after the system, was relocated to the second step from the bottom of the tailing dam, as shown in Figure 2 below.

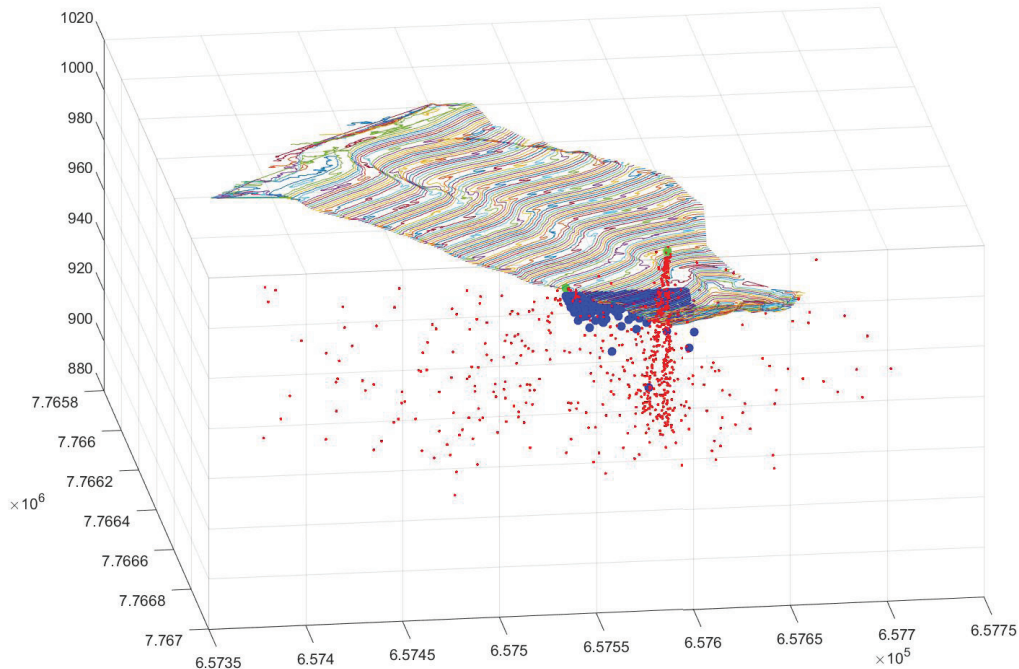
Figure 2 : P and S waves (Body and surface waves) typical as recorded post February 2017

The body of liquid movement is of the same area and size as before. Note it is to one side of the dam. This happens due to the fact that the old mine pit has a natural body of water closer to the right abutment of the dam – this was, in fact, one of the reasons Germano Pit was chosen for the tests in the first place, to check if the monitoring system would be accurate enough to detect this peculiarity. Some of the red seismic events are due to random activity outside of the dam (trucks and the like) and should be ignored as should any single events not forming a line or cluster.

There appear to be two seismic lines running from near sensor ‘B’, and this needs some further investigation, to establish the true nature of the event. For these dams, it would be proposed to monitor with three sensors to enable a tri-angulation of event location to be 100% accurate. This is a technique already deployed in Australia for monitoring large open pit walls.

For future installations, it is recommended that a minimum of three sensors are deployed to confirm and improve the location accuracy. The location of water to the dam wall would then be able to be accurately measured and displayed.

The addition of the third sensor will allow tri-angulation of the source of the events. This technique does not require accurate wave detection of primary and secondary (or surface waves) time of arrival differences. This will resolve any remaining uncertainty about the locations.
