Indian experience in flexible geomembrane for watertightness of ageing dams

2 **EXPERIENCE IN INDIAN SOIL – KADAMPARAI DAM, INDIA**

3 SERVALAR DAM (UNDER WORLD BANK FUNDED DRIP)

4 UPPER BHAVANI DAM, (UNDER DRIP - ONGOING)

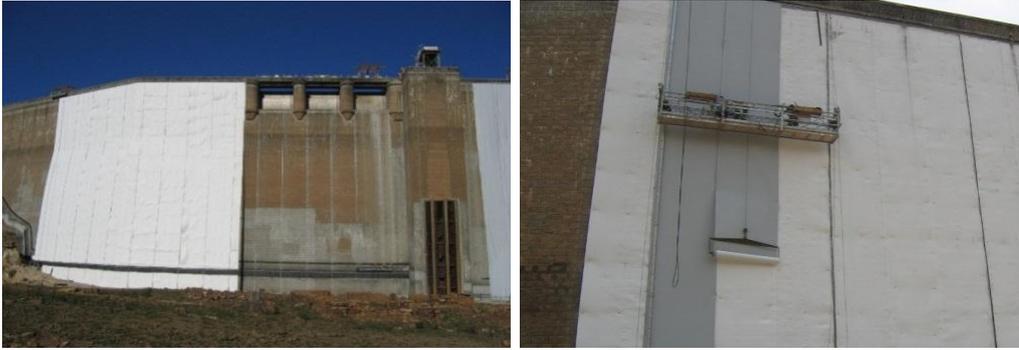
The major elements included the anti-puncture geotextile layer of 2000 g/m², installed on the entire upstream face of the dam to reduce risk of puncture by the very aggressive surface of the stone masonry blocks. The nonwoven needle-punched geotextile made of pure polyester fibre was anchored to the face (Figure 1 at left).

Figure 1. Installation of anti-puncture geotextile and of waterproofing geocomposite.

The geocomposite sheets were lowered from the dam crest and positioned on the upstream face by crews working from suspended platforms (Figure 1 at right). On the masonry face large offsets were observed and at the bottom perimeter seal area a layer of shotcrete was done to allow even adhesion of the stainless-steel element to the dam body.

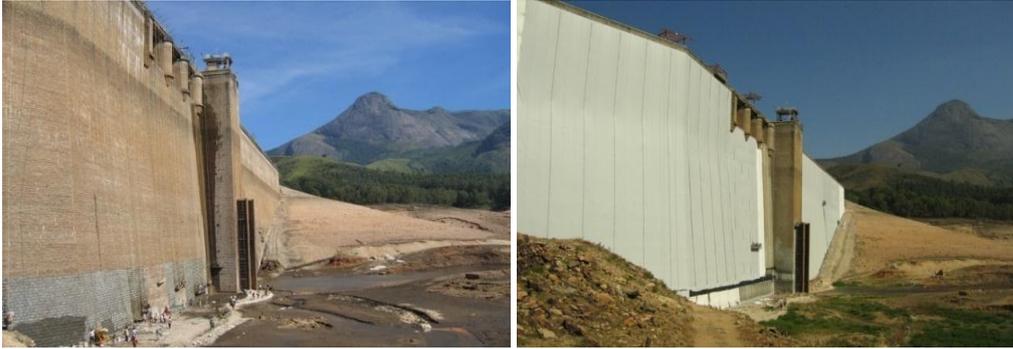
the client in terms of the results, and since its installation the dam is now filled up to the FRL (Full Reservoir Level) thereby allowing full generation power of 400 MW, which was not possible before geomembrane works as the dam was operated at nearly 10 metre below FRL

Figure 2. Upstream face of the dam before and after geomembrane installation.

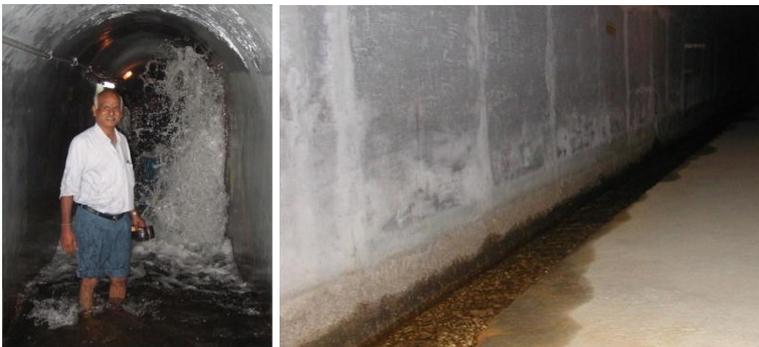
Figure 3. Drainage gallery before and after geomembrane installation.

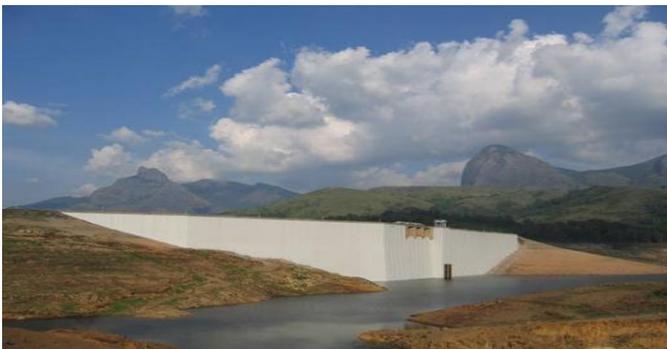
Figure 4. Kadamparai dam after installation of the geomembrane system.

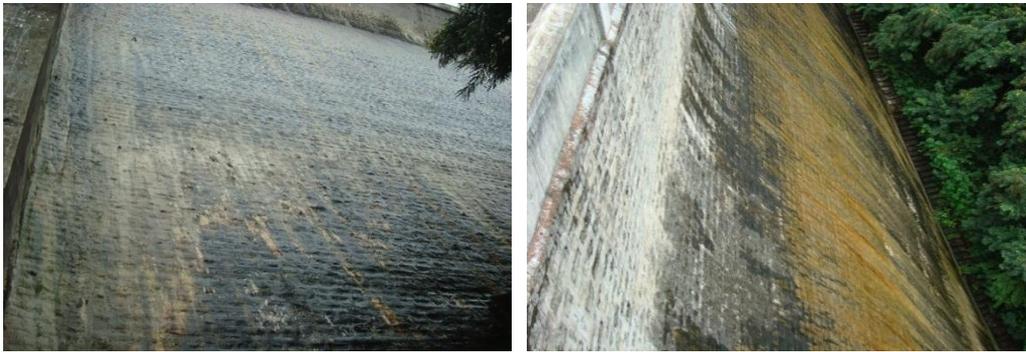
The major problem in Servalar dam is the high seepage collected inside the gallery through the vertical shafts and the extremely wet downstream side. The left flank of the dam experienced heavy seepage (Figure 5) when compared to that to the right flank, while a complete wet and oozing downstream side is visibly seen and goes unmeasured. The problem is attributed majorly to the poor quality of construction. The leakage which has been continuing for many years now has resulted in many of the drainage shafts getting choked, and heavy calcination was observed both inside the gallery as well on the downstream side of the dam.

Figure 5. Heavy seepage on left flank.

The last recorded leakage by DRIP in 2014, before the remediation works, was 743 l/minute and a complete wet downstream side (which is unmeasured – which can be approximated as around 6,000 l/minute). Most of the vertical drain shafts were choked. This continued leakage resulted in bulging of the entire dam on the left flank downstream which posed a serious risk to the dam.

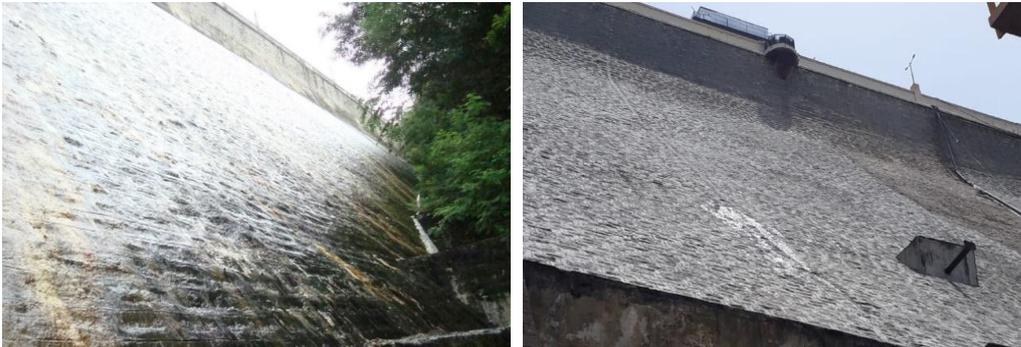
The entire work was completed on 14th of October 2018 and an inspection of the gallery was done on 15th of October jointly with the client and Carpi. Leakage from shaft reduced from 1,200 litres/minute to 1.31 litres/minute. The downstream face is now completely dry with water level almost close to FRL. The recorded leakage through the vertical shafts is 1.31 litres/minute on 09.11.2018 at water level 257.14 m.

Figure 6. Downstream side before and after geomembrane installation.

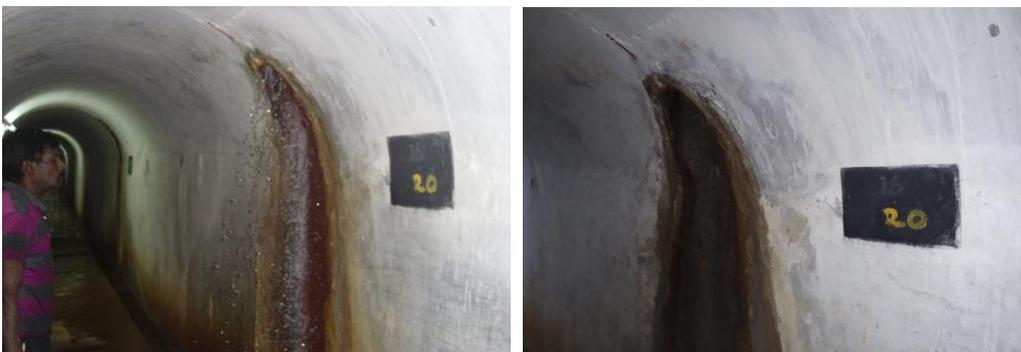
Figure 7. Vertical shaft leakage before and after geomembrane installation.

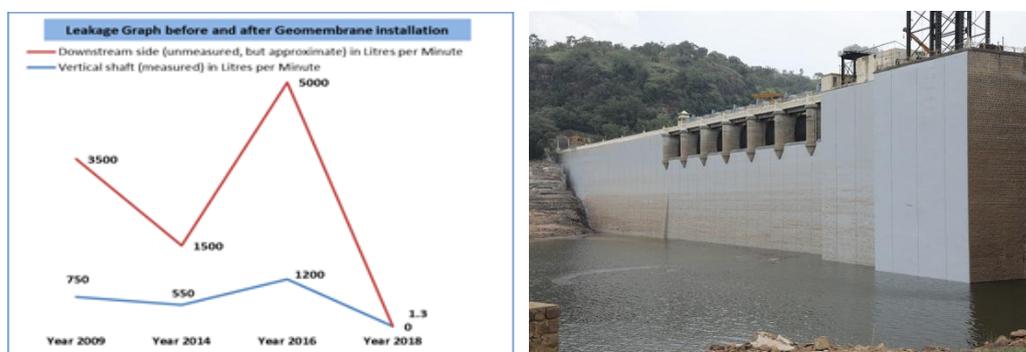
The results achieved is yet another proof of effective and professional design of geomembrane waterproofing system on large dams. A dam which was leaking at a rate of > 6,000 litres/minute is now reduced to just < 2 litres/minute on the left and spillway section.

Figure 8. Leakage pattern before and after geomembrane installation. At right, Servalar dam after geomembrane installation.

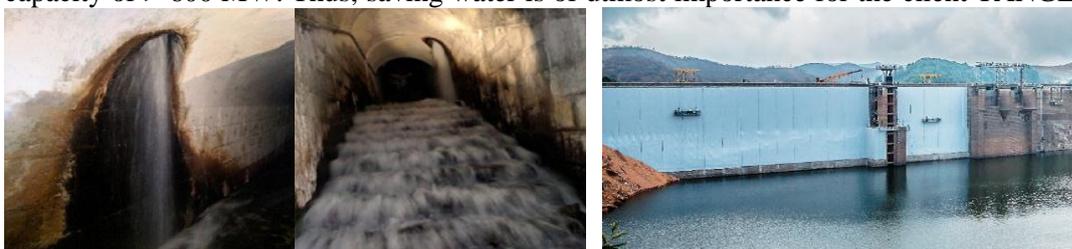
Upper Bhavani dam, a stone masonry dam of 80 m height, located in the Nilgiris District, Tamil Nadu (India) is the third project in India for Carpi and the second project in the DRIP program (Dam Rehabilitation and Improvement Project). The dam, constructed in the year 1965, started leaking badly since the early 2000ies. Leakage started increasing thereafter and especially the region surrounding the spillway started leaking very badly. Around 8,000 l/minute has been recorded as the leakage from the two shafts surrounding the spillway alone. Various repair attempts were made between 2003 and 2010 and the dam has been declared as the most distressed dam in spite of the conventional repair works carried out, which again did not provide good results. Ultimately it was decided to install a geomembrane waterproofing system citing the previous success stories of the Kadamparai and Servalar projects. The project is being executed in two phases out of which 20% of geomembrane installation has been completed in the first phase between April and June 2019. The next phase will commence by February 2020 once the monsoon ends by December 2019. Despite the challenges of extreme cold weather and location of the dam in a deep reserved forest, the balance work has been planned to get completed in second phase between Jan and June 2020. The water from the Upper Bhavani dam acts as the main source for a series of cascaded power houses with a total power generation capacity of > 600 MW. Thus, saving water is of utmost importance for the client TANGEDCO.

Figure 9. Leakage in vertical shaft of drainage gallery at left. At right, geomembrane lined on the upstream face of the dam as of June 2019.
