ICOLD Symposium on Sustainable Development of Dams and River Basins, 24th - 27th February, 2021, New Delhi

SASW SURVEY AND NUMERICAL MODELLING OF ROCK SCOUR AT GATED SPILLWAY (TEXAS, US)

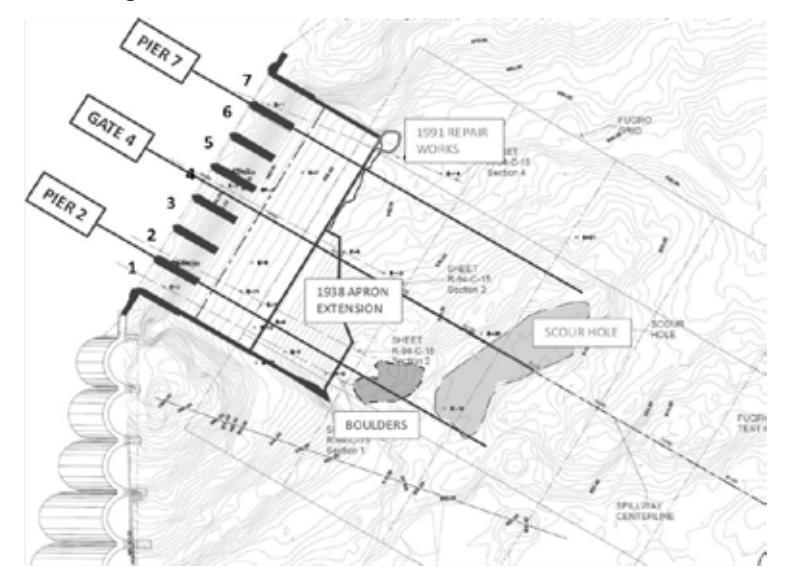
The 7-gate spillway structure was constructed to pass floodwaters via seven (7), 12 m long by 8 m tall radial gates. The reinforced concrete spillway includes a chute section flanked by training walls. The flood of record occurred at the dam shortly after construction was completed in 1938. During the flood all seven gates were operated at various sequences to 5.5 m open with a maximum of five gates opened concurrently and a peak discharge of approximately 2,265 m³/s. After flood operations were completed, scouring of the rock substrate adjacent to the spillway chute base slab directly downstream of Gates 1 to 3 was identified. The scour section along the right training wall was filled in and an approximately 46 m wide section of the spillway chute base slab were extended downstream approximately 30 m. The 7-gate spillway was not operated again until 1991 when another severe flood occurred in the basin and Gate 7 was opened to 5.5 m. The maximum discharge from the spillway was approximately 510 m³/s. After flood operations were completed, scouring of the rock substrate adjacent to the spillway was approximately and gate 7 was opened to 5.5 m. The maximum discharge from the spillway was approximately 510 m³/s. After flood operations were completed, scouring of the rock substrate adjacent to the spillway slab directly downstream of the opened gate was identified. The scour section was repaired with reinforced concrete.

Figure 2 : Plan view of 7-gate Spillway, showing the different gates and piers, as well as the original concrete apron and its 1938 extension.

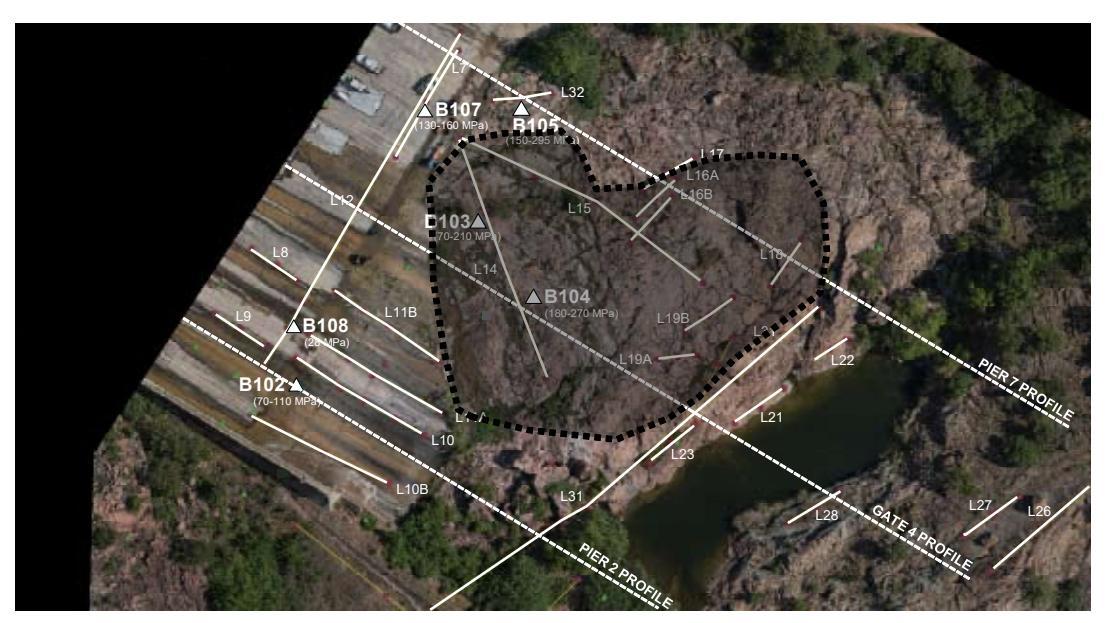
Spectral Analysis of Surface Waves (SASW) tests have been performed at the site (Stokoe et al., 2017). The locations of the tests are presented by the white continuous lines in Figure 4. The shear wave velocities are mostly situated in between 600 m/s and 3,400 m/s. Values of 2,400 to 3,400 m/s are considered representative for intact gneiss rock. Values less than 2,400 m/s represent weathered and/or more or less heavily fractured gneiss rock. Especially values less than 2,000 m/s indicate significant presence of fractures, or even loose rock. The plan view shows the main areas of highly fractured or decomposed rock as those surfaces that are not darkened in Figure 4:

- Underneath the initial chute and a part of the chute extension,
- Area of concrete repair in 1992 (downstream of gate 7)
- Near the downstream pond all around,
- Whole area downstream of the chute extension at gates 1-2.

A zone of lowly fractured or even massive rock exists in the center, as shown by the darkened area in Figure 4. This zone corresponds to the flow area of the 1938 flood event. This event has almost entirely scoured the initial rock surface layer over a thickness between 1 and 3 meters. The underlying rock mass (current surface) is clearly more massive and less weathered and fractured. At some locations, pieces of the initial surface layer remain visible. Some are located along the left-hand side of the basin, but the most significant ones are concentrated along the right-hand side, downstream of the chute extension. All of the investigations performed underneath the initial chute show highly fractured rock or decomposed rock, based on both boreholes and SASW data, which are in good agreement.

Figure 4 : Plan view of SASW test locations in rock mass downstream of 7-gate spillway.

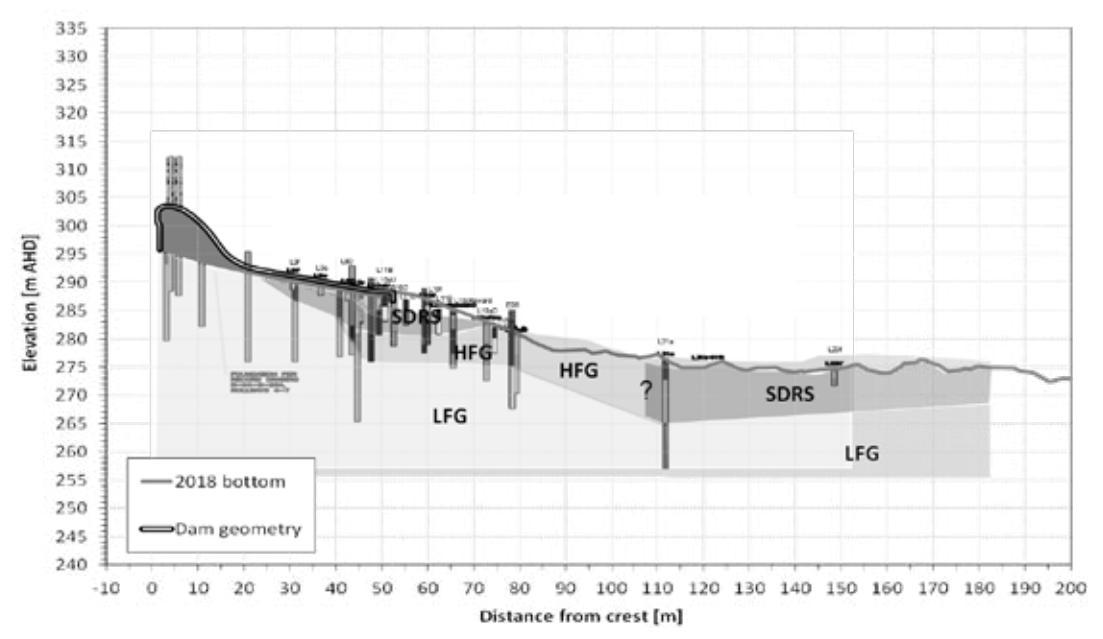
Figure 5 : Vertical geological profile downstream of pier 2, showing different boreholes and layers of lowly and highly fractured gneiss (LFG and HFG) and of soft decomposed rock (SDRS).

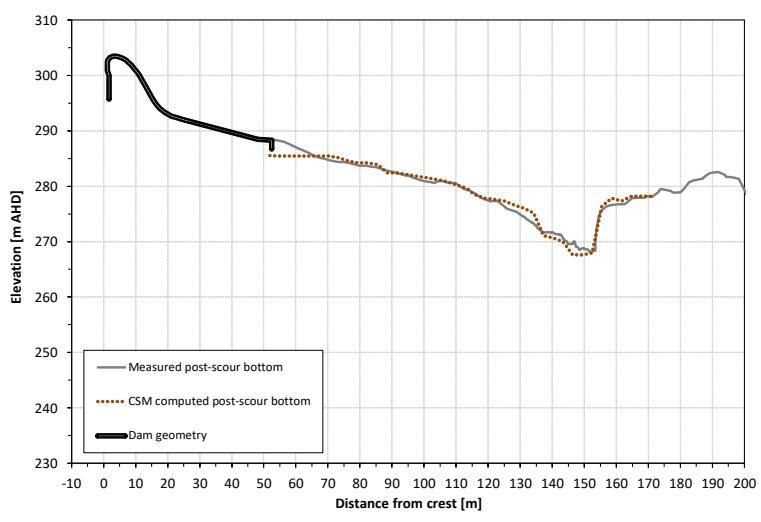
The CSM has been calibrated based on the 1938 flood event, for which significant damage was observed in the area repaired with a concrete apron at gates 1 and 2 and further downstream. Figure 9 illustrates a comparison between the measured and computed scoured bottom downstream of gate 4.

Figure 9 : Calibration of CSM based on the 1938 flood event (downstream of gate 4).

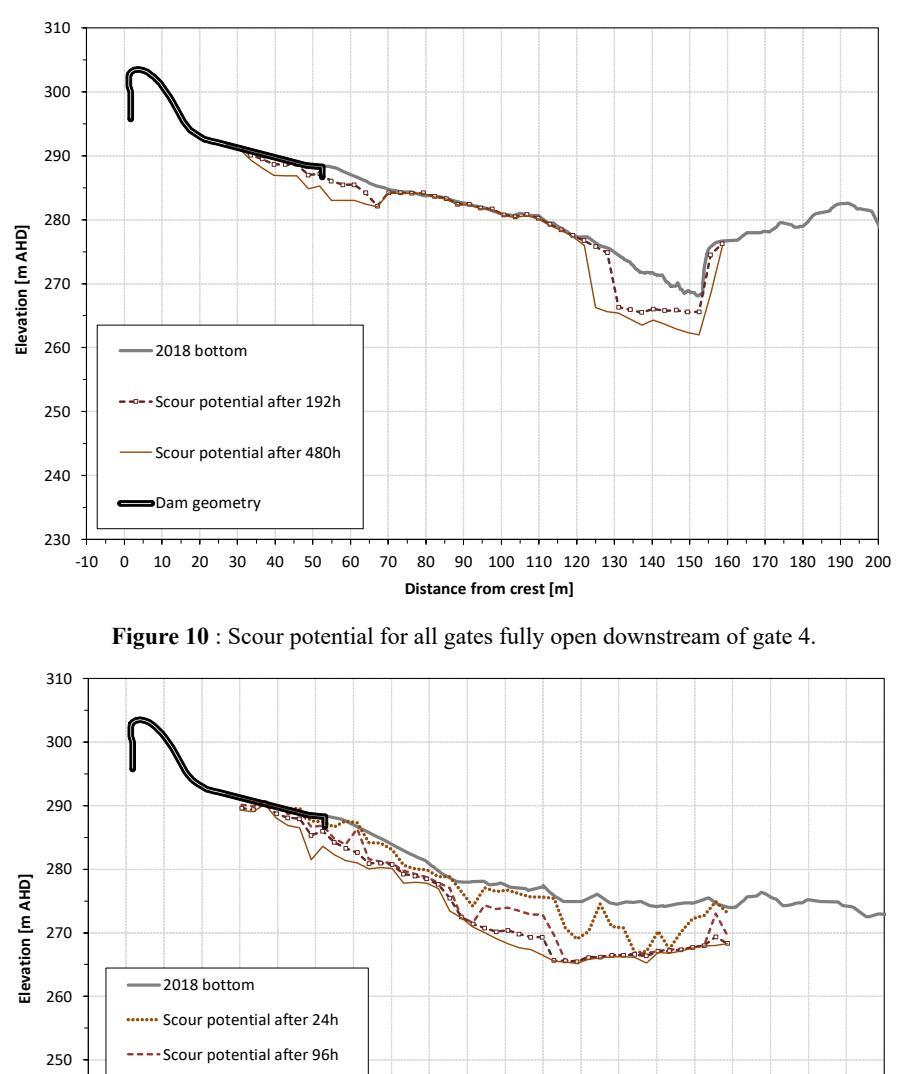
Distance from crest [m] Figure 11 : Scour potential for all gates fully open downstream of pier 2.

Figure 10 shows that, downstream of gate 4, scour will form rapidly in the weak rock layer at the downstream pond (soft decomposed rock). Also, scour will be retarded in the underlying better-quality rock, but will start in this layer after less than 20 days of flood. Finally, scour will form in the highly fractured gneiss layer close to the chute end, on the order of a meter in 4 days, and down to an elevation of 284 m asl in 20 days of flood.

The risk for undermining and progressive destabilization of the original apron exists, but most probably not within one flood event (All Gates, max. 96h). For such an event, scour potential just downstream of the apron remains limited to about 1-2 m. It is believed that the current foundations of the apron are able to resist and maintain the apron in place and operational. Based on the performed scour computations, scour will continue during subsequent flood events, and reach 3-4 m after 192 h, and 7-8 m after about 480h of All Gates functioning. For these scour depths, destabilization of the downstream part of the apron will progressively generate scour towards upstream, by increased turbulence and concrete protrusion of parts of the apron. This phenomenon will stop along the interface between the highly and lowly fractured gneiss rock. Destabilization of the downstream part of the apron is likely to occur at gate 4, but would need more than one flood. Similar to Pier 2, scour will take an end based on the weak rock underneath. As the exact extension of this layer towards the spillway is not precisely known, it must be considered that the spillway itself might be in danger.

Figure 11 illustrates that scour potential downstream of pier 2 is significant and will destabilize the 1938 apron extension, generating regressive scour by subsequent displacement and protrusion of local concrete elements, generating on their turn additional local turbulence from downstream to upstream by perturbation of the main flow conditions. Hence, local flow perturbations actually present (boulders etc.) are triggers for scour initiation and start of scour regression towards the dam. It is believed that the 1938 apron extension will be scoured within 72h. Once the original apron is reached, local flow turbulence conditions will be at least as severe as presented in Figure 11. Local perturbations by displaced and protruding concrete elements will intensify the turbulence and thus the scour potential at that location.

Hence, the downstream part of the original apron will also be undermined and destabilized during the same event. The scour will take an end based on the positioning of the weak rock layer underneath the apron (soft and decomposed rock). As the exact extension of this layer towards the spillway is not precisely known, it must be considered that the spillway itself might be in danger.
