ICOLD Symposium on Sustainable Development of Dams and River Basins, 24th - 27th February, 2021, New Delhi

INNOVATIVE METHODOLOGY TO CONTROL SEEPAGE OF PATHAZHAKKUNDU EARTHEN DAM IN KERALA, INDIA

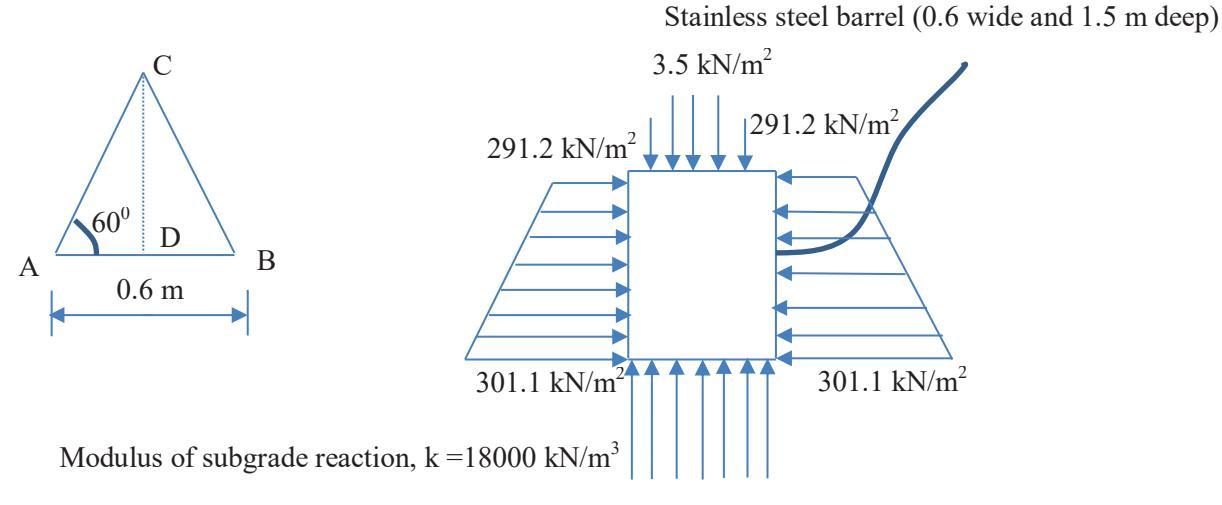
Pressure distribution at top of barrel is assumed to have a triangular distribution of pressure as shown in fig. 2. Maximum pressure in the triangular distribution of pressure

Fig. 2 : Stainless steel barrel with forces

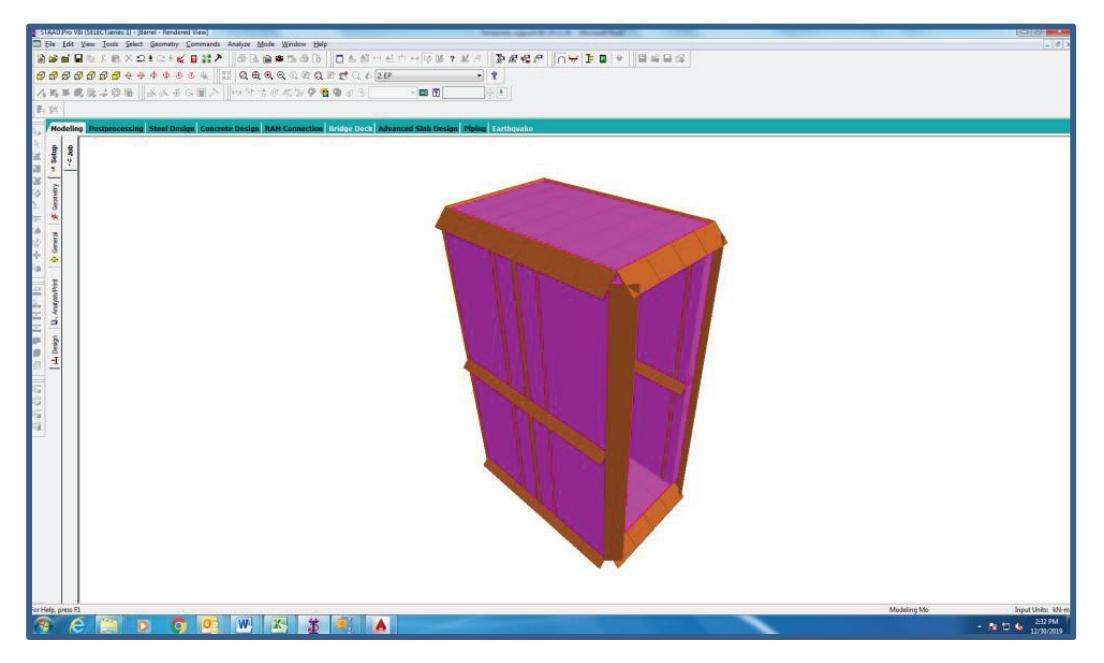
Results show that all members pass in the design check and the plate thickness of 6 mm is found to be sufficient.

Fig. 3 : 3 D view of the model of barrel

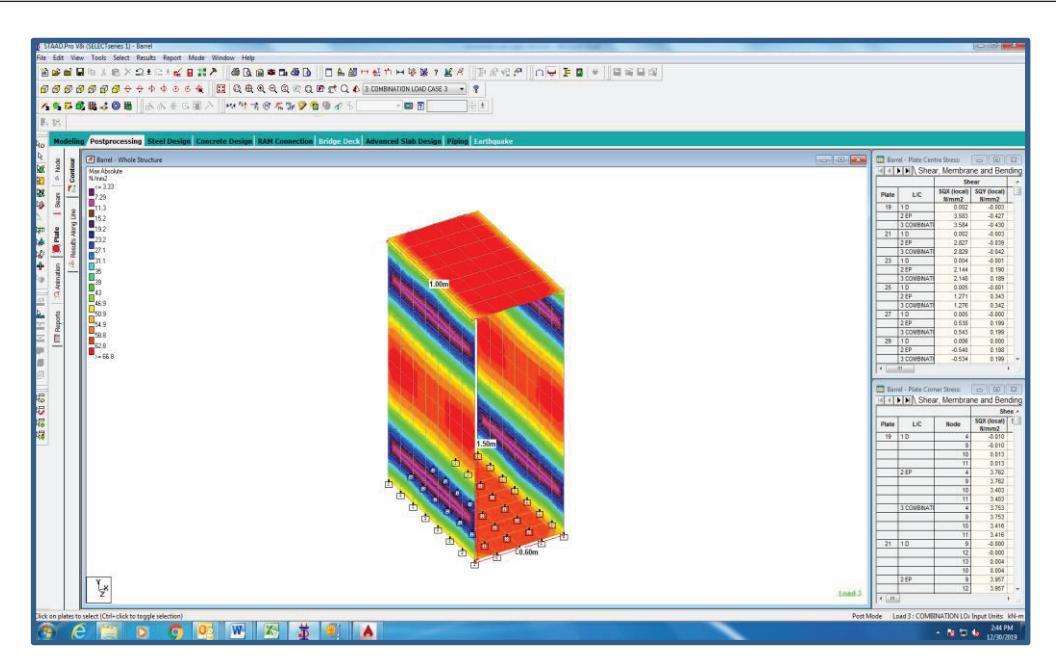
From the above deliberations, it is clear that the barrel pushing through rails are safe against the given loads. Stresses in the material as per STAADPRO are also within safe limits as per stress contour in Fig. 4.

Fig. 4 : Stress contour in the stainless steel showing within limits
