ICOLD Symposium on Sustainable Development of Dams and River Basins, 24th - 27th February, 2021, New Delhi

INNOVATIVE REMEDIAL DESIGN OF BARREL ARCH DAM

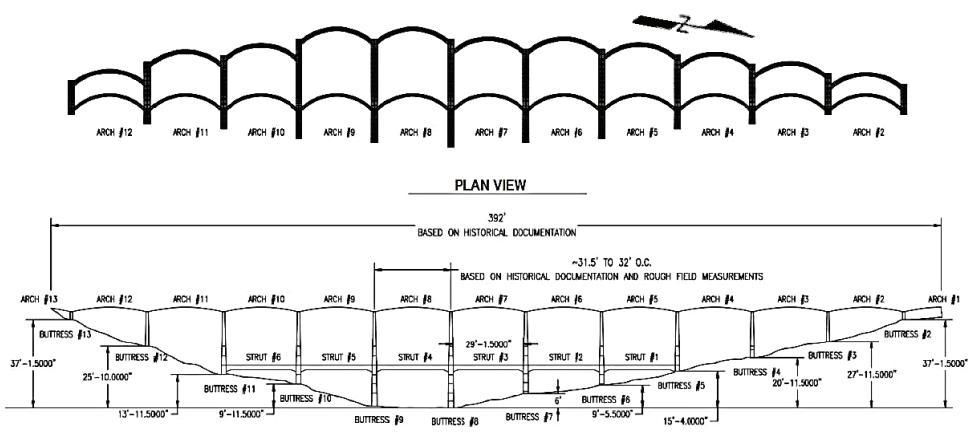
Figure 2 : Plan and Elevation View of Existing Dam

The Argonaut dam is a Concrete Multi-Arch (CMA) dam, designed and constructed around 1916 by John S Eastwood for the purpose of storing mine tailings. Eastwood designed and constructed over ten similar CMA dams in California during this period. The CMA dam is located in Amador County, approximately one mile north of Jackson, CA, at the corner of the Argonaut Drive and Sutter Streets. The dam is about 420 to 450 feet long and 46 to 50 feet tall at its highest point. The dam consists of 13 contiguous arches and includes tie beams for bracing between buttress walls for six of the tallest arches.

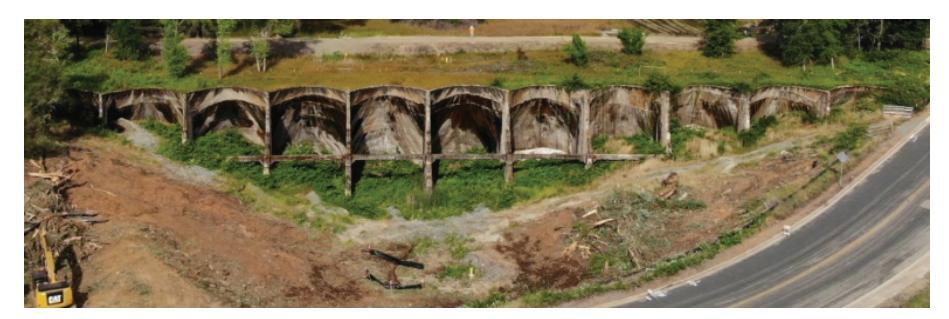
Figure 4 : Site Photo (Pre Construction)

With no longer any spillway structure, site stormwater management has been a problem as runoff from the site would pool behind the CMA dam and flow through a small hole which has been broken through in the concrete shell on the right side of the dam (date and responsible party unknown). In heavy runoff events flow would overtop the dam. In 2016, in order to re- route runoff around the dam away from the CMA structure, DTSC had a temporary berm installed behind the dam. The runoff is re-routed using pipe and temporary pump station.
