# UAV-BASED MULTI-LAYERED DATA COLLECTION METHODS AND DEFECT DETECTION ALGORITHMS FOR PREDICTIVE ANALYTICS

## ABSTRACT

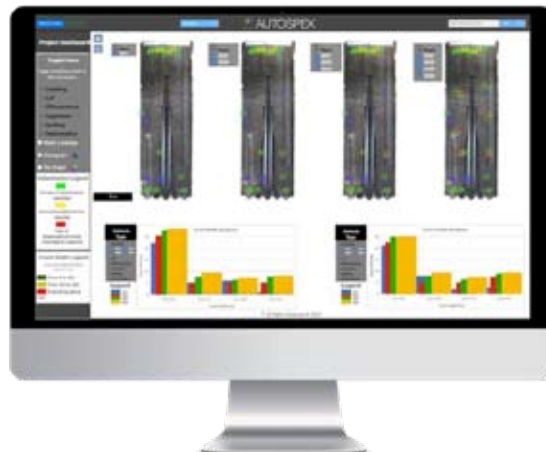
Fig. 2 : Defect Detection and Quantification Software Platform (AUTOSPEX)

The multi-layered data collected is fed into the software shown in Figure 2. Optical images allow for detection and quantification of surface defects such as cracks, spalling. Infrared sensor allows for detection of subsurface delamination, moisture ingress, surface vegetation growth etc. for up to 50 mm (requires clear sunshine) from the top concrete surface. Acoustic sensor detects and quantifies deeper (up to 200 mm) voids/delamination in concrete sections. In addition, it captures the relative reduction in compressive strength of concrete. The software uses a deep learning model to detect and quantify defects automatically. The deep learning model is trained to classify images into two classes of images, for example; with cracks and without cracks. A powerful deep-learning model based on convolutional neural network (CNN) is being used for training. In order to ensure the accuracy, a dedicated quality check person is assigned.

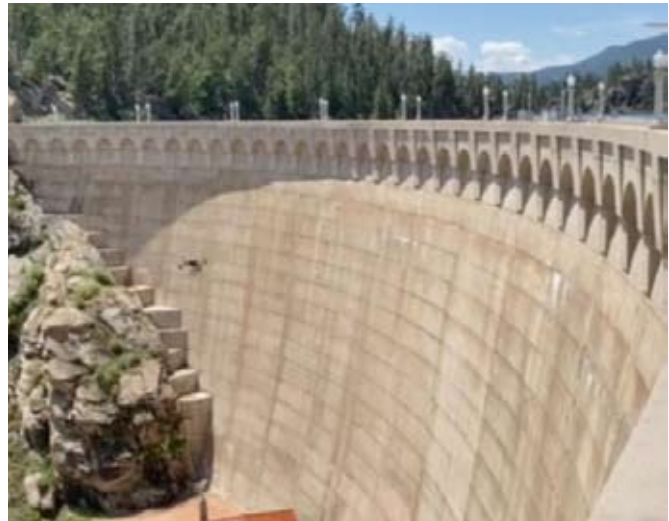
**Fig. 4 :** Automated Data collection- Optical images and Thermal images

To implement the software and the data collection technology, a concrete spillway structure and a concrete arch dam located in Canada and the United States of America were identified. Matrice M210-RTK- Unmanned Aerial Vehicle (UAV) was used to collect LiDAR, optical images, thermal images, and acoustic signatures at both the sites. Figure 3 shows the UAV navigation direction while capturing the data points. RTK base station was setup on the side structure during the entire data collection process. First 2 sets of flights (Only LiDAR) were conducted to capture the overall geometry (Length, slope etc.) of the structures. The data was captured at 50 m above ground level (AGL). Second multiple sets of flights were conducted at a lower altitude (less than 8 m) with the slope and other information of the structures. This information was used to adjust the angle of the camera (keeping the camera perpendicular to the surface). Infrared images were acquired at a higher altitude (more than 20 m) to cover the entire structures while maintaining the optimum pixel/ground distance ratio. Figure 4 shows the collection of optical images and thermal images at different acquisition distances. Note that during all the flights, images were captured with approximate 70% front and side overlap. This is to ensure that the orthomaps are generated without any difficulties.

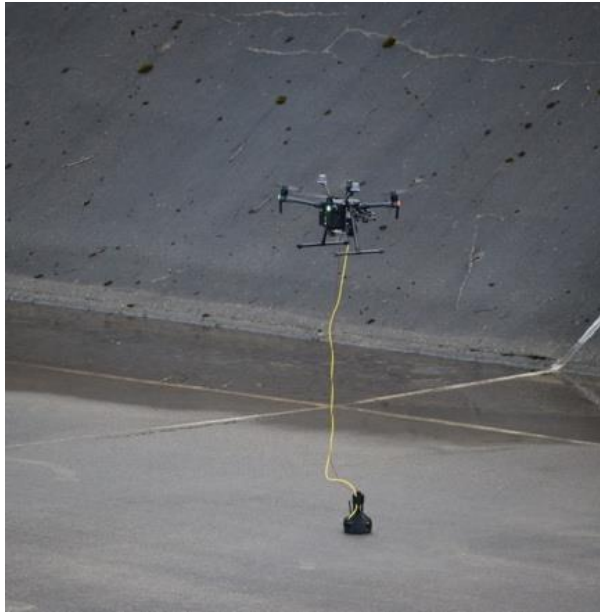
Fig. 5 : Acoustic data collection on a spillway slab

Last sets of flights were conducted using Niricson's proprietary acoustic sensor. The payload was about 1 kg. Over 600 data points were collected on the predefined grid. Figures 5 and 6 show the collection of acoustic data points on the predefined grid. Each acoustic data point was collected in about 15-20 seconds. The average flight time for each acoustic flight was about 30 min.

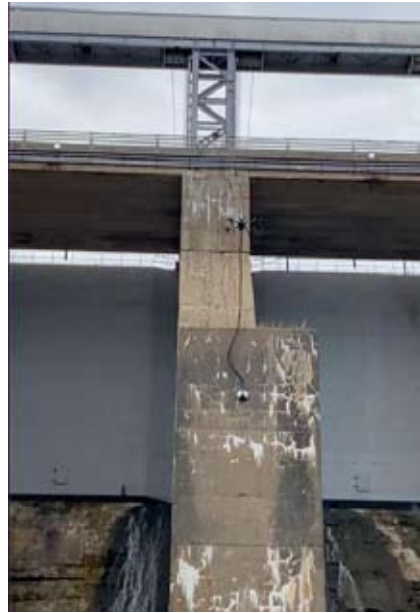
Fig. 4 : Acoustic data collection on a spillway pier

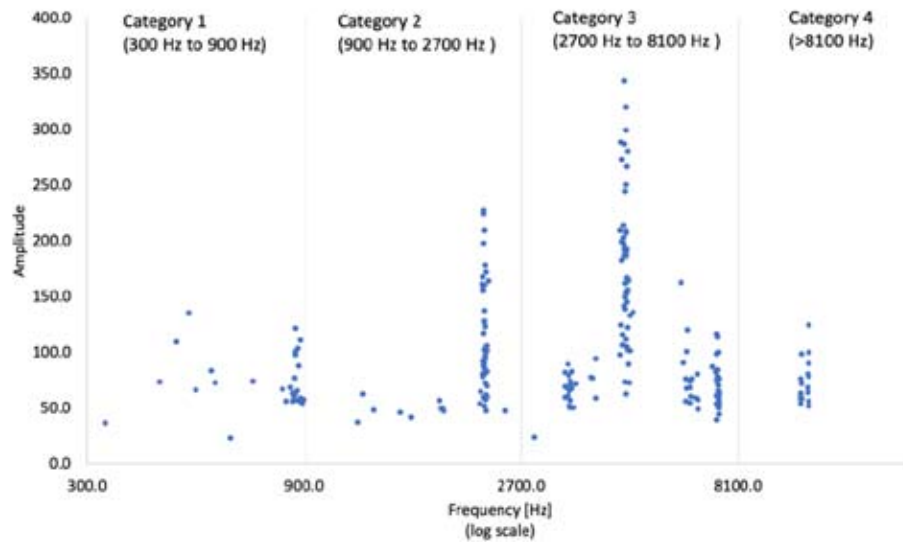
**Fig. 10 :** Frequency Distribution of the collected Acoustic Signatures

The frequency distribution Example is given in Figure 10 below.

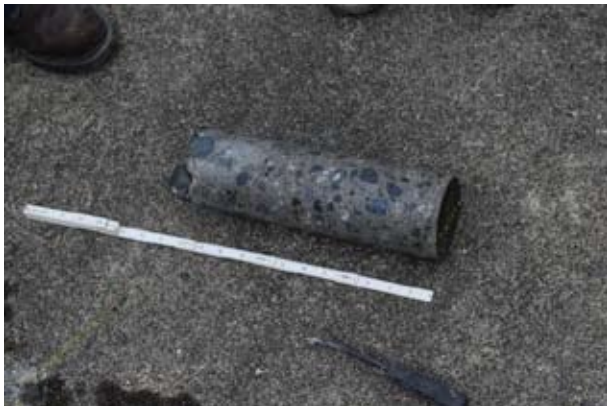
**Fig. 11** : Concrete core from “Green area”

In order to validate the area requiring attention and further verification (“Red area”) compared to the area requiring no attention (“Green area”), the concrete core samples were extracted as shown in Figure 11 and Figure 12. Core samples were extracted from “Green” location with Condition Type- “No indications of concern; may not require further attention” and “Red” location with Condition Type “Indications of low strength or deterioration; may require further attention and verification” for comparison.

A third-party engineering firm was hired to test the core samples and verify the results presented. The compressive strength of the core sample in the “Red area” was found to be quite low compared to the core sample which was taken from the “Green area”. From the drawings, the slab that core sample (“Red area”) was drilled from, is found to be much older than the slab that core sample (“Green area”) was drilled from. These findings validate the inspection results presented in Niricson’s preliminary assessment report.

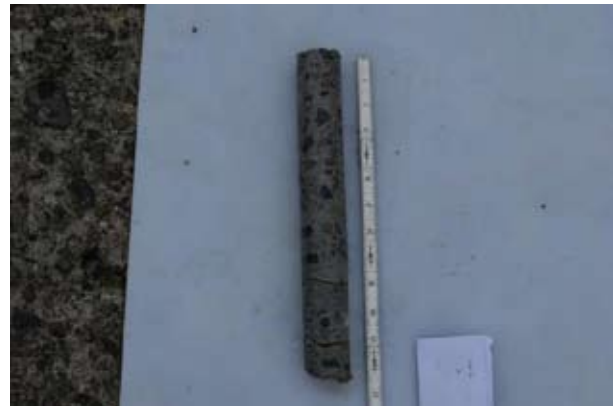
**Fig. 12** : Concrete core from “Red area”
