Upgrading Historical Masonry Dam with Environmental Friendly Technologies : A Case Study

Mohammad Safi¹, Seyed Saeed Beheshti²

1- Assistant Professor, Shahid Beheshti University, Tehran, Iran

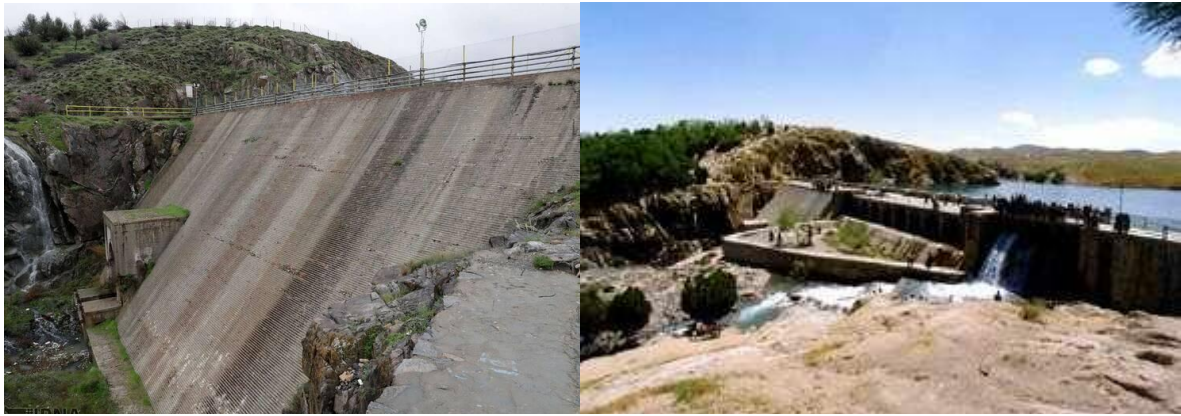
Figure 1- Downstream view of the Golestan historical dam

Golestan historical masonry dam, located in north east of Iran close to Mashhad city and 1050 km north east of the capital is a tourist area. Figure 1 shows the downstream view of the dam which was constructed about 520 years ago. The dam was heightened about 5 meters in 1947 and has a maximum height of 21.5 meters from foundation level and total crest length of 132 meters. The width at the foundation and crest levels is 29.6 and 10.5 meters respectively. A water intake is located close to the right abutment for daily water consumption. A small spill way is also located at the left abutment. The dam is currently under operation for local irrigation but it has major leakage problem in case of high water levels.

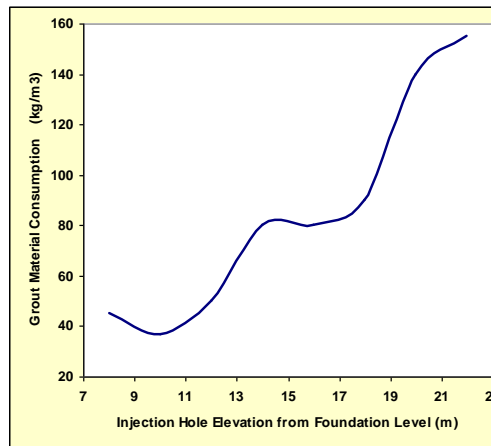
Figure 2- Consumption of grout material through height at Golestan masonry dam

Grout tests were also performed and resulted to the maximum allowable grout pressure of 1.9 bars. The average grouting volume per hole was also estimated. The variations of the values were considerably different for different zones in the dam body. Figure 2 shows the consumption of the grout material. The stress strain behavior of the masonry material for Golestan dam in deteriorated and grouted conditions has been presented in figure 3. For this case grouting has improved the strength up to 40 percents and also increased the ultimate strain by 3percents.

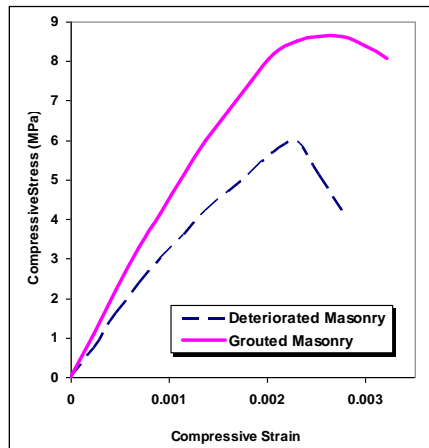
Figure 3- Stress strain behavior of the shell material in deteriorated and grouted conditions for Golestan masonry dam

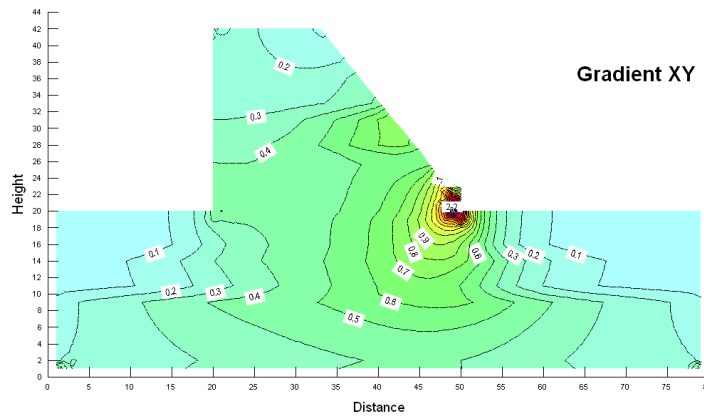
Figure 4– Distribution of resultant hydraulic gradients obtained from seepage analysis

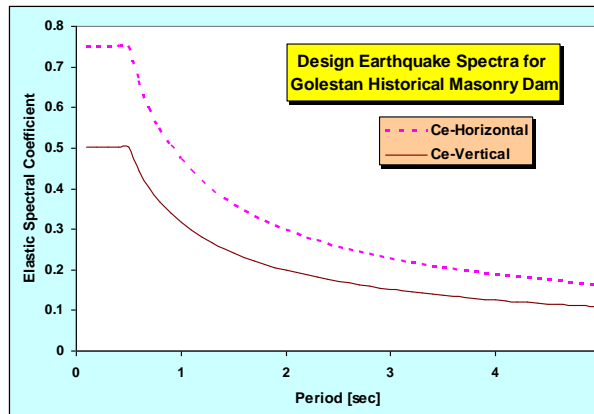
Figure 5- Horizontal and vertical smoothed site specific spectra for Golestan historical masonry dam

Site specific spectra were obtained based on seismic hazard studies and have been shown in figure 5. Figure 6 shows the maximum shear stress in the masonry obtained from spectrum analyses. The results showed that the maximum shear stress exceeded the allowable values at the interface of the new and old part and also the foundation level. It was determined that shear cracks may occur during earthquake at some point. Thus the crack potential was carefully checked using nonlinear analysis.

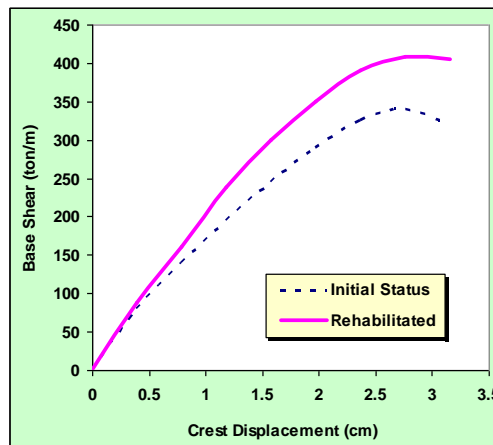
Figure 9- Base shear – crest displacement curve for the dam before and after retrofit

Similar nonlinear model was used to assess the crack potentials in the dam body. The step-by-step analysis under seismic and dead loads was carried out, using a force-based convergence criterion, until failure of several elements due to cracking or crushing led to deterioration of the stiffness matrix, and the procedure became unstable. Figure 8 shows crack potential found in the dam section before and after retrofit. The crack pattern shown for the retrofitted case was obtained by increasing the load in the nonlinear analysis by 66 percent more than the maximum credible load. Base shear – crest displacement for the two conditions has also been presented in figure 9. It can be seen from the results that the ultimate deformation capacity is not considerably changed as a strength based method was employed for the retrofit design. The results also showed that no distributed crash zone was created. Thus seismic retrofit works should be concentrated at the upstream zone of the dam same where as water proofing works should be executed. Comparing the linear and nonlinear analyses results the maximum behavior factor of 1.7 may be used for equivalent analysis.

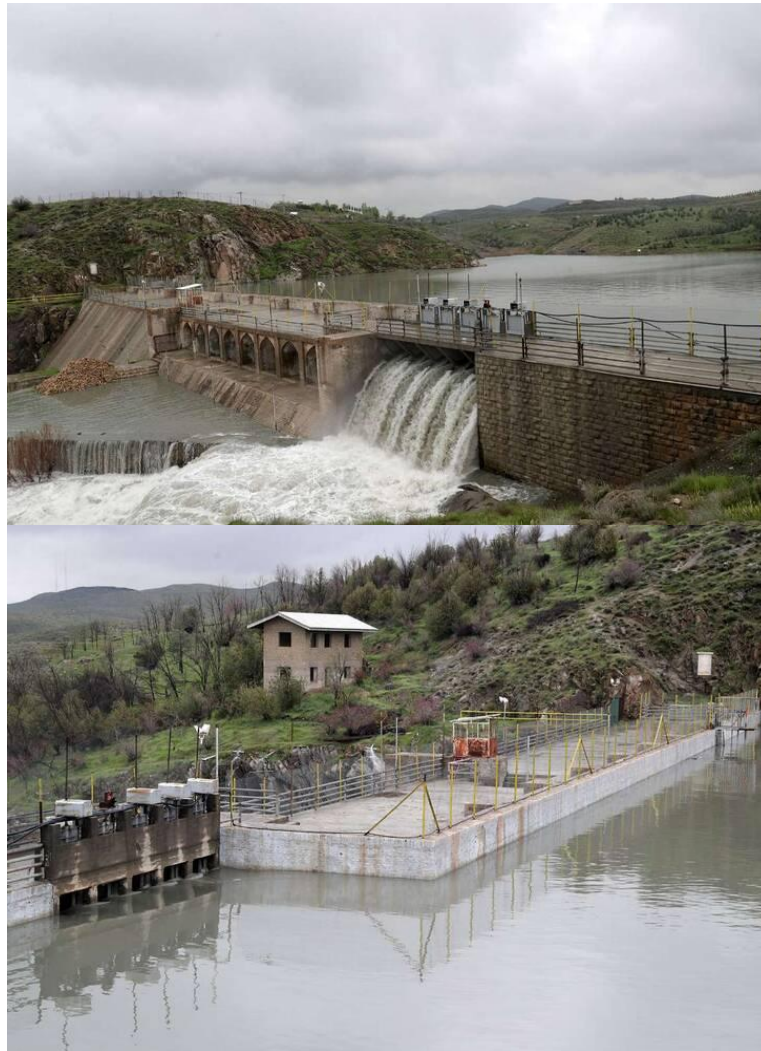
Figure 10- Acceptable performance of the retrofitted dam under 1398 flood, an environmental friendly retrofit including the upstream, downstream, crest, spillway and bottom outlet
