SONIC WAVE VELOCITY MEASUREMENT FOR EVALUATION OF IN-SITU QUALITY OF DAM

Central Water and Power Research Station, Pune, Maharashtra

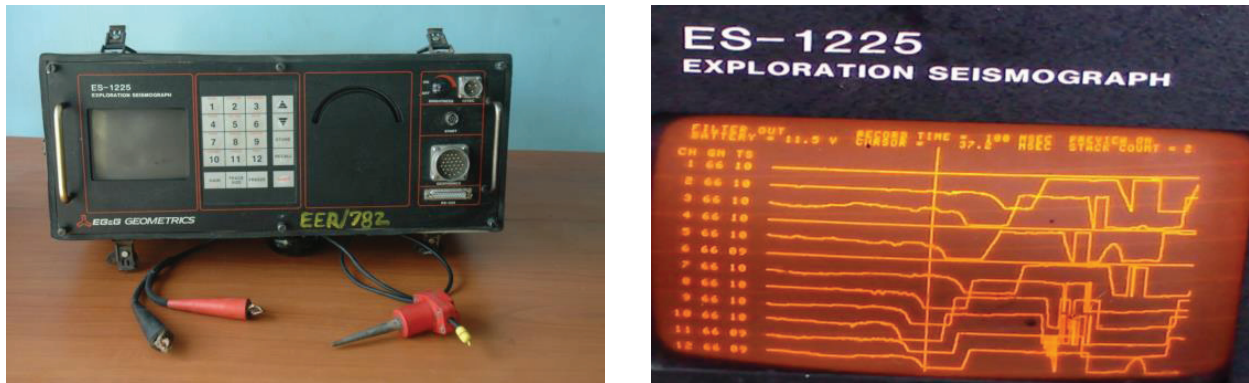
Figure 2 : 12-channel signal enhancement seismograph with accessories and a typical record showing the onset of P-waves at 12 locations

A 5 kg hammer is used for generation of seismic waves and vertical geophones with natural frequency of 8 Hz were used for detecting the arrival of the seismic waves. A starter switch attached to the hammer triggers the instrument and recording of waveforms from all the geophones starts as soon as the hammer strikes the dam surface.

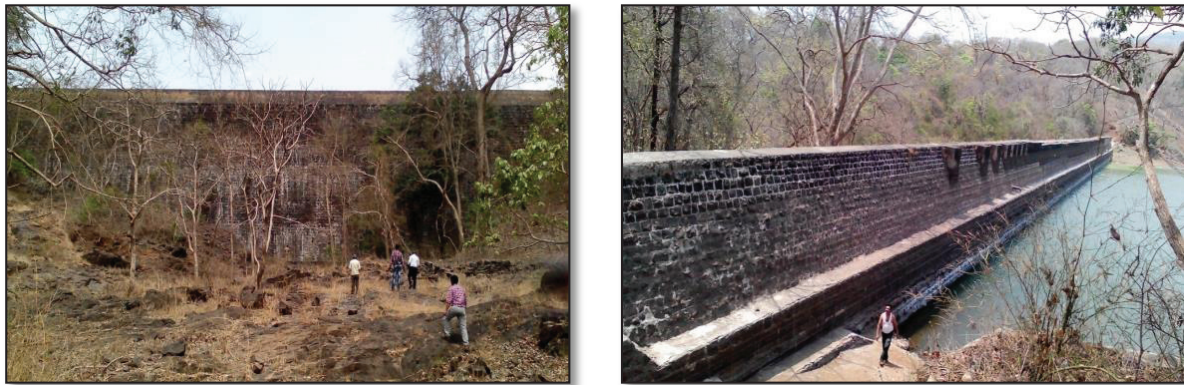
For conducting non destructive testing of masonry portion, two profiles have been made as per Pattern B shown in Fig.4. Selected locations of Tulsi dam have been marked at about 31.5 m and 51.5 m bottom and top of downstream side respectively. Fig. 5 shows its upstream and downstream side of the dam.

Figure 5 : Locations of Geophones at the downstream face and upstream face of the Tulsi dam No.1

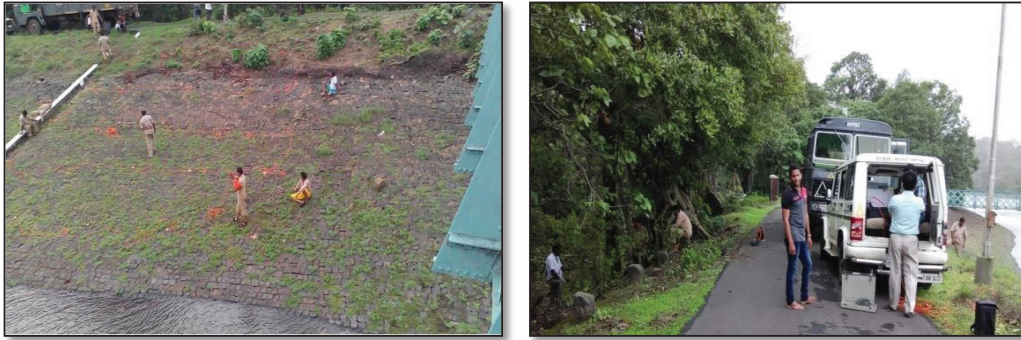
For conducting non-destructive testing of earthen portion of the dam, two profiles have been made as per Pattern A and are shown in Fig.3. Selected locations of Tulsi dam have been marked at about 23 m from left side on downstream side from intake well bridge. Fig. 7 shows its upstream and downstream side.

Figure 7 : Locations of Geophones at the downstream face and upstream face of the Tulsi dam No.2

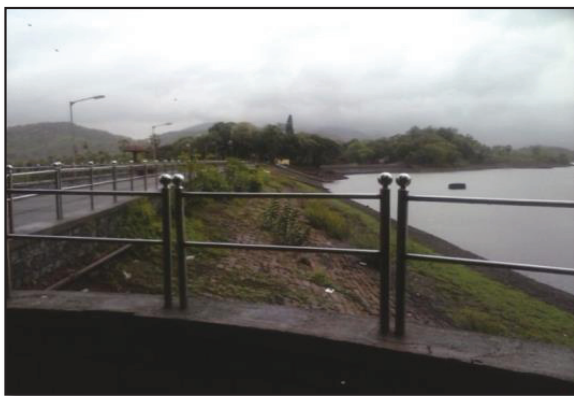
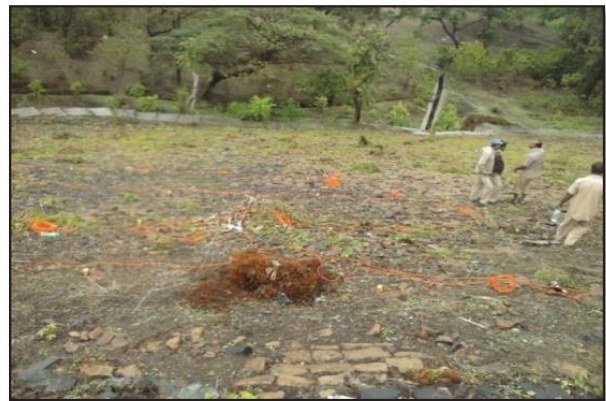
Vihar Dam is the one of the oldest earthen Dam in Maharashtra, India commissioned in 1859 and located at Latitude of 19° 5’N – 19° 10’N and Longitude of 72° 50’E – 73° E. It’s catchment area is about 18.96 sq.km. with total length of 711.20 m, top width of (a) 7.31 m, (b) 6.09 m, (c) 6.09 m and maximum height of (a) 25.60 m, (b)12.80 m, (c) 14.90 m. Fig.11 shows its upstream & downstream side of the dam.

Figure 11 : Locations of Geophones at the downstream face, upstream face of the Vihar dam (Central Portion)

For conducting non destructive testing of main portion of the dam, four profiles have been made as per Pattern - A as shown in Fig. 3. Selected locations of Vihar dam have been marked on downstream side, at 85 m from left side of the dam, profile 2 marked to the right side of profile 1, profile 3 marked below profile 1 and profile 4 marked below profile 2. The distribution of P-wave velocities in Vihar dam (Main Dam) is shown in Fig. 12. It has been observed that the velocities of elastic compressional waves in the earthen portion of the dam is in the range of 0.64 km/s to 1.17 km/s and the average P-wave velocity has been observed to be 0.92 km/s which indicates the in-situ quality of material in the earthen portion to be good to very good.

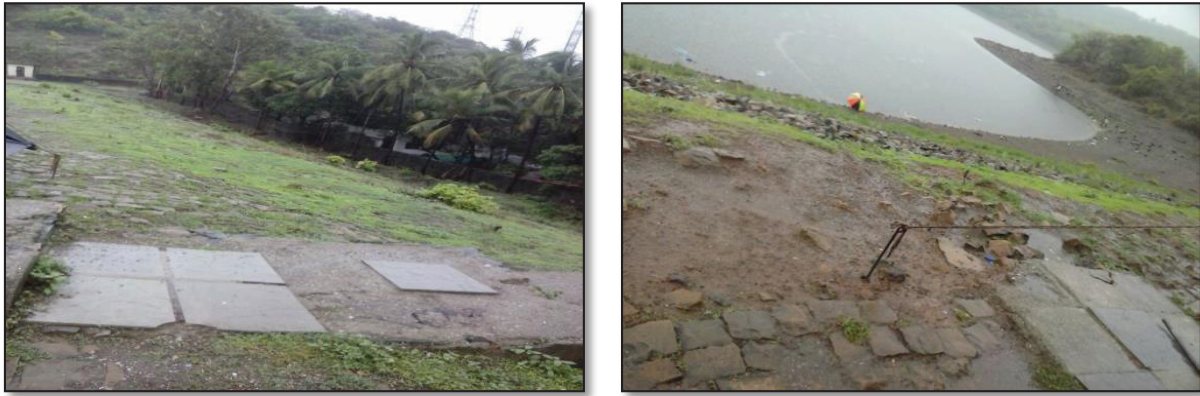
For conducting non-destructive testing of earthen portion near to Durgah, two profiles have been made as per Pattern A shown in Fig.3 at selected locations of Vihar dam No. 2. Profile 1 and 2 (12 m x 12 m) have been marked about 78 m from left side on downstream side. Fig.13 shows its upstream & downstream side of the dam.

Figure 13 : Locations of Geophones at the downstream and upstream faces of the Vihar dam near Durgah

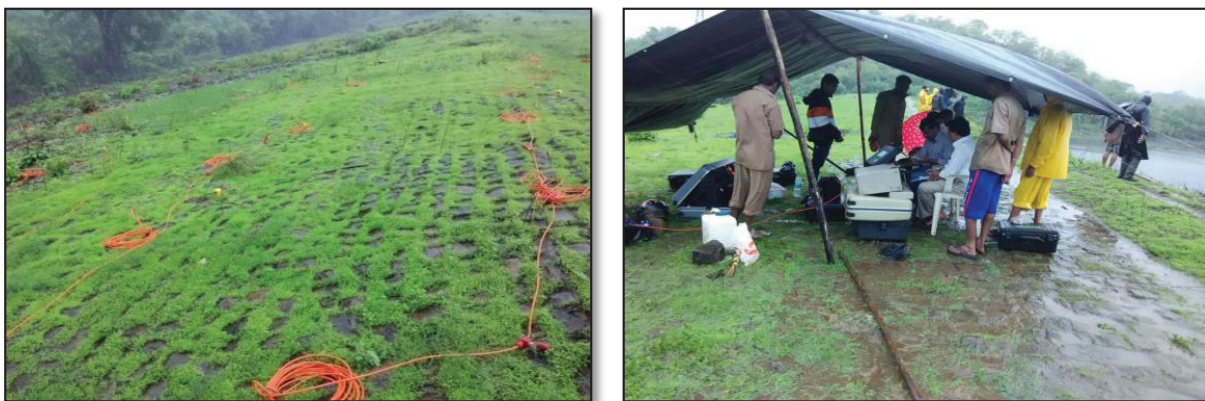
For conducting non-destructive testing of earthen portion near to pumping station, two profiles have been made as per Pattern A as shown in Fig.3. Selected locations of Vihar dam profile 1 and 2 (12 m x 12 m) have been marked at about 66 m from board side located at left and right side of steps on downstream side respectively. Fig.15 shows its upstream & downstream side of the dam.

Figure 15 : Locations of Geophones at the downstream face, upstream face of the Vihar dam near Durgah
