ICOLD Symposium on Sustainable Development of Dams and River Basins, 24th - 27th February, 2021, New Delhi

RESTORATION AND REHABILITATION OF SPILLWAY WITH MODIFIED ENERGY DISSIPATOR-A CASE STUDY

Indira Sagar Project (ISP) is situated on river Narmada in Khandwa district of Madhya Pradesh, India. The project is in operation since 2004-05. The energy dissipator was in the form of slotted roller bucket with different bucket invert levels for both main and auxiliary spillways. It was observed by the project authorities that during every monsoon, the bucket area of the main spillway gets damaged and there is recurring need to restore the damaged area. During the site inspection of design and project engineers, it was observed that the spillway glacis and a slotted roller bucket of main spillway have been damaged badly. The spillway was operated continuously for a considerable time during the 2013 flood with high discharges of the order of 20,000-35,000 m³/s. It was concluded based on theoretical calculations and site observations that the damages to the energy dissipators are due to hydraulic as well as structural reasons. Deficient tail water levels during initial period of operation

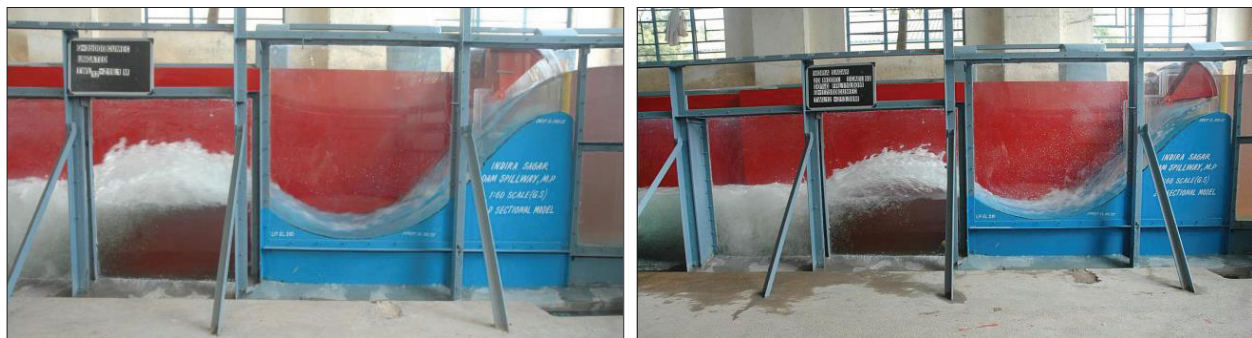
Figure 5 : Flow condition for (a) gated and (b) ungated operation of main spillway

(a) $Q = 17,769 \text{ m}^3/\text{s}$ at FRL El. 262.13 m (b) $Q = 35,537 \text{ m}^3/\text{s}$ at FRL El. 262.13 m

- Clear ski action was observed for discharges up to 17,769 m³/s (50%) for gated and ungated operation of the spillway. Submerged ski action was observed for higher discharges. The throw distances were found to be varying between 52 m to 72 m for the ungated and gated operation of spillway for the various discharges. Thus, the performance of spillway and ski jump bucket was found to be satisfactory.
