ICOLD Symposium on Sustainable Development of Dams and River Basins, 24<sup>th</sup> - 27<sup>th</sup> February, 2021, New Delhi

# MOSUL DAM – A MULTI-NATIONAL DAM FOUNDATION REHABILITATION EFFORT

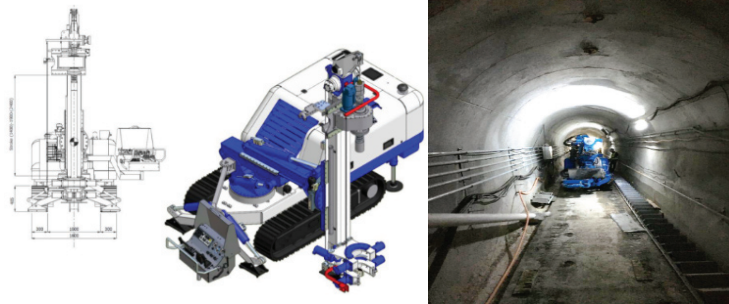
**Figure 7 : SoilMec SM-5 Drill Rig for Gallery Operation**

The grouting units (pumps and dispensing hoppers) were designed to fit within the limited space. Customized drill rigs (designed and provided by Soilmec), specifically designed to fit within the gallery and traverse the slopes and tight turns were critical to the success of the project. Drill rigs capable of drilling through different types of geology, up to 150 m deep, core holes, and work through artesian groundwater conditions were designed for this project. Rigs were equipped with drilling parameter recording (DPR) capability to collect and provide various parameters for analysis. Figures 7 and 8 shows the drill rigs being used in the gallery and their configurations.

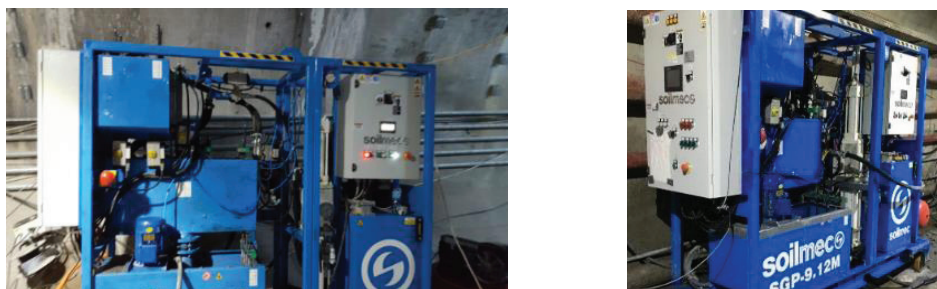
**Figure 9 : Soilmec Batching and Grouting Unit (BGU)**

The batching and grouting units are also custom designed to operate in the gallery with potentially high artesian pressure conditions and with the ability to pump at high pressures and flow rates, see Figure 9.

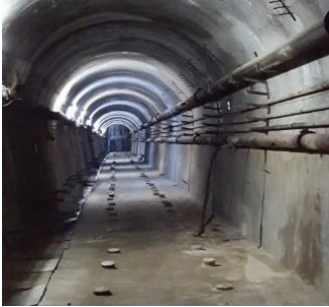
**Figure 10** : Grouting Gallery with Legacy Infrastructure and Standpipes

Figure 10 indicates the legacy Iraqi standpipes set into the concrete floor in the gallery through which GoI conducted grouting. The risk of damage to the tracks of the new drill rigs existed due to the protruding 5-inch diameter legacy standpipes. Therefore, the original standpipes were cut and new 4-inch threaded standpipes inserts were grouted in place that are flush to the grouting gallery surface. The threaded standpipe assists in attaching auxiliary equipment to the collar, and to cap it if needed. The new standpipes were installed flush to the surface for easy movement of equipment and personnel. Figures 11 and 12 show the upgraded infrastructure in the gallery.

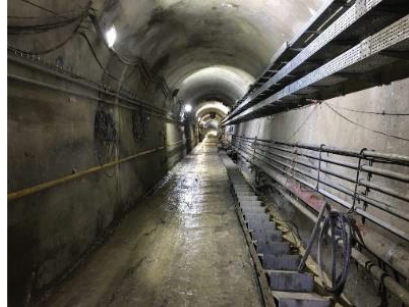
**Figure 11** : Grouting Gallery with Updated Infrastructure

grout conveyance, grout mixing plants, communication/internet, lighting, ventilation, and concrete delivery installations. Figures 10, 11, and 12 show typical views of the gallery with legacy and upgraded infrastructure, respectively.

- Electrical: Removal of over 3000m of old cables and installation of new cables (170,000 m), cable trays, transformers, and generators to supply power to the gallery and crest of the dam.

- Water/wastewater: Over 4500 m of new pipelines were installed (and 2000 m relocated) to carry fresh water and wastewater in and out of the gallery. New submersible pumps to circulate fresh water across the 3.4 km dam were installed. This upgrade also included installation of new sump pumps that carry the wastewater from the sumps to the siltation tanks outside the gallery.

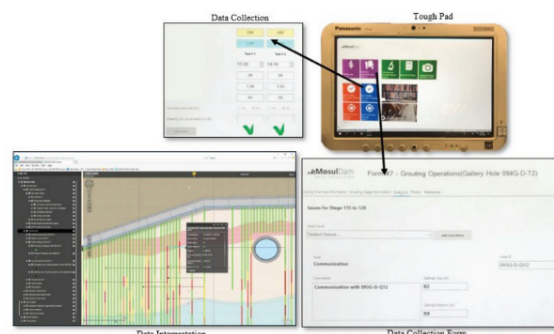
Figure 15 : Construction Database

A comprehensive construction database (Fig. 15) was built to document the field observations. The database included multiple forms to digitally document the drilling, grouting and quality control observations. The database also included features to develop daily field reports capturing equipment usage and personnel involvement. The database is customized to capture information in a format for easy integration into other software programs, graphic display and analysis. The database was installed as an application on field tablet computers for field personnel to capture the information which is available for review immediately and for easy access to the staff on the next shift.
