# ADAPTIONS TO CLIMATE CHANGE INDUCED UNCERTAINTIES FOR SAFEGUARDING EXISTING DAMS – CASE STUDY OF BANAS BASIN, GUJARAT, INDIA

**VIVEK P. KAPADIA**

*Water Resources Department, Government of Gujarat, Gandhinagar, India*

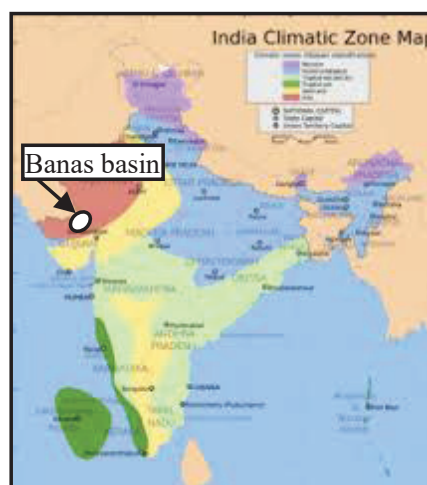
**Figure 1 :** Agroclimatic zones of India and location of Banas basin

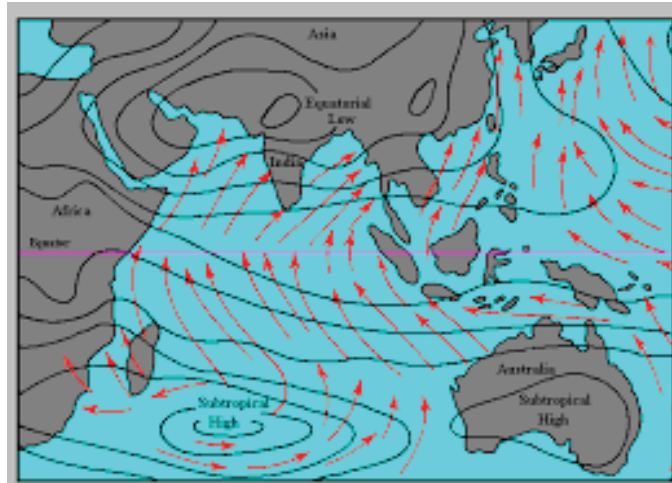
Figure 2 : Normal monsoon pattern for western India i.e. southwestern wind induced rain

Western India normally receives monsoon due to southwestern wind as shown in Figure 2 which loses its strength by the time it reaches the northern part of Gujarat and Rajasthan and therefore they are arid. Main reason for location of deserts of Kachchh and Thar is the scanty rainfall in the normal monsoon.

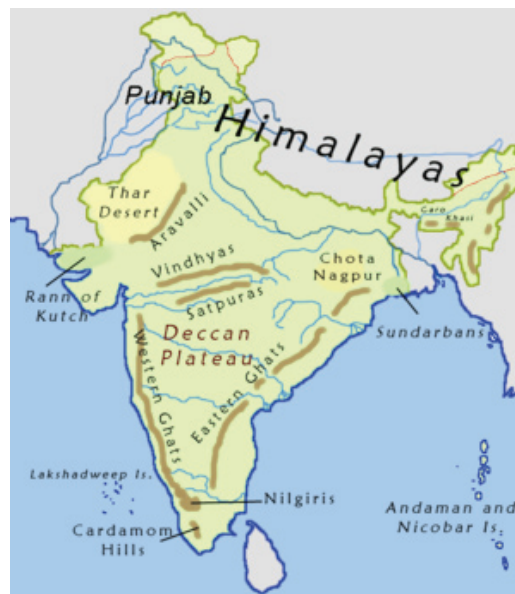
Figure 3 : Arvalli and Vindhya mountain ranges

Exceptional monsoon passing between the Aravalli and Vindhya mountain ranges occurs when low pressure is formed in Arabian sea. Such monsoon brings heavy rains in the Banskantha district and desert of Kachchh.

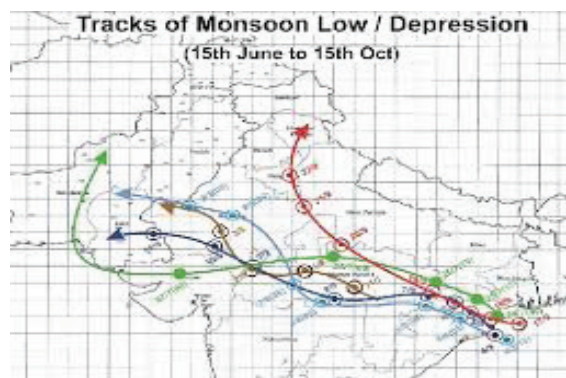
Figure 4 : Exceptional monsoon pattern for western India

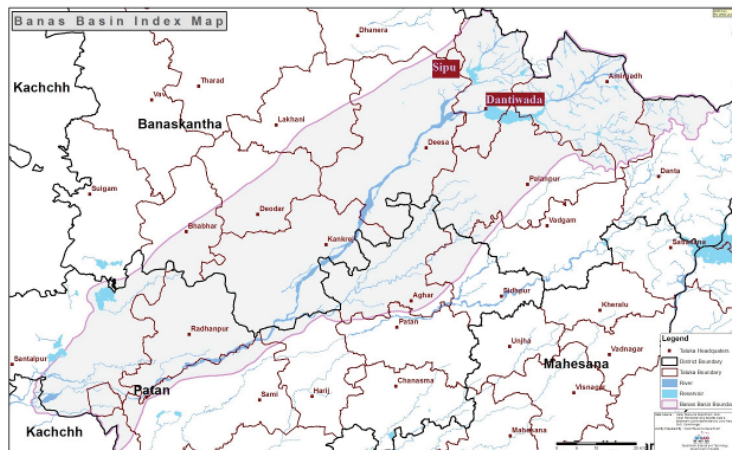
Figure 5 : Index map of Banas basin

As shown in Figure 5, a tributary name by Sipu meets Banas in the upstream of Deesa town. Banas main course and Sipu, both have their upper catchment in Abu hills of the Aravali mountain range. There is a dam on each of the two river

courses – Dantiwada on Banas and Sipu on the Sipu river course. Both the dams are located on the foothills of Aravalli mountain range. Catchment area of Banas river at Dantiwada dam site is of 1130 square miles (2862 Km<sup>2</sup>) of which 432 square miles (1093 Km<sup>2</sup>) in Rajasthan state and the rest in the Gujarat state. Catchment of Sipu Dam is 1221 Km<sup>2</sup>. Free catchment in the downstream of both the dams is 2090 Km<sup>2</sup>.

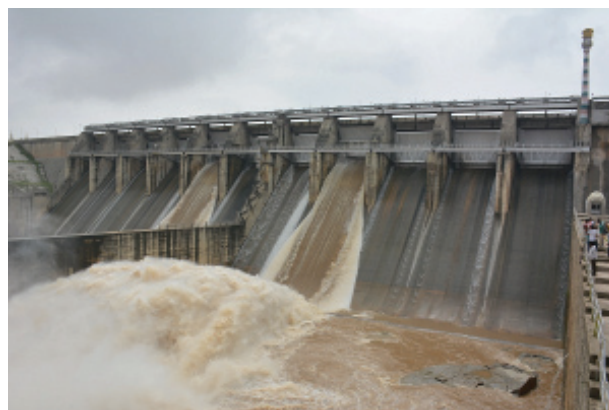
Figure 6 : Dantiwada Dam

Dantiwada dam is constructed across river Banas near village Dantiwada of Banaskantha district of Gujarat state in India. It was envisaged in 1950s and surveying and geological investigations were carried out in 1955 onward. Its design was completed in 1960 and construction in 1965. Its gross storage is 464.381 Million Cubic Meter. Its Full Reservoir Level is R.L. 184.15 m. Its command area is 45,823 hectare. Earthen flanks are on both the sides of the river gorge and in the middle portion is the masonry spillway with 11 radial gates each of size 12.50 m X 8.23 m. Length of the masonry dam is 601 m. Only seven times in its history the dam has received water up to its Full Reservoir Level. The geology of the dam site is characterized by penultimate granite outcrop of river Banas.

Design flood at the Dantiwada dam site was computed as 2,35,000 cusec i.e. 6,650.5 m<sup>3</sup>/ sec for the catchment area of 2,862 Km<sup>2</sup> against which a flood arrived of the size of 11,942 m<sup>3</sup>/ sec on 31<sup>st</sup> August, 1973 at 20.00 hours. On 1<sup>st</sup> September, 1973 at 8.00 hours another peak of flood arrived of the size of 12,112 m<sup>3</sup>/ sec. The former was due to heavy rainfall in the catchment of Banas river whereas the latter was due to breach in Swarupganj tank which was in upstream of the Dantiwada dam in Rajasthan state. Very soon from the completion of the construction of dam, the event of facing a severe flood - more than the design flood, posed a question on safety of the dam. The gates and apron were badly damaged and erosion in the river bed in the downstream of the apron was severe. Because the inflow peak was much higher than the spillover capacity, the radial gates which were open had to take a great thrust and the water level

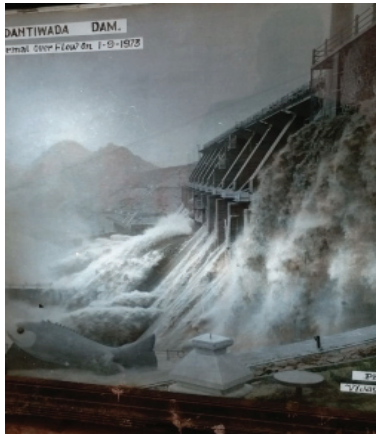
Figure 7 : Dantiwada Dam – actual flood much more than the design flood

went higher to surmount the top of the gates. The office building adjacent to the spillover section was having through openings in the forms of doors and windows which were also used by the flood water as additional waterway as shown in Figure 7 and 8.

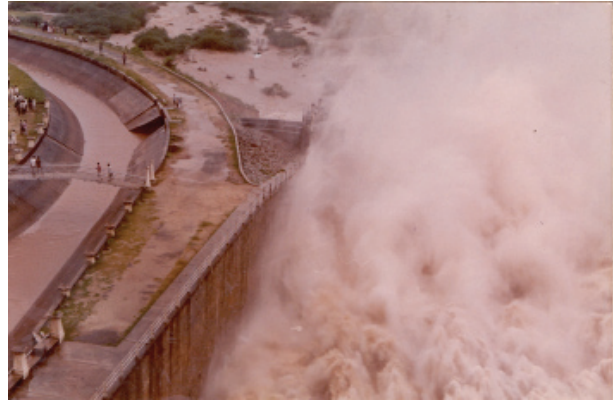
Figure 8 : Dantiwada Dam – endangered due to heavy flood

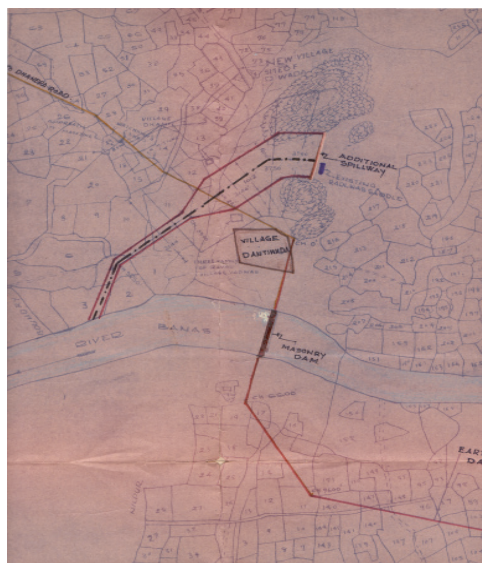
Figure 9 : Alignment of Dantiwada Dam and Additional Spillway

As the flood of 31<sup>st</sup> August and 1<sup>st</sup> September, 1973 proved that the design flood of 6650.5 m<sup>3</sup>/ sec was not sufficient, the Central Water Commission took up the review of it. Even in 1973 the rain gauge and river gauge data were not sufficient and therefore the fabricated hydrograph from the actual flood data was the only way out. The flood hydrograph of 4,22,000 cusec with a peaking time of 3 hours suggested the need of a unit hydrograph with 1 hour duration. With trial and error, the unit hydrograph that was in unison with the flood data was prepared and was converted in to 6 hour hydrograph to obtain the flood hydrograph. It was compared with the actual flood data and was found satisfactory. With 70% of run off factor and 23 hours as the base period the Probable Maximum Flood (PMF) was worked out as 6,40,000 cusec (18653 m<sup>3</sup>/ sec). Total flood volume was estimated as 1450 Million Cubic Meter. Considering the said results, additional spillway with 14 vertical gates each of the size 18.29 m X 4.88 m with approach and tail channels was constructed on the right flank of the dam. Length of the additional spillway was designed as 308.5 meter and its crest level as R.L. 179.22 m. Its spilling capacity was worked out as 6792 m<sup>3</sup>/ sec. The construction of the additional spillway was completed in 1985.

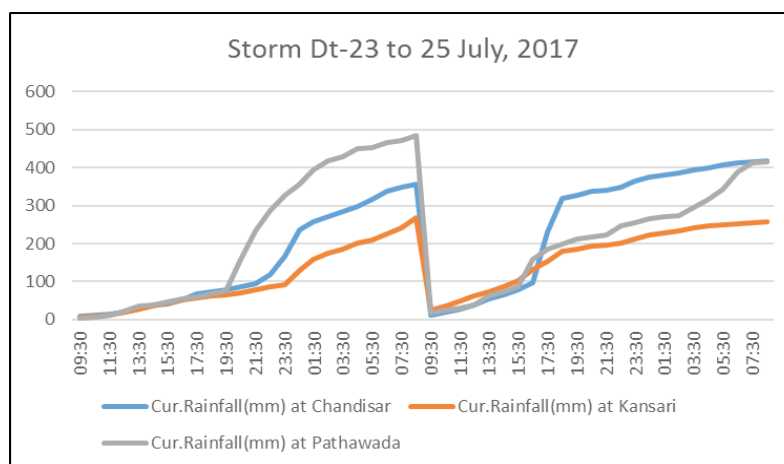
**Figure 11** : Storm intensity at different rain gauge stations

Rainfall in monsoon of 2015 which was of exceptional type instead of southwestern type, was concentrated for a short period in the Banas basin. It was 250 mm in 12 hours. But the rainfall in monsoon of 2017 which was again of exceptional type was unprecedented. Total rainfall occurred till end of July, 2017 was 960 mm. On 23<sup>rd</sup> and 24<sup>th</sup> July the rainfall intensity was at its peak. Only in 2 hours there was 250 mm rainfall recorded at Dantiwada. During the same period there was heavy rainfall in Rajasthan also. Mount Abu recorded 750 mm rainfall in only 24 hours. All the water suddenly came to Sipu and Dantiwada dams as the topography of the catchment is hilly and the gradient is steep. Observations of rain gauge stations were studied to understand the storm. Fortunately, sufficient rain gauge stations have been provided which became very useful in understanding the situation. Various parts of the catchment areas of the Banas basin had received the storm of identical characteristics and that, too, almost simultaneously which could be appreciated from Figure 11 i.e. the chart prepared from the rainfall data of some rain gauge stations located sparsely. Actually the entire basin somehow was clouded evenly and hence the precipitation pattern was identical which happens rarely.

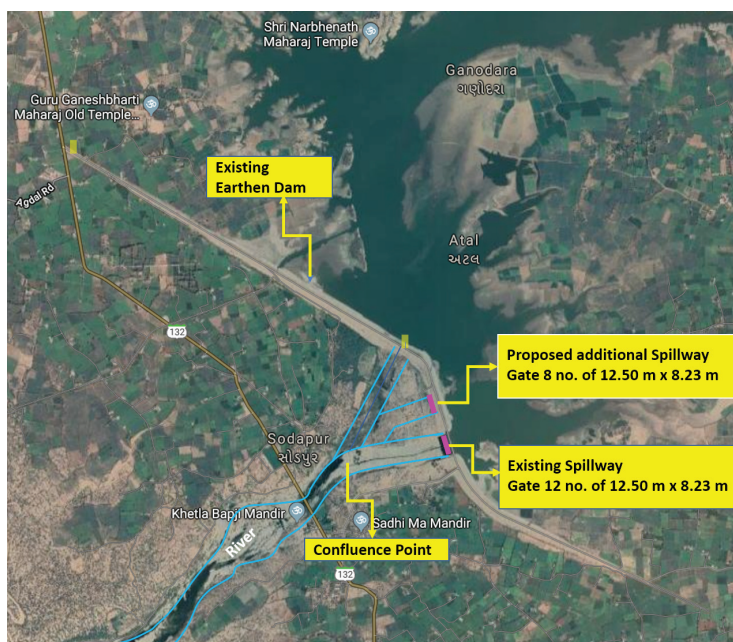
Figure 12 : Proposed additional spillway

With the revised hydrology, additional spillover section with 8 gates of 12.50 m X 8.23 m each is being provided. Additional spillways would have the designed spillover capacity of 5078 m<sup>3</sup>/ sec. Thereafter the total spillover capacity of the Sipu dam would be 12158 m<sup>3</sup>/ sec.
