# Upgrading Pikes Creek Dam Spillway with a Fusegate System<sup>(\*)</sup>

Hasan T. KOCAHAN  
*Project Manager, HYDROPLUS, INC.  
Tampa, FL, UNITED STATES*

Chad HOOVER  
*Project Manager, GANNETT FLEMING, INC.  
Camp Hill, PA, UNITED STATES*

Paul SCHWEIGER  
*Vice President, GANNETT FLEMING, INC.  
Camp Hill, PA, UNITED STATES*

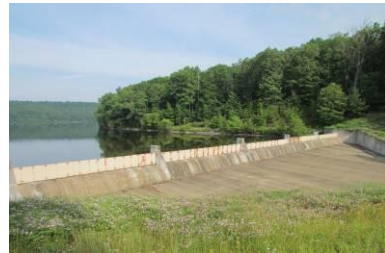
Fig. 2  
View of auxiliary spillway  
F..

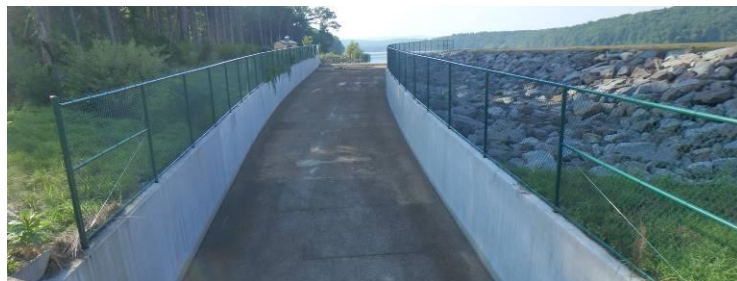
Fig. 3  
Principal spillway chute and left wall berm (looking upstream)  
F..

Hydraulic analyses of the principal spillway determined that the spillway chute had a discharge capacity less than the principal spillway weir. Modifications to the principal spillway included construction of a riprap-lined berm along the left chute wall to confine the flow to the chute and increase the capacity of the principal spillway. Concrete deterioration of the principal spillway ogee crest, chute walls and slabs were also repaired.

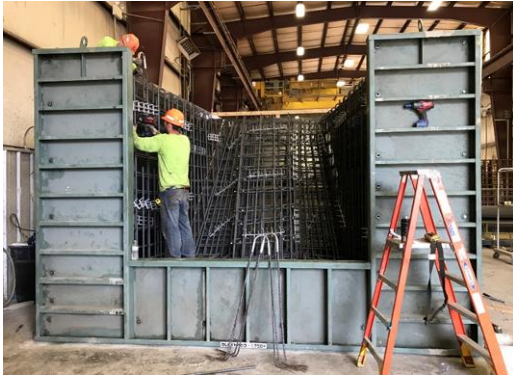
Fig. 11  
Custom-made formwork and steel placement  
F..

The Fusegates at Pikes Creek Dam were made of pre-cast reinforced concrete and weighed approximately 36 tons each. The Fusegates were fabricated by Old Castle Precast located in Telford, Pennsylvania. After each Fusegate was fabricated, it was weighted to verify the concrete ballast requirements. A hydraulic jack was used to weigh each Fusegate.

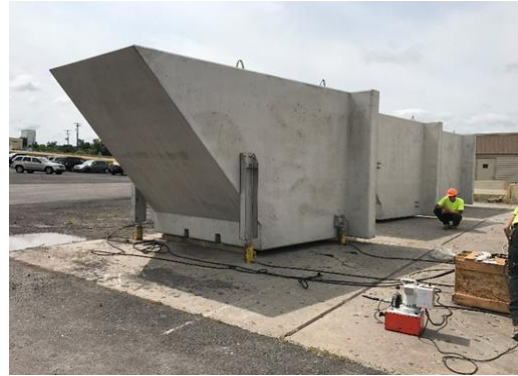
Fig. 12  
Fusegate jacking to verify ballast requirements  
F..

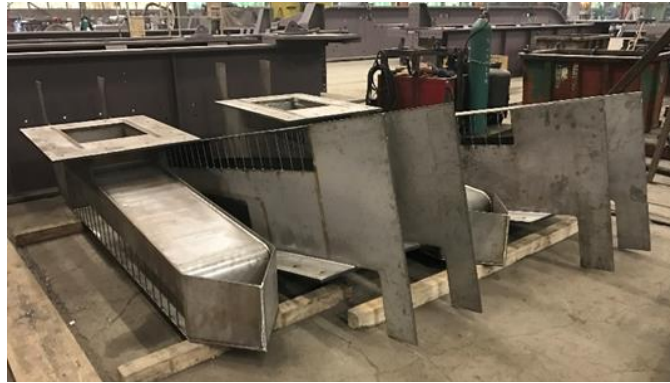
Fig. 13  
The production of the steel Fusegate components  
F..

The steel components of the Fusegates were manufactured at Johnson Machine Works plant in Charito, Iowa. Figure 13 shows the completed inlet wells.

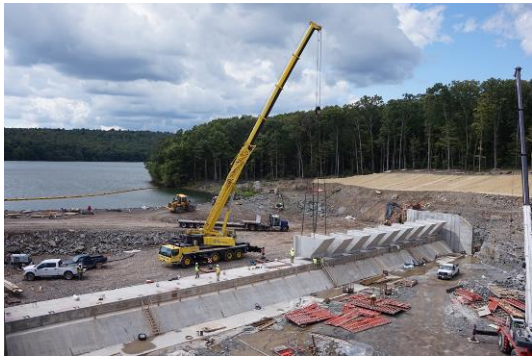
Fig. 14  
Fusegate Installation at Pikes Creek  
E..

When the Fusegates were delivered to the site, they were placed on the spillway sill using a mobile crane. The inlet wells, ballast blocks and deflectors were installed after the Fusegates were placed on the spillway sill.

The watertightness system was installed last. This involved installing stainless steel angle bars on the Fusegates to allow EPDM rubber compression seals to be wedged between the angle bars and the foundation. After completion of the seals, leakage tests were performed on selected Fusegates by enclosing the upstream 30 cm section of the Fusegate up to its crest using formwork and sandbags. Compression seals were adjusted and additional sealant was applied when necessary. The Fusegates were installed by December 2017.

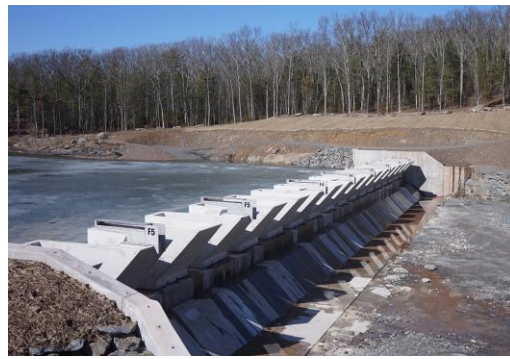
Fig. 15  
Completed Fusegate System at Pikes Creek  
E..

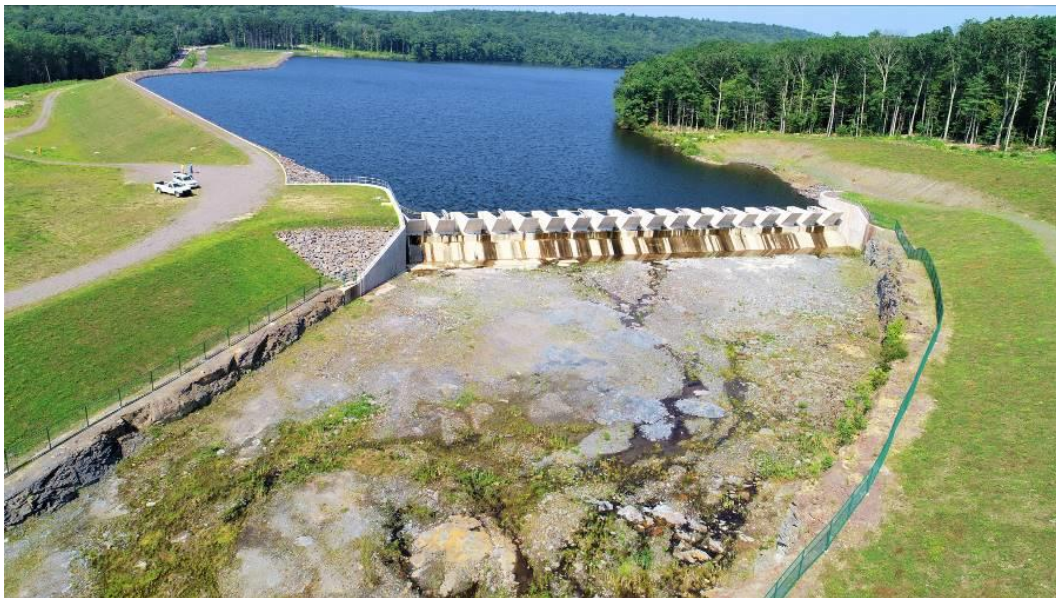
Fig. 16  
Completed Auxiliary Spillway at Pikes Creek  
E..
