# Analysis of Artificial Lake formed on river Phutkal, J&K and Management of Outburst Flood at Nimmo-Bazgo dam

Balraj Joshi, Narendra Kumar, Keshav Deshmukh, Rajeev Baboota, Bharti Gupta, NHPC Ltd., A Govt. of India Undertaking, Faridabad, Haryana, India

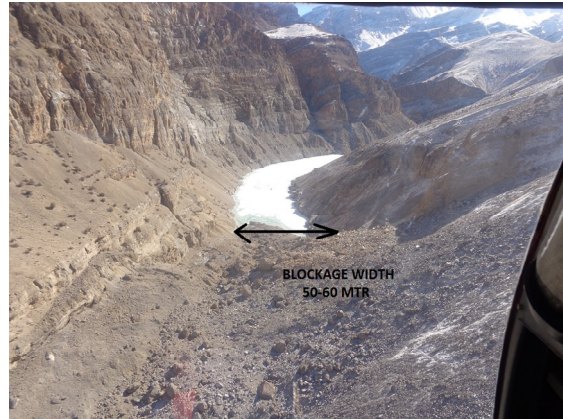
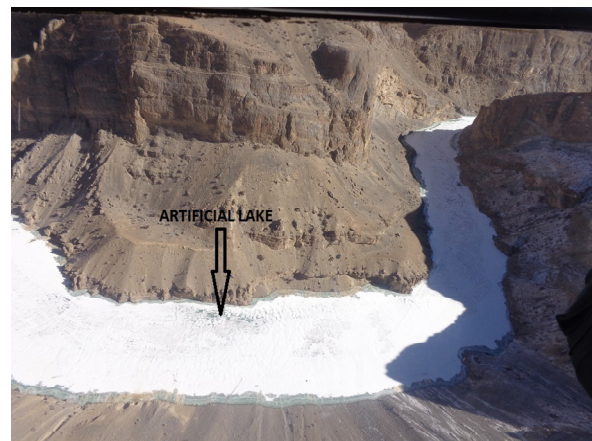
**Figures 5(a) to 5 (d): Dimensions of the blockade and artificial lake formed**

Using multi date satellite data, NRSC provided necessary information on the landslide to the concerned government authorities. NRSC analyzed the high resolution (1 m) CARTOSAT-2 data of 20<sup>th</sup> January 2015 along with the DEM data of CARTOSAT and provided the satellite image of the landslide area. A High resolution satellite image showing detailed view of landslide and water impoundment is shown in Figure 4. The dimensions and some features of the landslide as well as impounded area are mentioned below and shown in Figures-5 (a) to 5(d):

- The landslide scar is observed and the length of the blockade created has a length of about 600 m and width of about 60 m .
- The length of the lake formed due to impoundment of water as per initial information was about 15 km with a surface area of about 55 Ha. Surface of the artificial lake formed was completely frozen.

As per preliminary analysis based on the dimensions of blockade coupled with differential discharge at Nimmo-Bazgo dam site due to blockade, the estimated volume of the artificial lake was worked out as 40 Mcum during Jan 2015.

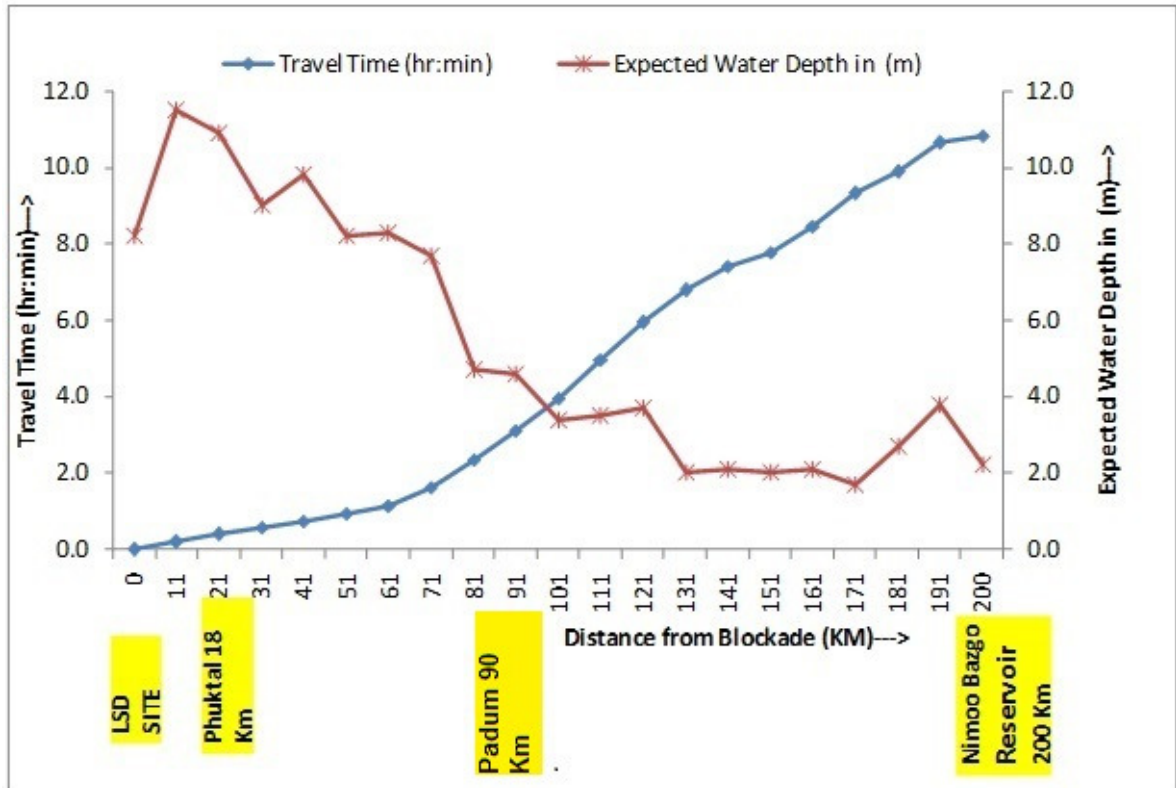
Figure-6: Plot showing the travel time and possible rise in water level with respect to distance from blockage site

Based on the above data dam break study was carried out to estimate the possible discharge reaching in the downstream reaches and expected water levels corresponding to those discharges using 1-D mathematical model MIKE-11. In this tentative study, it was estimated that in case of outburst of this artificial lake a discharge of about 1460 cumec shall be reaching at Indus-Zanskar confluence (approx near tail end of Nimmo-Bazgo reservoir) after a lag of about 11 hours. Thus it was expected that Nimmo-Bazgo power station may experience a discharge of 1460 cumec in addition to regular discharge coming from river Indus. The approximate depth of water along travel reach would vary from 2.0 m to 15 m depending upon the river geometry along the reach. A plot showing the travel time and possible rise in water level with respect to distance from blockage site is shown in Figure-6.

After two months in Mar 2015, the analysis was revised considering some increase in lake volume as the lake had not breached by that time and the water level behind the lake was increasing. Breach analysis considering the volume of lake as 50 Mcum was carried out and it was estimated that in case of outburst, a discharge of about 2142 cumec shall be reaching at Indus-Zanskar confluence after a lag of about 10 hours.

In the eventuality of outburst of this artificial lake, there would have been sudden increase in discharge at Nimmo-Bazgo power station and therefore, suitable reservoir operation guidelines were being followed at the power station. The FRL and MDDL of Nimmo-Bazgo power station are EL 3093.0 m and EL 3090.0 m respectively and the live capacity of the reservoir as per Sep 2014 survey was 9.67 Mcum. The flood hydrograph reaching at Indus-Zanskar confluence due to outburst of artificial lake was routed through the reservoir for passing the flood safely in the downstream. Power station was advised to maintain the reservoir level at MDDL and for carrying out reservoir routing, the flood hydrograph was impinged at MDDL i.e. EL 3090.0 m and the spillway outflow curve was assumed in such a manner so as to contain the maximum water level within FRL i.e. EL 3093.0 m. As a precautionary measure, NHPC along with local administration had been monitoring the water level at various locations enroute Zanskar river, ever since the news of blockage first appeared.
