# A combination of dredging/dewatering technologies to manage artificial reservoir sedimentation

F. Galante & L. Masotti

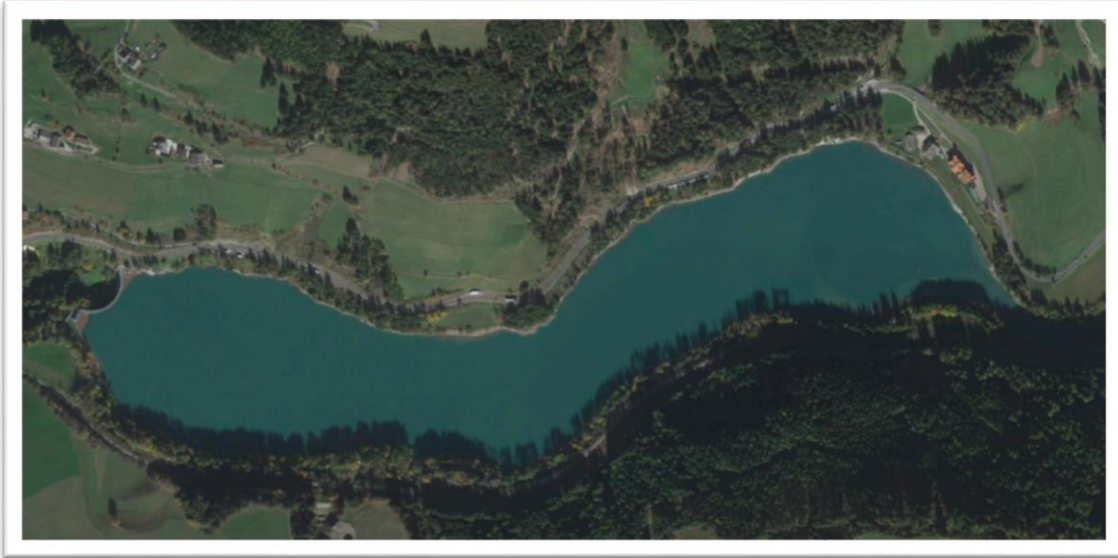
Monguelfo dam has been built in 1957 - 1958 on Rienza stream, a tributary of Adige river, in the eastern part of the Dolomites (Bozen province). Monguelfo dam is a concrete dam, with the following characteristics (Figure 1):

Figure 1. Monguelfo reservoir

- Dam height: 51.00 m
- Free board: 1.00 m
- Normal operating water level: 1,055.00 m a.m.s.l.
- Maximum water level: 1,056.00 m a.m.s.l.
- Dam volume: 9,500 m<sup>3</sup> of concrete
- Crest length: 140.00 m
- Reservoir volume: 6.54 x 10<sup>6</sup> m<sup>3</sup>
- Catchment basin surface (direct): 430 km<sup>2</sup>
- Catchment basin surface (connected): 160 km<sup>2</sup>
- Flood control volume: 0.44 x 10<sup>6</sup> m<sup>3</sup>
- Flood discharge: 795 m<sup>3</sup>/s

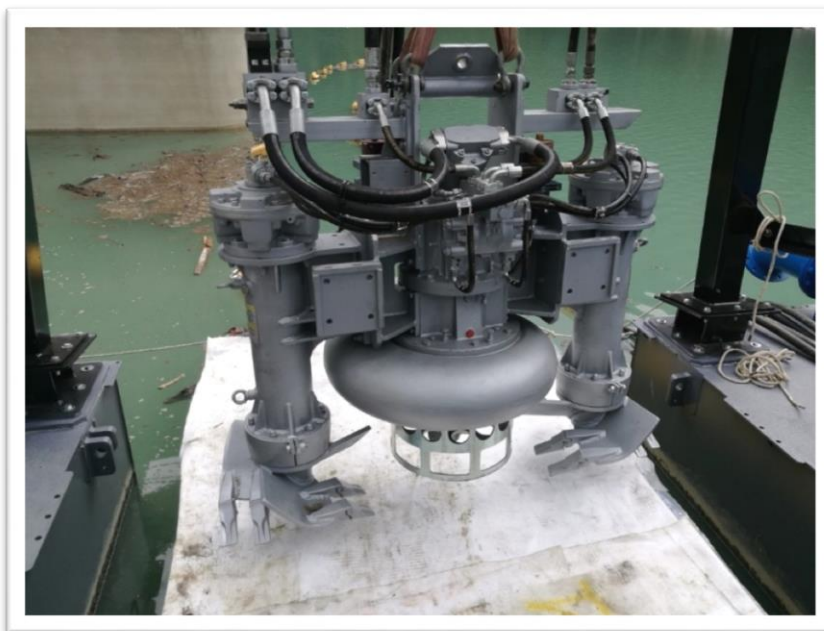
Considering the characteristics of the sediment to be dredged, and the total dredging time allowed by the Client, average slurry discharge has been equal to 500/600 m<sup>3</sup>/hour, with a volumetric concentration of 7 – 10%, and discharged into geotextile tubes located roughly 200 m far from dredging area itself. The pump selected for this project has been DRAGFLOW pump HY85/160B; it's a centrifugal slurry pump equipped with side excavators (Figure 4).

Figure 4. Centrifugal slurry pump with side excavators

Selected pump is a slurry hydraulic pump with a total power of 115 kW at 1,450 rpm, with a capacity of 500 – 600 m<sup>3</sup>/h and a total head of 36 m. Hydraulic engine of the pump is driven by a power pack with a diesel engine able to supply a total power of 220 kW needed for all the equipment of the pontoon (winches, hoist, side excavators, cabin heating and conditioning, night lights, etc.).

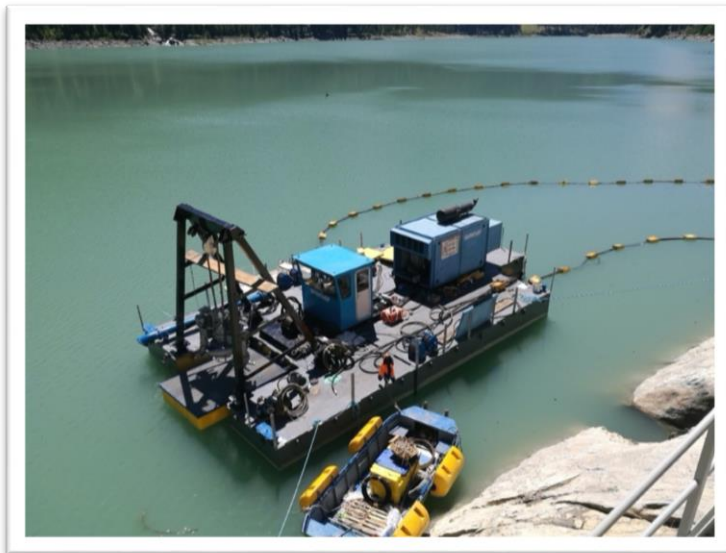
Submersible pump has been installed and managed through a pontoon specifically equipped (Figure 6). DRAGFLOW's pontoons follow a modular design that has been tested over the years in several projects all around the world. The submersible pumps adopted for this project allowed to use very compact pontoon, achieving at the same time quite large working depths requested by ALPERIA.

Figure 6. Pontoon

All DRAGFLOW's pontoons are designed for an easy transportation either by container or by trucks. The pontoons are built with internal reinforcement structures and divided in different compartments. The pontoons follow a catamaran design with a steel tripod and hoist as main movement system for the submersible dredging pump. The pontoon is complete with handrails and skids under the floaters with an integrated high capacity fuel tank.

The pontoon is equipped with four mooring winches driven by individual electric motors, each one with cable length of up to several meters. The entire dredging equipment is easily controlled

and operated from the central cabin were the operator manages all necessary controls to drive each component of the dredging system with indicators of working depths, current absorption and bathymetric survey system.

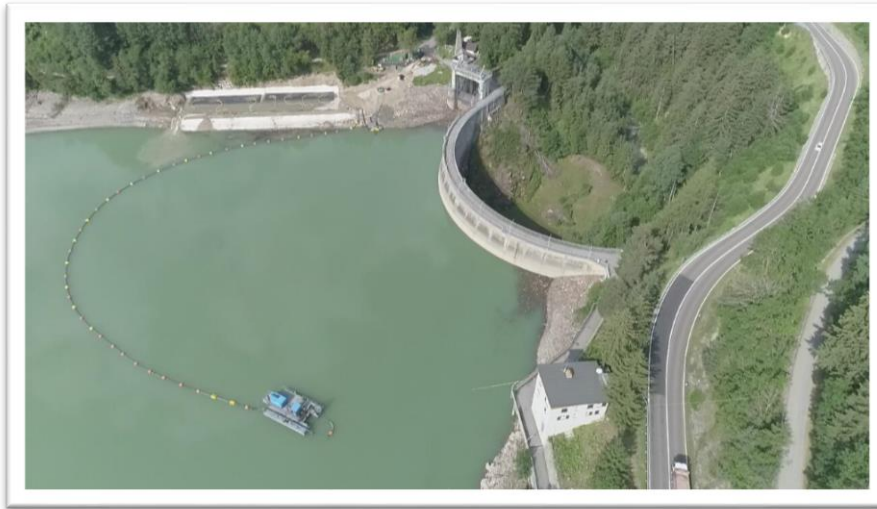
Figure 7. Aerial view of the dredging activity

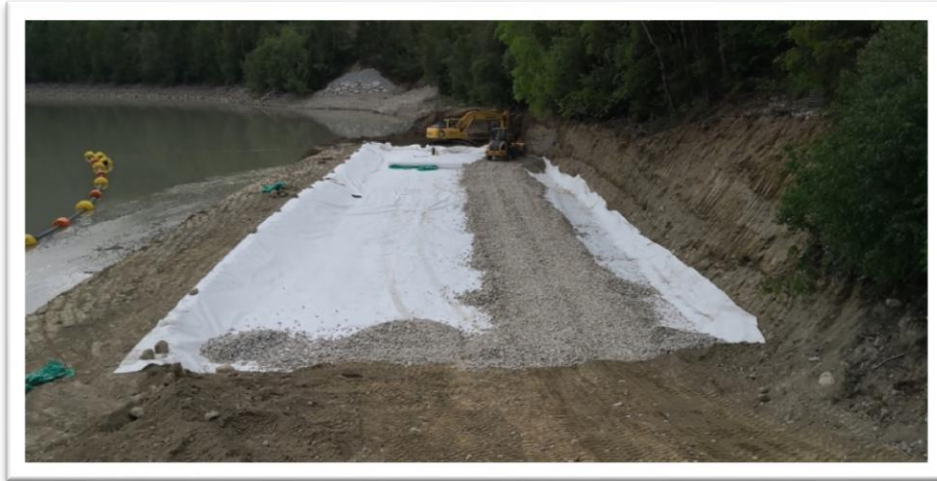
Figure 9. Final disposal area preparation (granular material over the geotextile)

The disposal area has been excavated and levelled, and a layer of granular material has been laid over a geotextile to assure a correct drainage of the dredging water. Above the drainage layer, N. 4 geotextile tubes have been laid in two rows (2 tubes per row), and over them N. 2 bigger geotextile tubes have been laid (one row).

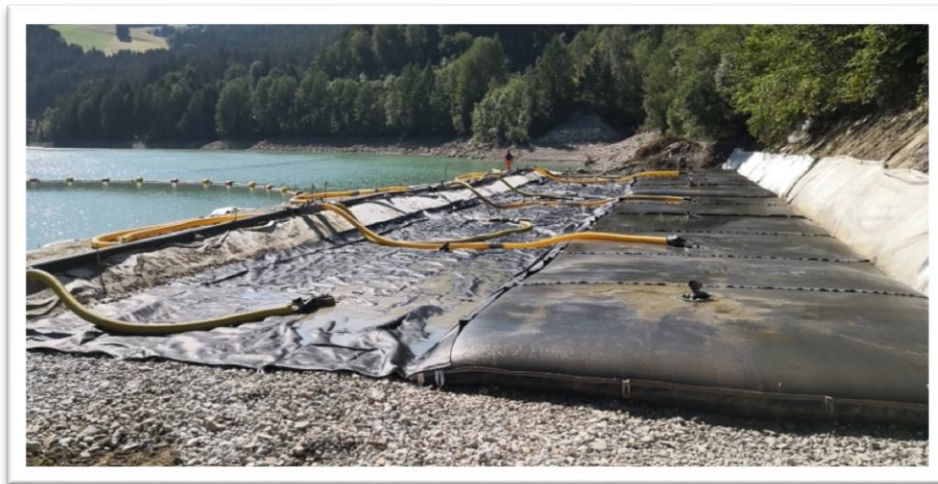
Figure 10. Geotextile tube filling

Every geotextile tube has been equipped with three filling ports, connected through a pipeline to the main pumping line, needed to have a regular tube filling all along the tube.

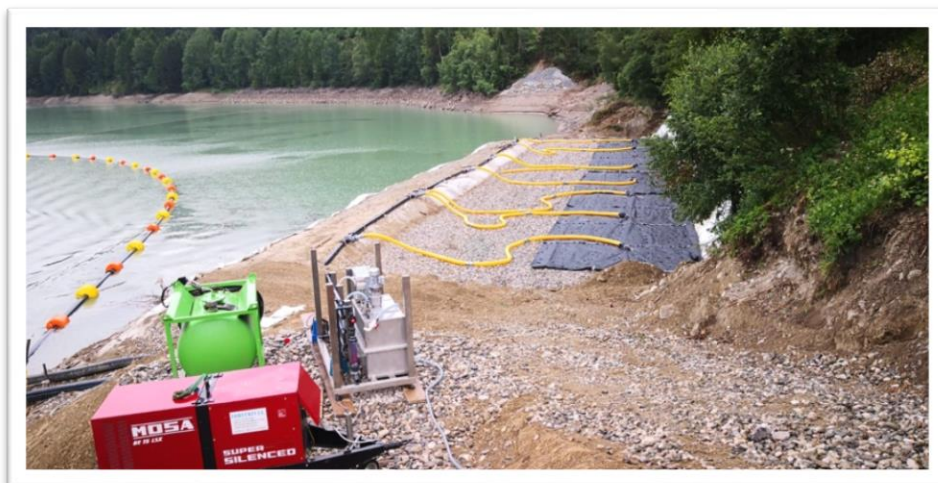
Figure 11. Flocculant mixing plant

According to laboratory test developed on samples of sediments to be dredged, a total percentage of flocculant (anionic poly-electrolyte) equal to 100 ppm has been selected taking into consideration geotextile porosity, dewatering total time, mineralogy and grain size distribution of the sediments to be dredged.

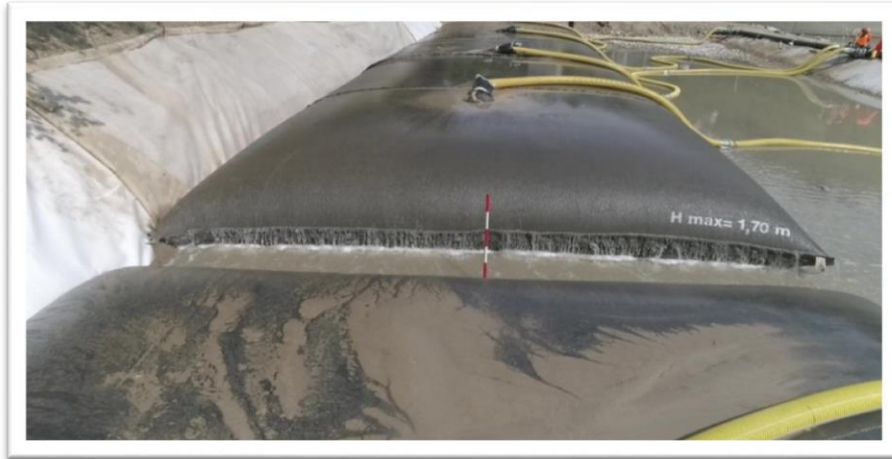
Figure 12. Dewatering of dredged sediments

A proper calibration of flocculant quantity per cubic meter of slurry allowed to develop dewatering process in a reasonable time, minimising the loss of fine sediments through the geotextile tubes.

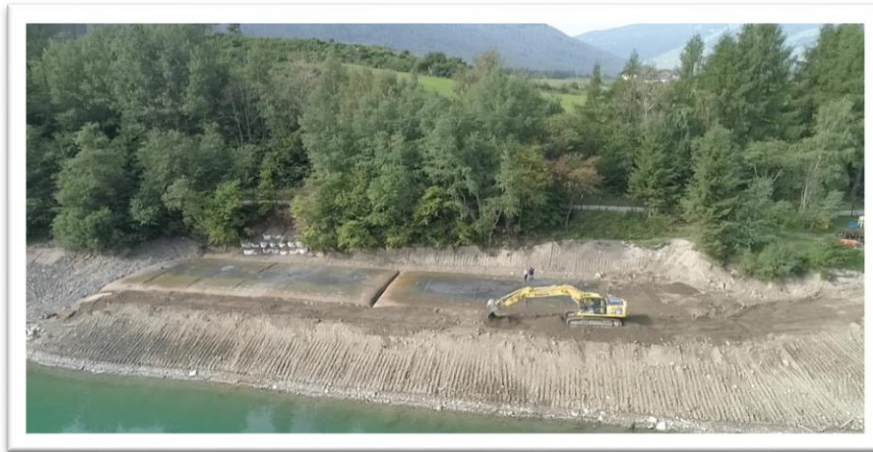
Figure 13. Final covering of the geotextile tubes with soil

At the end of the filling activity, and once consolidation time has been completed, a soil coverage layer has been laid and compacted above geotextiles tubes, where a grass layer grew in a quite short time.
