IMPACT OF SOFT WATER ATTACK ON DAM CONCRETE OF HYDRO POWER STRUCTURES IN THE HIMALAYAN REGION – CASE STUDIES

1. TEHRI HYDRO POWER COMPLEX, TEHRI DAM PROJECT, UTTARAKHAND

2. NATHPA JHAKRI HYDRO POWER STATION (NJHPS) , H.E. PROJECT ,SJVN, HIMACHAL PRADESH.

4. BAGLIHAR H.E. PROJECT J & K

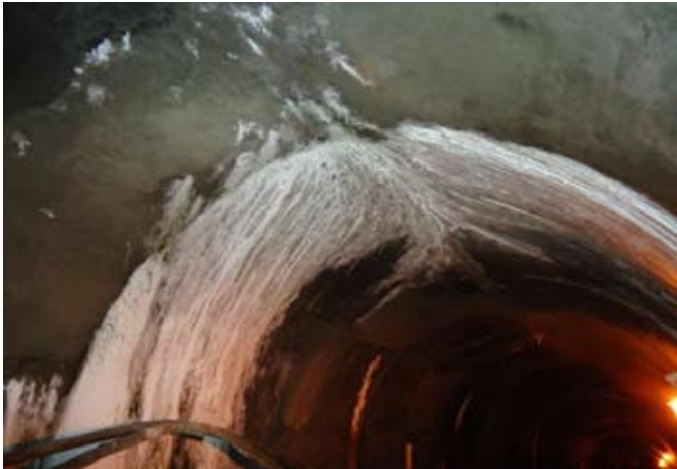
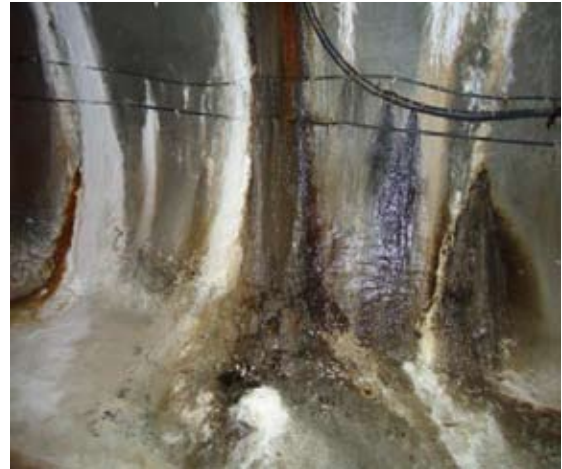
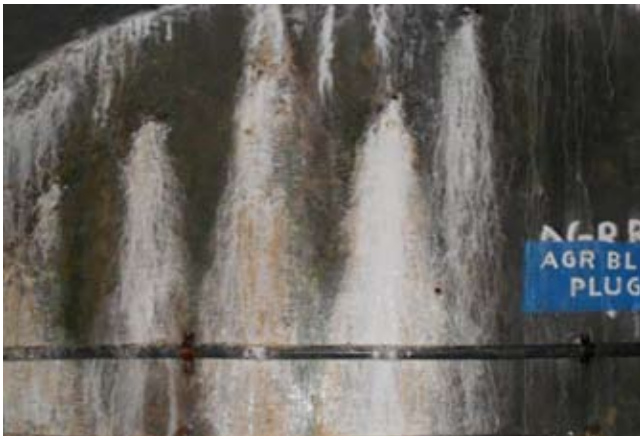
The inspection gallery (Grouting Gallery Riverbed Right (GRBR), Grouting Gallery Riverbed Left (GRBL)), AGRBR and AGRBL has concrete lining. Leaching of lime has been observed at many locations in these galleries (Figure 1-4). In the present case the problem apprehended is possible deterioration of concrete due to softness of water. This necessitates the adoption of suitable remedial measures. Before deciding on remedial measures, it is important to establish the degree of aggressivity of water with respect to various parameters. Once this is established, reference to categorize aggressiveness can be made to various codes and practices. Investigation to determine the cause and mineralogy of the leached material was carried out.

Fig. 1-4 : White, Black and Brown Leachate deposit in the inspection galleries

- Water samples are moderately aggressive as per values calculated by Langilier index
- The mineralogical composition of the white as well as black leachate samples indicates presence of Calcite as the main mineral.
- Leaching of lime from concrete structures facing aggressive water has been observed.

- The case histories discussed above is the alarming indication towards deteriorating health of project in the Himalayan region. Further exposure of concrete to the aggressive conditions will lead to worsening of conditions. It is thus important that the durability/performance of concrete should be constantly monitored so that the cause of deterioration can be ascertained and effective remedial measures be explored.

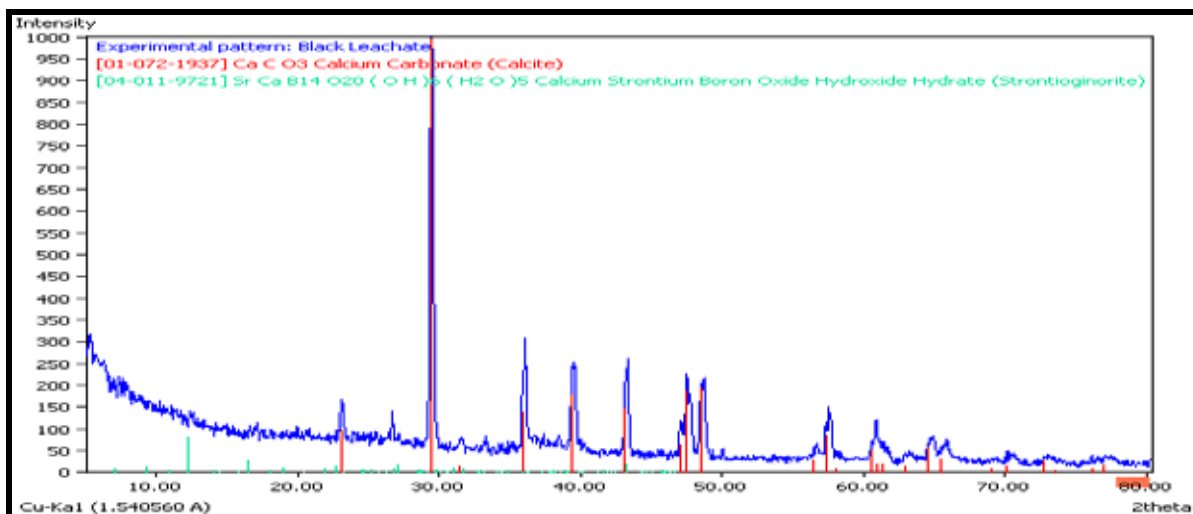
Leachate material samples collected from galleries were analysed using X-Ray Diffractometer (Figure 5 and 6) for determining their mineralogy.

- In the X-Ray Diffraction analysis, the phase identification with ICDD database and AMCSD database for all the leachate samples indicates presence of Calcite as the predominant mineral.

Fig. 6 : X-ray Diffractogram of Black Leachate material

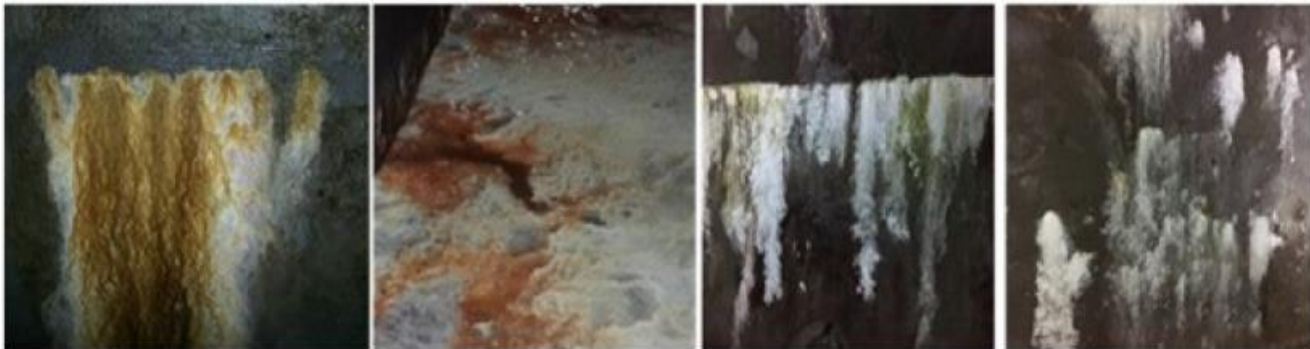
Baglihar Dam is built on Chenab River in the Doda district of Jammu & Kashmir. The hydro power project 'Baglihar Hydroelectric Power Project', is a run-of-the-river power project on the Chenab River. This project was conceived in 1992, approved in 1996 and construction began in 1999 and was commissioned in year 2009. It is 450 (3 X 150 mw) MW project. The Problem started surfacing soon after first filling of the reservoir with heavy seepage in the inspection galleries followed by deposition of leachate material on the roof and walls of galleries was observed.(Fig.8)

Fig. 8 : Leaching of Lime
