Review and Study on Evolution of the Cracks in Karun 4 Dam during First Impounding

Mohammad Ali Karimi¹, Ghasem Basereh², Fatemeh Momeni¹

1- AbanPazhouh Consulting Engineers, Tehran, Iran

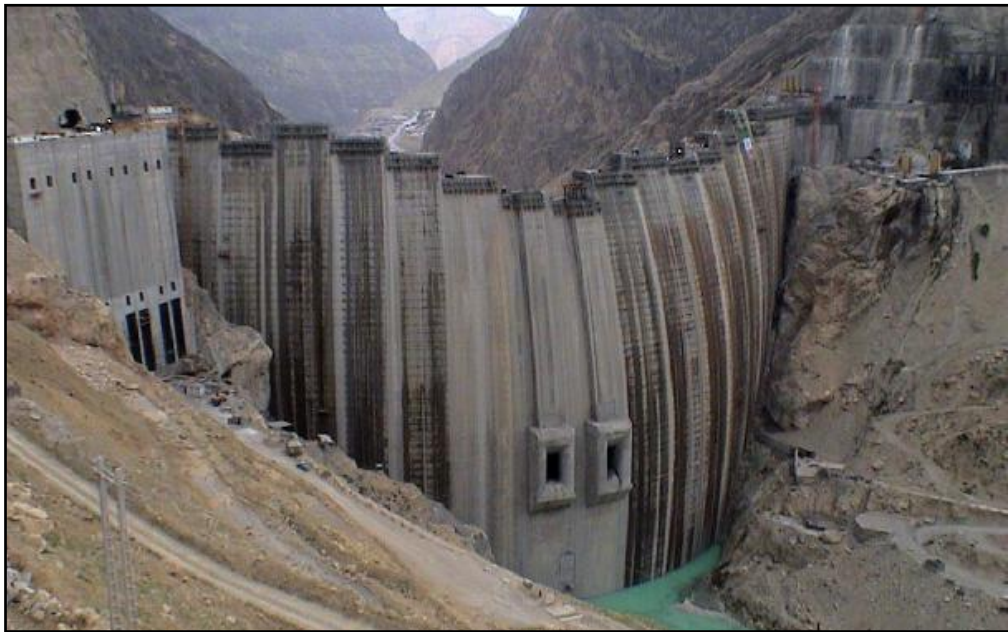
Figure 1. Construction progress at the start of Karun 4 reservoir impounding (March 25, 2010)

As indicated in Figures 1 & 2, concrete works of the dam blocks, and consequently, grouting of the dam contraction joints were not completed at the time of impounding (Table 1) [3]. At the start of reservoir impounding, the highest dam blocks were at EL. 1031masl – close to the dam crest - and the lowest ones were at EL. 1001masl (central blocks 3 & 1).

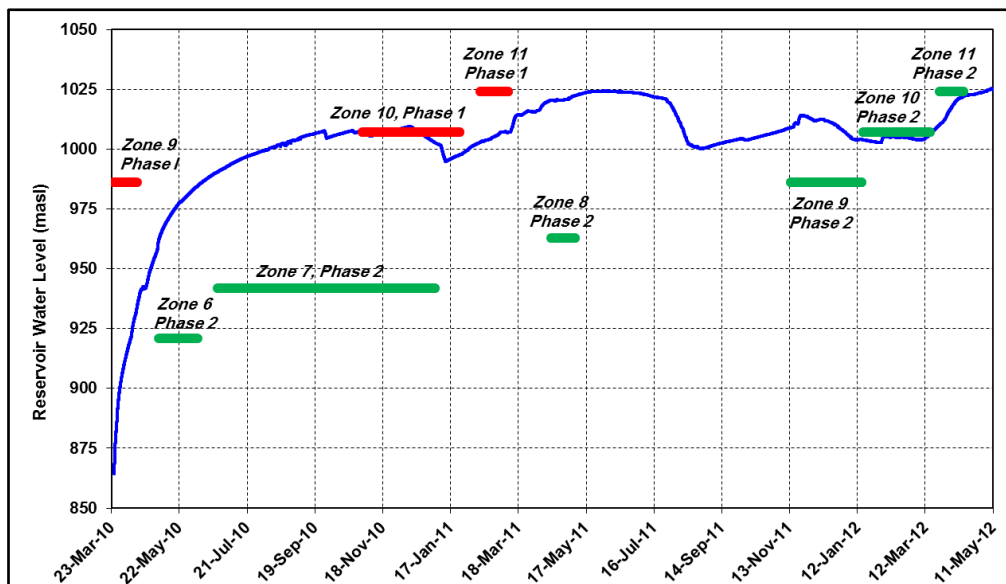
Figure 3. Karun 4 dam - Rate of the first reservoir impounding & status of contraction joint grouting
