Sensitivity of the Monitoring Results and their Interpretation to Minor Imprecision in Instrument As-Built Drawings (Case Study of Karun 4 Dam)

Mohammad Ali Karimi¹, Mohammad Reza Abedini¹, Ali Dadi¹, Fatemeh Momeni¹
1- AbanPazhouh Consulting Engineers, Tehran, Iran

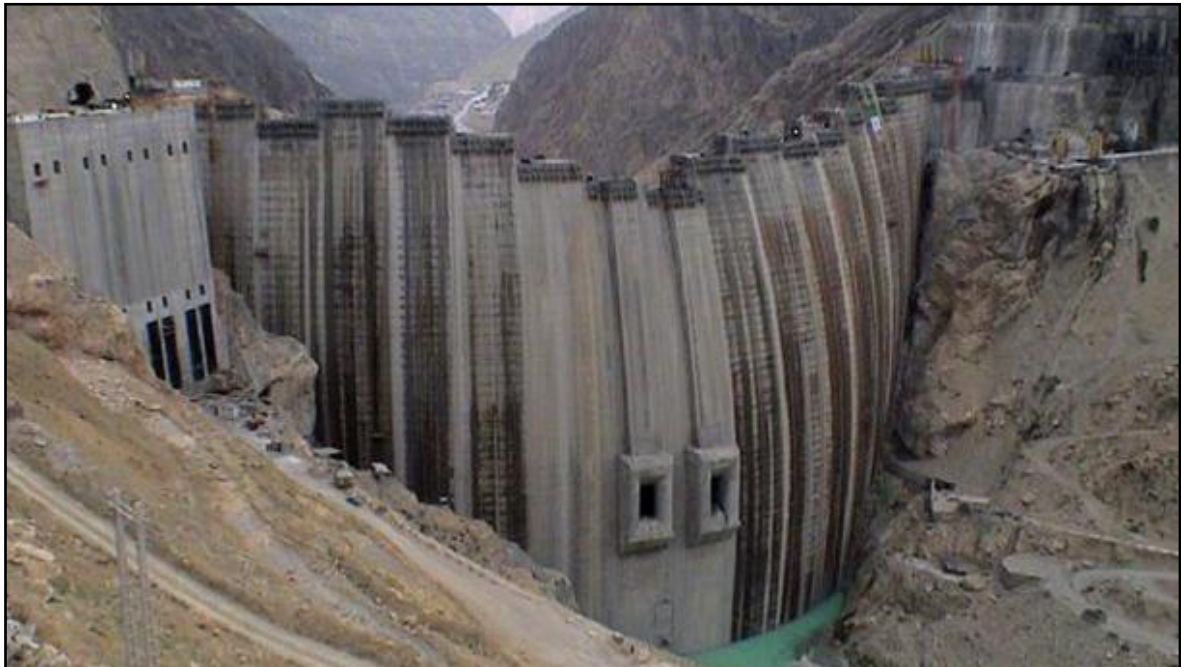
Figure 1. Construction progress at the start of Karun 4 reservoir impounding (March 25, 2010)

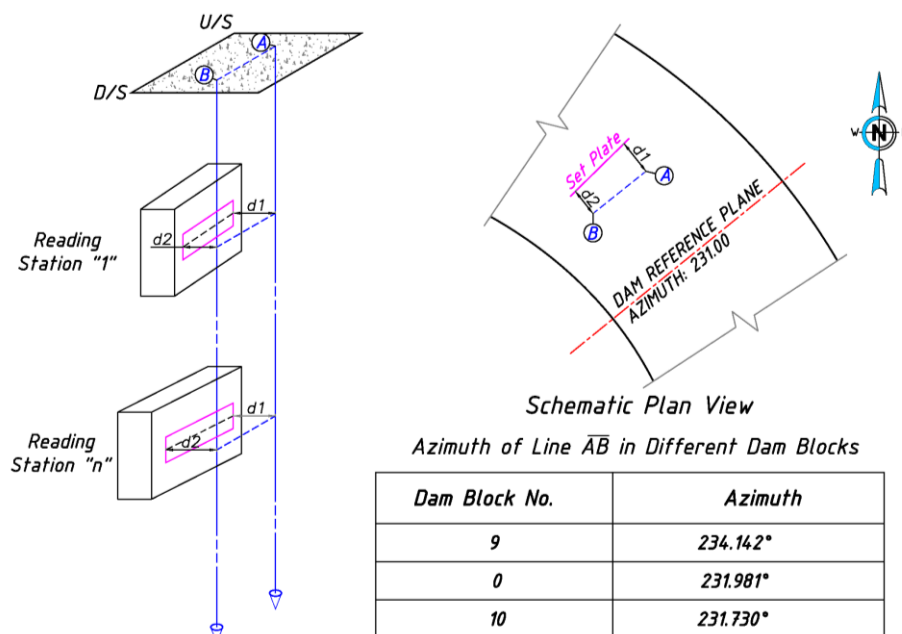
Figure 6. Schematic explanation of method used for surveying of set-plate azimuths in pendulum reading stations

The obtained results are presented in Table 1; accordingly, the average deviation in set plate azimuths is about 2.7 degrees, with the maximum values of 4.5° in block 9, 5.1° in block 0, and 6.4° in block 10. Despite these minor deviations in the pendulum set plates, sensitivity analysis of the displacement vector indicates that the lateral component of displacement is highly sensitive to minor variation of the set plate azimuth. As indicated in Figure 7, 5°-rotation in set plate azimuth could introduce 87% error in the lateral displacement component. This effect magnifies by increasing the displacement component in U/S-D/S direction.
