ICOLD Symposium on Sustainable Development of Dams and River Basins, 24th - 27th February, 2021, New Delhi

SASW SURVEY AND NUMERICAL MODELLING OF ROCK SCOUR AT GATED SPILLWAY (TEXAS, US)

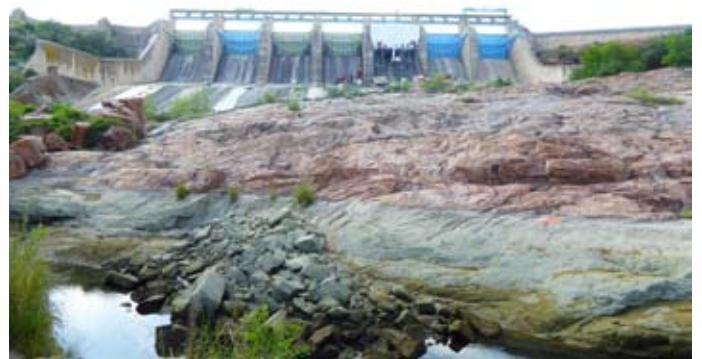
Figure 1 : 7-gate Spillway.

The 7-gate spillway structure was constructed to pass floodwaters via seven (7), 12 m long by 8 m tall radial gates. The reinforced concrete spillway includes a chute section flanked by training walls. The flood of record occurred at the dam shortly after construction was completed in 1938. During the flood all seven gates were operated at various sequences to 5.5 m open with a maximum of five gates opened concurrently and a peak discharge of approximately 2,265 m³/s. After flood operations were completed, scouring of the rock substrate adjacent to the spillway chute base slab directly downstream of Gates 1 to 3 was identified. The scour section along the right training wall was filled in and an approximately 46 m wide section of the spillway chute base slab were extended downstream approximately 30 m. The 7-gate spillway was not operated again until 1991 when another severe flood occurred in the basin and Gate 7 was opened to 5.5 m. The maximum discharge from the spillway was approximately 510 m³/s. After flood operations were completed, scouring of the rock substrate adjacent to the spillway was approximately and gate 7 was opened to 5.5 m. The maximum discharge from the spillway was approximately 510 m³/s. After flood operations were completed, scouring of the rock substrate adjacent to the spillway slab directly downstream of the opened gate was identified. The scour section was repaired with reinforced concrete.

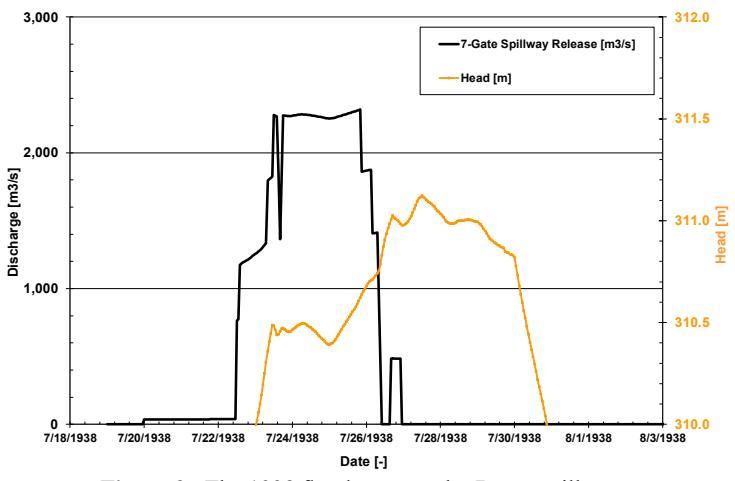
Figure 3 : The 1938 flood event at the 7-gate spillway.

As shown in Figure 3, the 1938 flood event had a total duration of about 96 h, for a maximum discharge of 2,300 m3/s during 48h. Gates 1-5-6 were used during the first 24h of the event at max. 1,200 m3/s, while gates 3 to 7 took over during the remaining 72 h of the event, because of the observed damage encountered along the concrete apron just downstream of gates 1 and 2. The 1991 flood occurred in December 1991 and lasted for about 48h at a quite constant discharge release of only 520 m³/s.

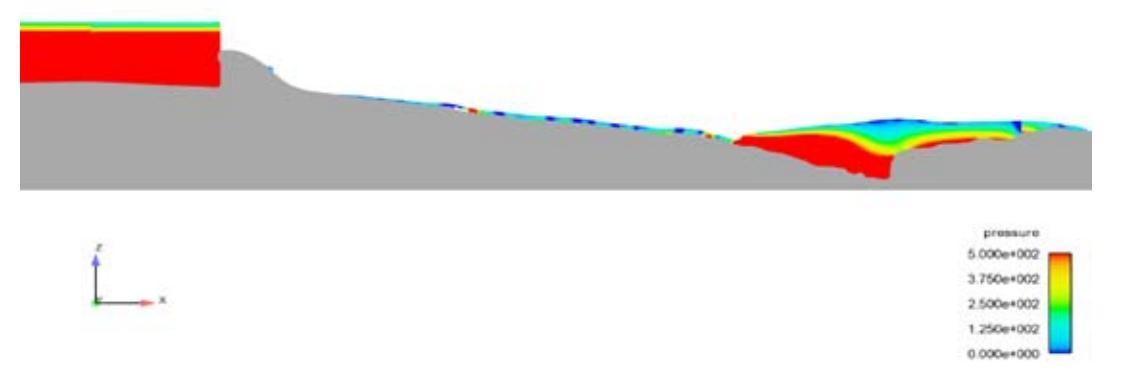
Figure 6 : 3D dynamic pressure field computed downstream of gate 4 during the 1938 flood event.

Freese and Nichols, Inc. performed a detailed 3D CFD numerical modelling of the dynamic pressures (average values and RMS fluctuations) and the velocity field (average values) for the 1938 flood event and for different future gate operating scenarios. The computed data has been used as input to the Comprehensive Scour Model (Bollaert, 2004). Figure 6 shows an example of 3D computed dynamic pressures along the gate 4 geologic profile during the 1938 flood event (gates 1-5-6 open). Figure 7 shows the RMS and average dynamic pressures computed by CFD for all gates fully open.
