ICOLD Symposium on Sustainable Development of Dams and River Basins, 24<sup>th</sup> - 27<sup>th</sup> February, 2021, New Delhi

# REHABILITATION AND PREVENTION OF FROST DAMAGE TO THIN CONCRETE DAMS IN COLD REGIONS

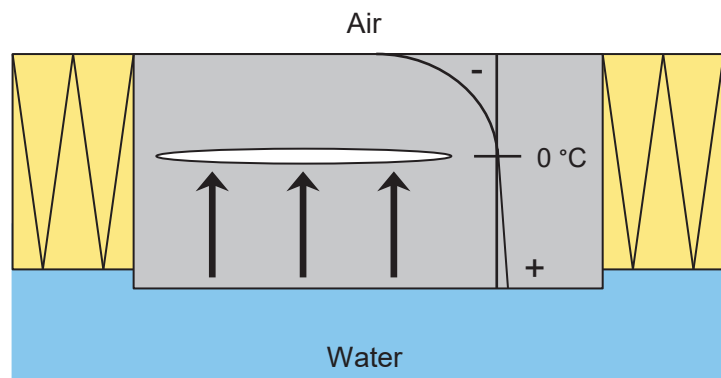
**Figure 6** : Test setup used to subject concrete specimens to unidirectional freezing.

The risk of macroscopic ice lens growth in hardened concrete subjected to unidirectional freezing was studied in the laboratory. A test setup was designed to correspond to conditions present at the two dams (Figure 6). The top surface of concrete specimens of size 150x150x70 mm was subjected to freezing, whereas the bottom surface was in contact with unfrozen water. To ensure one dimensional heat flow in the specimens, the remaining surfaces were insulated. The specimens were placed in a box filled with water, letting the lower surface stay in contact with water. Moreover, a heating coil was placed on the bottom of the box to control even water temperature. Also a water pump was put into the water to keep it circulating.

In rather stable thermal conditions, macroscopic ice lens growth occurred only in mechanically sound concrete with w/c-ratio 0.9 or higher. Such low quality concrete is not normally used in thin concrete dams. On the other hand, if normal quality concrete becomes water saturated and subjected to freezing, internal damage may occur. It was shown that macroscopic ice lenses form in frost-damaged concrete within a few days regardless of the w/c-ratio.

Of similar importance are cavities and other imperfections of the concrete material that may exist in the vicinity of reinforcement bars due to inadequate compaction during casting. It was shown that growth of macroscopic ice lenses also occur in normal quality concrete with imperfections (Figure 7). However, the period of freezing required to facilitate the formation of macroscopic ice lenses increases with decreasing w/c-ratio. Nevertheless, the risk of concrete spalling in thin concrete dams cannot be overlooked since unfavourable temperature and moisture conditions may occur over time in structures with long service life. Hence, extension of the service life of thin concrete dams is closely related to the issue of durability of concrete.
