EXPERIENCES IN THE REPAIR OF MORE THAN 300 DAMS WITH FULL RESERVOIR LEVEL

A. GONZALO

HCC-ES, Madrid. Spain

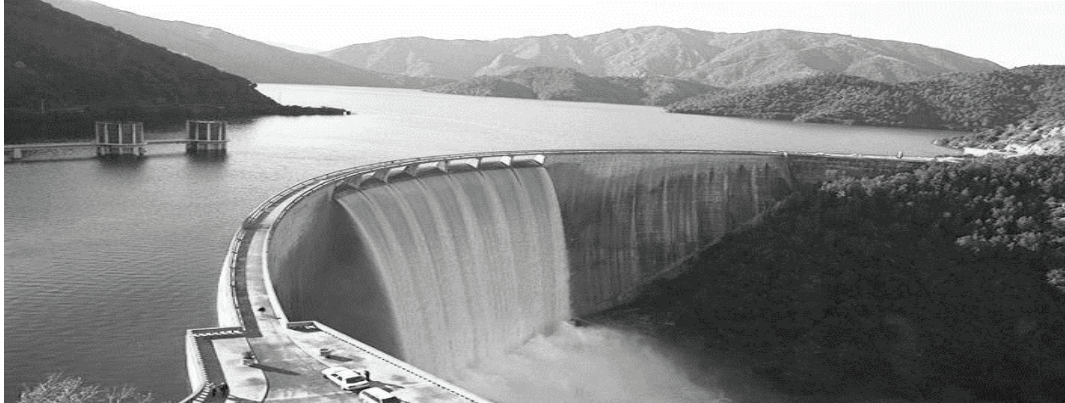
Figure 7 : Susqueda Dam overview.

Auscultation of the Dam revealed that the transmission of compressive stresses of contiguous blocks did not have the desirable continuity for a structure of this kind. Therefore, the opening of joints between blocks showed some drift, which made advisable to proceed with the re-grouting of the vertical joints, to improve the structural response of the dam to the solicitations it received, mainly thermal and hydrostatic load, and to regain their ability to transmit stresses between blocks, up to the stirrups.

The analysis of the dam's prior behavior, recommended carrying on the re-grouting of the contraction joints of the structure. According to these studies, we decided to perform a grouting project that would define in detail, the most appropriate method and times to execute the grouting.
