THE USE OF HYDROPHILIC WATERSTOPS IN DAMS CONSTRUCTION

S. TAUBERT AND P. BUCHANAN

GHD Pty. Ltd., Melbourne Dams, Tailings and Hydropower, Victoria, Australia

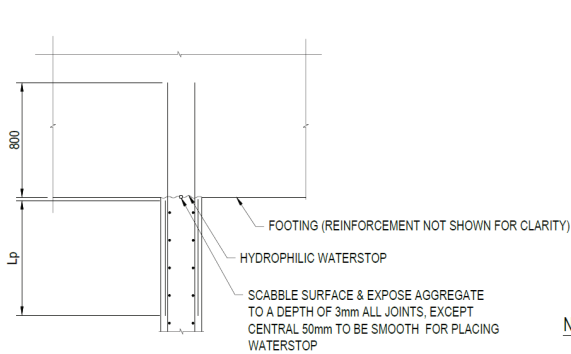
Both the ramp and channel were designed with hydrophilic waterstops to protect the joints from water leakage. All waterstops were documented as being designed in accordance with manufacturer's recommendations.

Figure 17 : Vertical construction joints

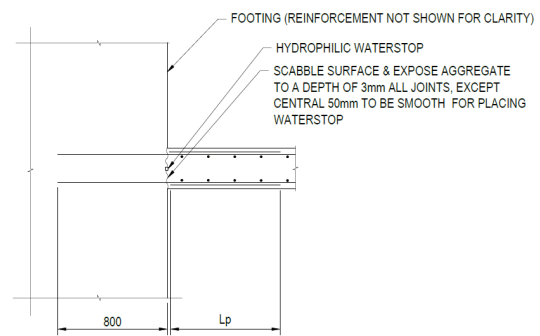
Figure 18 : Horizontal construction joints
