ICOLD Symposium on Sustainable Development of Dams and River Basins, 24th - 27th February, 2021, New Delhi

INSPECTION OF DAM INFRASTRUCTURES USING ROVS - AN INNOVATIVE APPROACH

KANNAPPA PALANIAPPAN P, JOHNS T MATHAI, NIRMAL THOMAS AND SUDHEESH K

EyeROV (IROV Technologies Pvt. Ltd), Ernakulam, Kerala, India

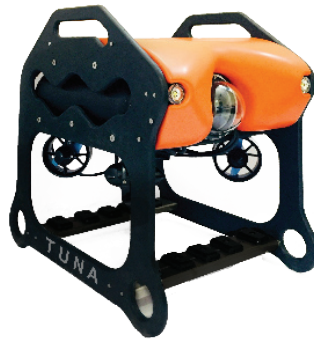
The ROV used for the following inspections methods and research studies is of the model - TUNA ROV (Fig. 1.) made by EyeROV (IROV Technologies Pvt. Ltd.), an Indian company specialised in marine robotics. The TUNA ROV system is a custom modular ROV (Remotely Operated Vehicle) designed with a high performance on board computers and an intuitive control console for critical infrastructure inspection and surveillance operations. It is designed for carrying custom payloads as per the requirement of the operation having a range of attachments and sensors.

Figure 1 : EyeROV TUNA ROV

- Depth Rating of 100 m
- Optimised Thruster Configuration
- High Manoeuvrability
- External Sensor Interface – Serial and Ethernet
- Power Options : External/On-board batteries
- Live HD Video
- High Intensity Lights
- Payload: 2 kg to 5 kg
- Payload Options: SONAR, CP Sensor etc.

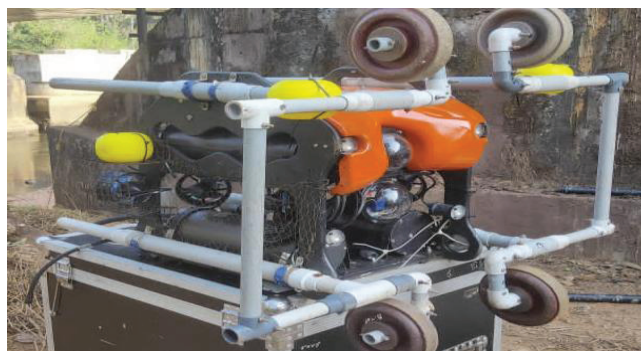
Based on the dam structure it may be necessary to attach site specific customisations on to the ROV to effectively hold it in position (Fig. 2).

Figure 2 : Customisation for Dam Inspection

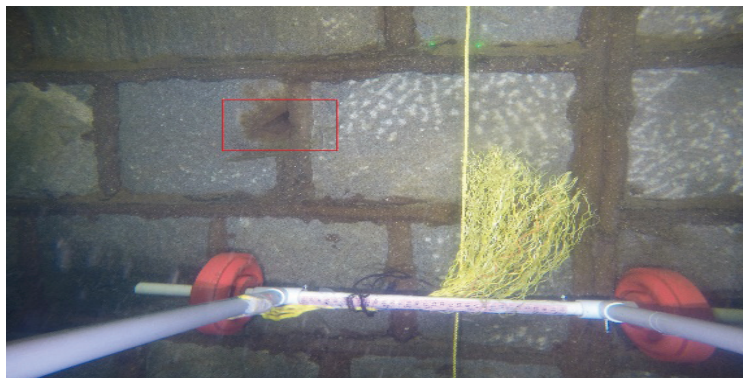
Visual imaging is one of the main technique that is being used to assess concrete deterioration. With the help of High Definition cameras, ROV can capture the details of underwater concrete structure and transmit the video data to ground station where the ROV pilot/operator is seated. The pilot can then easily find out concrete structure defects. Visual imaging is suitable only for clear water conditions (Fig. 3).

Figure 3 : Anomaly found using EyeROV TUNA during a Dam Inspection

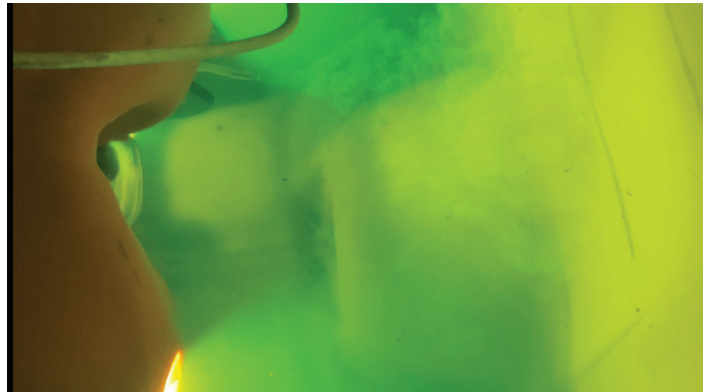
TUNA ROV has a Fluorescent dye injection mechanism to perform leakage detection. A chamber is filled with green fluorescent dye which is injected to water by using an electronic system. An Ultraviolet Torch light is then used to trace the path of dye.

Dye could be injected from a location very close to the crack. This can ensure that the dye moved into the crack rather than elsewhere on the dam. By tracing the path of dye using UV light and camera, the exact leakage point can be located (Fig. 7.).

Figure 7 : Dye Injection testing using EyeROV Tuna

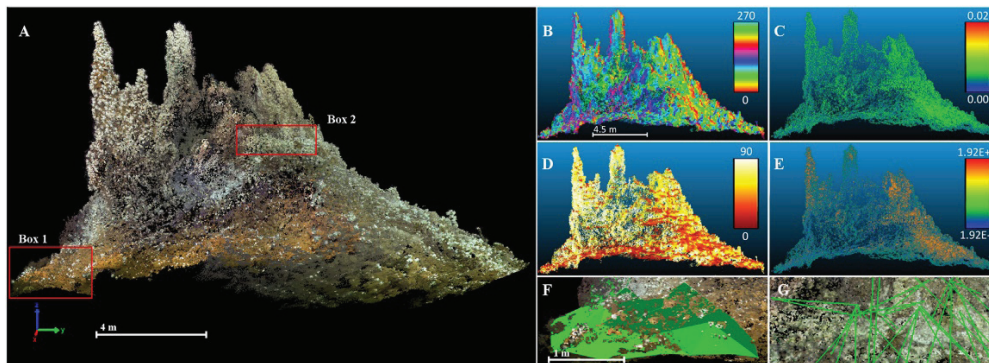
Due to significant attenuation of light in underwater, a single image covers only a few square meters. To assess the entire underwater structure surface, hundreds or thousands of such images are required. Here we use an image processing technique called ‘3D Reconstruction’ to produce the exact three dimensional view of inspected underwater structure (Prabhakar & Kumar, 2012). Multiple frames of the underwater structure is taken from different angles and directions. These images are then stitched together to form a 3D construction of the entire underwater structure and the local environment. The user can then navigate through the 3D visuals similar to a 360° image and closely inspect the data in the post inspection assessment (Fig. 10).

Figure 10 : A 3D reconstructed image of a Coral Reef (Mapping the seabed with underwater videogrammetry, 2020)
