CONSTRUCTION OF BORINQUEN DAM 1E AT THE PANAMA CANAL

The recently completed Panama Canal Expansion project required construction of a 6.7-km-long channel at the Pacific entrance to the Panama Canal. The channel banks are partially formed by four dams, which retain Gatun Lake, the main waterway of the Panama Canal, approximately 27 m above the Pacific Ocean. The dams were designed as rockfill embankments with central impervious cores of residual soil. Design and construction of the dams posed multiple challenges including: 1) variable foundation conditions with occasional unpredictable weak features, 2) use of residual soils as core materials, 3) a wet tropical climate with a 4-month dry season, and 4) geologic faults across the dam foundations. The largest of the dams, Borinquen Dam 1E, is 2.2 km long and 32 m high. Construction of Dam 1E included: 1) erection of a 1.3-km-long cellular sheetpile cofferdam, 2) excavation of a 460-m-long cement-bentonite slurry cutoff wall, 3) injection of a 2.4-km-long grout curtain, and 4) installation of a 100-m-long secant pile wall. This paper provides an overview of the construction of Dam 1E and its key features and describes important design

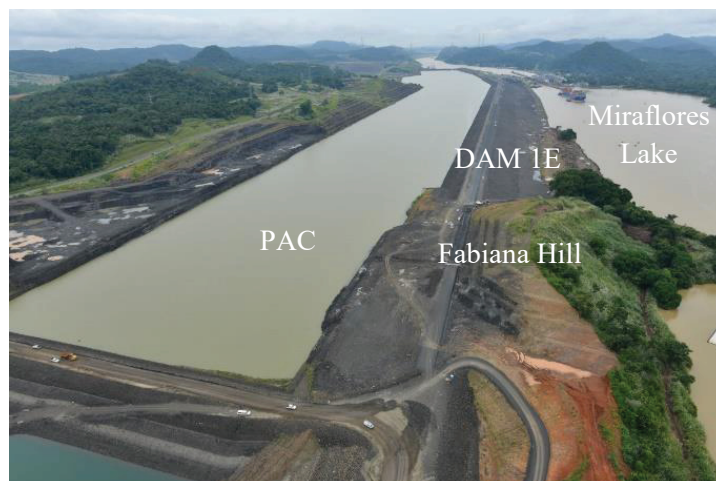
Figure 1 : View of Pacific Access Channel (PAC) and Dam 1E, looking North

The recently completed Panama Canal Expansion Project required construction of a 6.7-km-long channel at the Pacific entrance to the Panama Canal, to provide navigation access from the new Post-Panamax locks to the Gaillard Cut section of the Canal. The new channel, known as the Pacific Access Channel (PAC), is partially formed by four dams, referred to as Borinquen Dams 1E, 2E, 1W, and 2W. The dams retain Gatun Lake, the main waterway of the Panama Canal, approximately 11 m above the level of Miraflores Lake and 27 m above the Pacific Ocean. A view of the 5-km-long, northern portion of the new channel and of Dam 1E is shown in Figure 1.

Following completion of the cellular cofferdam, the dam footprint was dewatered, and the foundation was excavated to remove muck from the former bed of Miraflores Lake (Fig. 1). Between 1 and 2 m of material were left above the foundation level for removal during final excavation. Figure 4 shows the dam foundation after bulk excavation and initial placement of rockfill on the inboard foundation. The volume of channel and foundation excavation totaled 26,989,000 m³.

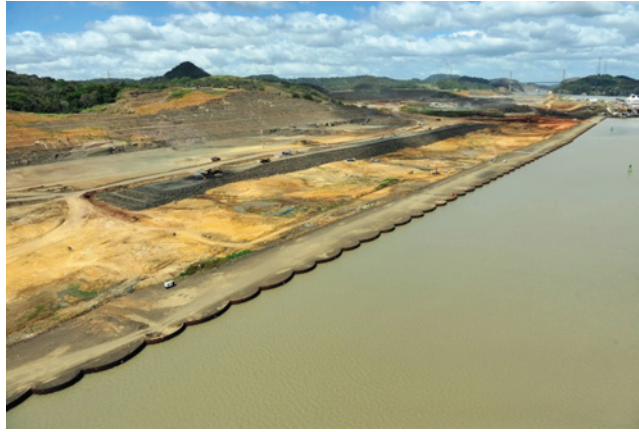
Figure 4 : Dam 1E foundation with cellular cofferdam in foreground, PAC excavation in background, and rockfill shell on the inboard dam foundation

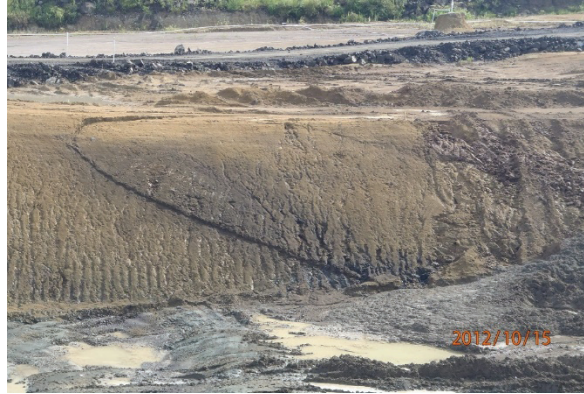
Figure 5 : Example failure of outboard core trench slope

stabilize the slope. No failures occurred on the inboard slope. The slumps developed on adversely oriented features such as bedding shears or joints, which caused wedge failure of the trench walls, as shown in Figure 5.

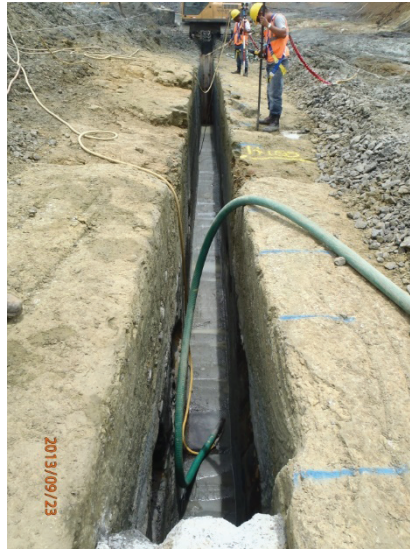
Figure 6 : Cleaning of concrete cutoff wall trench

Following initial cleaning and mapping of the core foundation, the concrete cutoff wall was installed along the inboard row of the grout curtain. The wall is 3 m deep and 0.6 m wide and was extended to the full length of the foundation. The wall trench was excavated with a trenching machine with a 0.65-m-wide blade. Compressed air, water, and suction were used to remove rock fragments, water, and debris at the base of the trench prior to backfilling with concrete (Fig. 6).

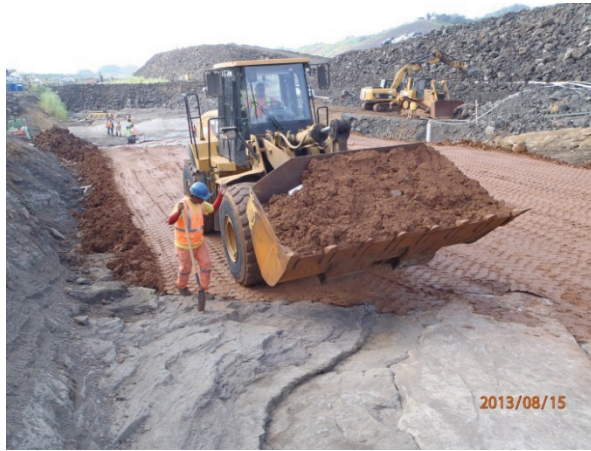
Figure 8 : Compaction of core Zone 1A with front-end loader

A zone of select core material (Zone 1A) up to 1 m thick was placed at the base of the core to provide a good contact with the foundation. Alluvial soil without rock fragments was typically used for this zone. A 300-mm-thick lift was placed first to avoid damaging the foundation. A 200-mm loose thickness was used for subsequent lifts within Zone 1A. The materials were compacted with 8 passes of a weighted front-end loader, as shown in Figure 8. In confined areas inaccessible to the loader, gasoline-powered hand tampers were used with a reduced lift thickness of 150 mm.

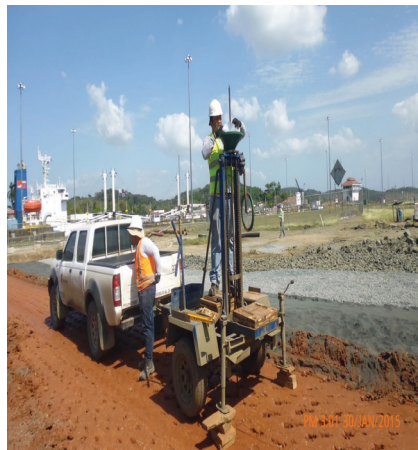
Figure 9 : Vane shear testing of compacted core material

Compaction was indexed by measuring the undrained shear strength of each lift using a field shear vane in accordance with standard ASTM D2573. Figure 9 shows a shear vane strength test in progress. This proved to be a rapid and reliable quality control test method. Periodically, field density tests were also performed as part of the quality assurance program, using the sand replacement method (ASTM D1556) at the same locations tested with the shear vane. The in-place average water content of Zone 1 was +5.7% above the standard optimum. The average vane shear strength was 114 kPa. The relative compaction of the material averaged 93.2% of the standard maximum dry density (ASTM D698).

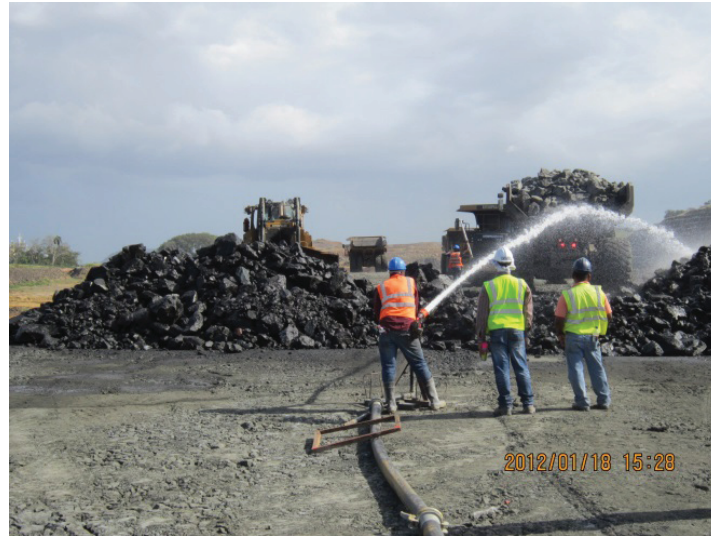
Figure 10 : End-dumping, spreading, and watering of shoulder rockfill

Shoulder rockfill was placed by end-dumping from large trucks and by spreading out and leveling the material in 0.9-m lifts with a bulldozer. Water was added with water cannons or water trucks during spreading (Fig. 10). The rockfill was compacted by 6 passes of a 12-ton, smooth-drum, vibratory, self-propelled roller. Eleven in-situ density and gradation tests were completed in the rockfill. An average dry density of 2,310 kg/m³ was measured using standard ASTM D5030.

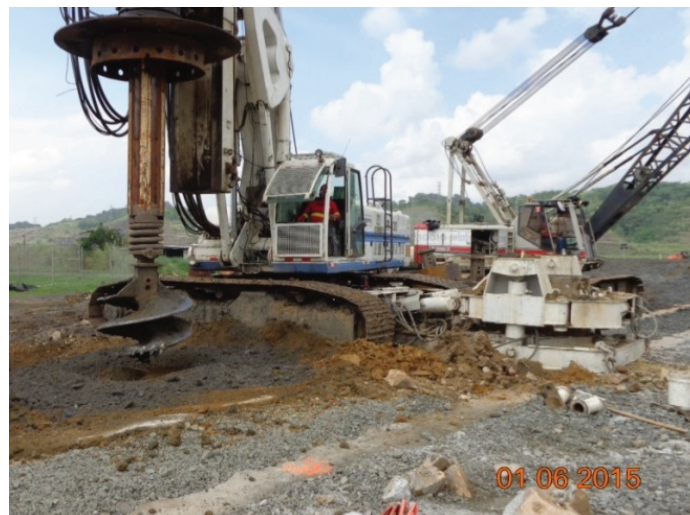
Figure 11 : Excavation of secant piles

The North Tie-In Cutoff Wall completes the Dam 1E water barrier between the dam embankment and the Pedro Miguel Locks. The wall is a plastic concrete secant-pile structure, 97 m long and up to 26 m deep. It penetrates into sound rock of the La Boca Formation, and overlaps vertically with the grout curtain. A cutter-tooth auger bit and a hydraulic oscillator successfully drove steel casing to support the holes in the cobble and boulder backfill of the Pedro Miguel Locks and the auger excavated the materials out (Fig. 11). The shaft bottom was carefully cleaned with a bucket auger.

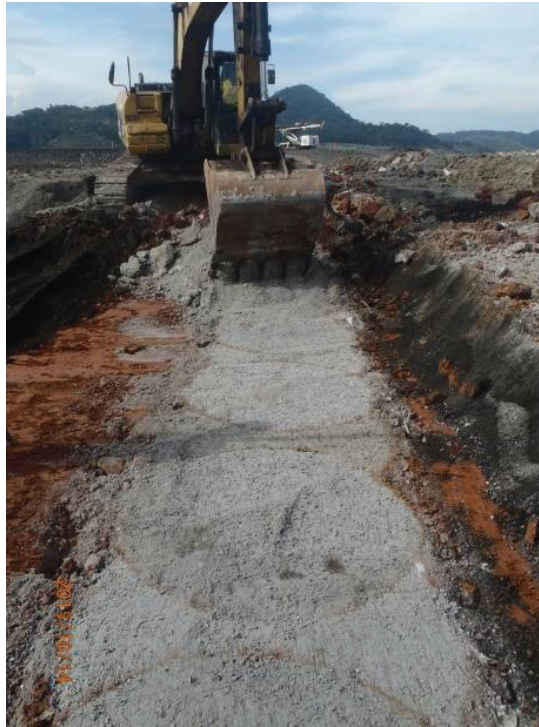
Figure 12 : Trimming the top of the cutoff secant-pile wall

Upon completion of the wall, the concrete guides were removed, the top of the wall was trimmed to the design elevation, and the embankment was completed over the wall alignment. The joints between piles were delineated at the surface by a thin smear of clay/bentonite around the perimeter of the secondary piles (Fig. 12). The contact between piles and the integrity of the piles was verified at depth with drillholes. Core recovery and camera inspection of the holes showed a good contact between piles, and between the foundation rock and the base of the piles.
