MOSUL DAM – DATA MANAGEMENT

ABSTRACT:

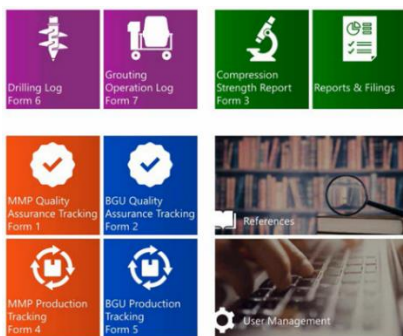
Figure 3. Mosul Dam QA Application

As the drilling and grouting activities progressed and expanded the data management practices and procedures adapted to support the on-site team. AECOM equipped its field engineers with windows-based tablets with a custom-built Microsoft Windows Forms application (see Figure 3). The application utilized a SQLite backend database. The application was designed to be an internal tool used primarily by the QA Field Engineers to improve the quality and efficiency of the data collected. To access the application the user would enter their username and password. The application home page contained links to each of the seven forms, reports and filings, references link, and user management, for users with administrator rights.

To access a form, the field engineer would click on the form's link which would take the user to the forms landing page. This page would list all of the forms (e.g., Form 7) that had been created. The field engineer could view previous forms, add a new form, and in some cases edit existing forms. The purpose of each form is listed below.
